C. C. KOERNER HOUSE

Built in 1912

**1824 SOUTH MOUNT VERNON
Spokane, Washington 99223**

Spokane Register of Historic Places Nomination Form

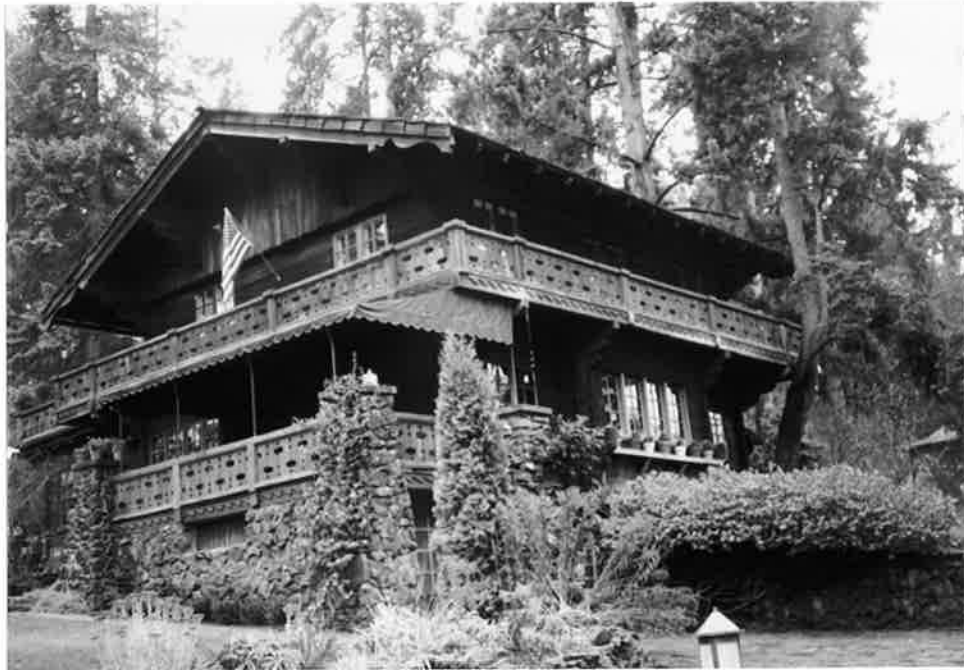
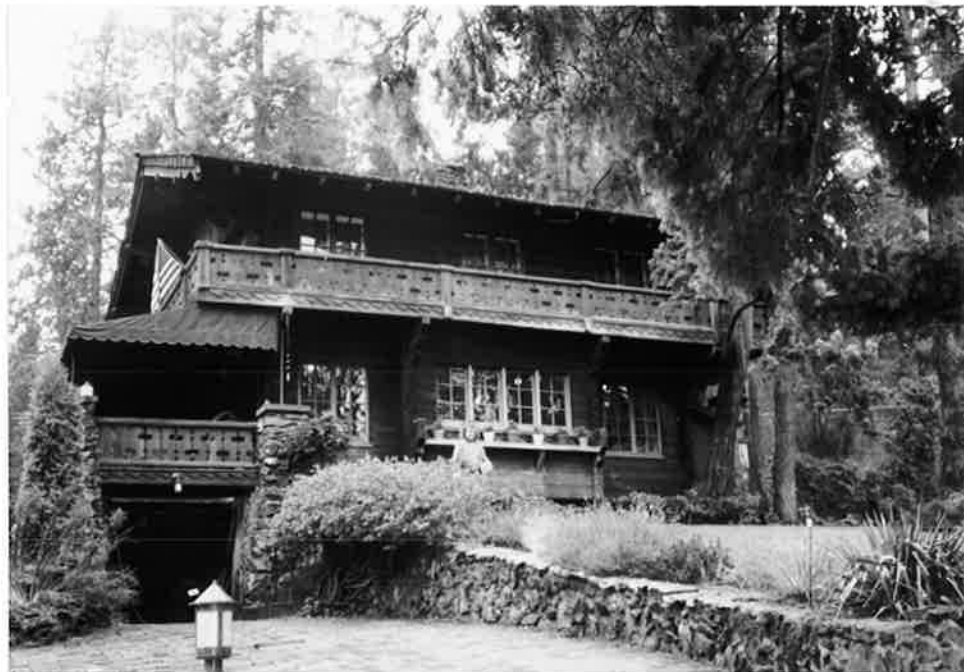
Photos 1 and 2: Northeast and north facades of house. Photos taken in 1998.

The Koerner House is a fine example of the American residential Swiss Chalet architectural style. Defining features of the style include a low-pitched front-gabled roof with widely overhanging eaves, scalloped vergeboard, massive decorative brackets or corbelled consoles, rough-cut wood siding, and second-floor balconies and gallery porches with flat, cut-out balustrades. Displaying excellent architectural integrity, the well-preserved Koerner House exemplifies these elements.

The two-story Koerner House forms a slightly irregular, rectangular footprint measuring approximately 26 feet by 38 feet with nearly 1000 square feet on each floor. The house features a wood-shingled, front-gabled, low-pitched roof with prominent, widely overhanging eaves and exposed rafter tails supported by powerful consoles composed of massive, corbelled, square-hewn log ends. A scalloped bargeboard highlights the roofline. A four-foot wide, second-floor gallery porch embellished with a decorative, flat, cut-out balustrade of rustic rough-cut cedar is a distinguishing feature of the house, and completely encircles the home. The gallery porch is supported by corbelled log-end consoles. The exterior of the house is clad in horizontal rough-cut pine shiplap siding stained dark brown. Outer corners are embellished with false V-notched log-ends. Together, the horizontal shiplap and false corner timbering give the impression of square-hewn log construction, a typical feature of the classic Bernese Oberland chalet. The house is supported by a 12- to 18-inch thick mortared basalt rock foundation.

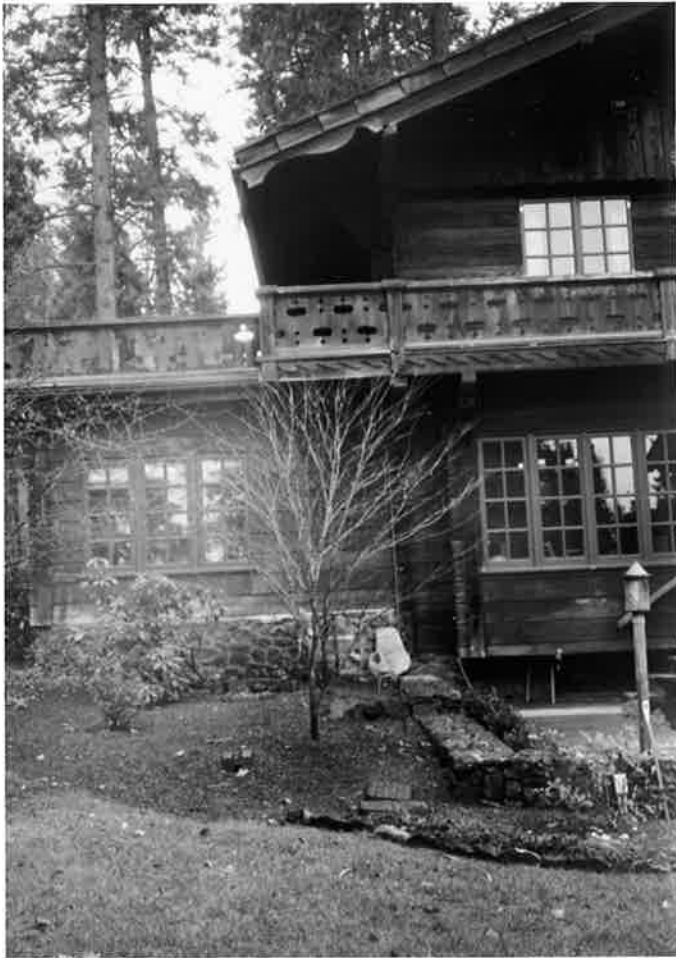
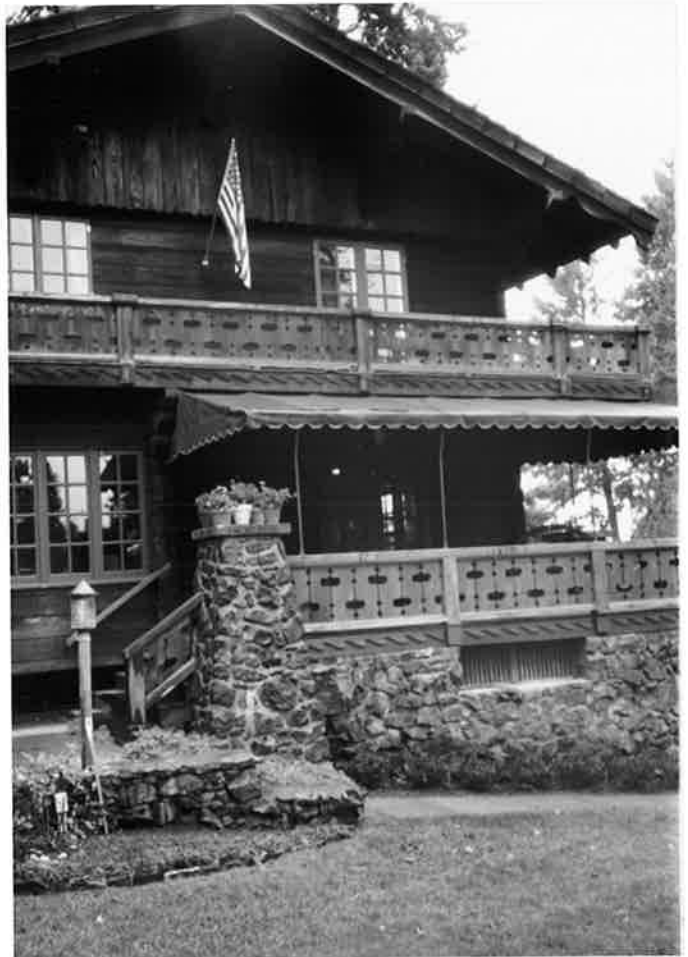
Photos 3 and 4: East facade of house. Photos taken in 1998.

The primary facade of the Koerner House faces east and features a first-floor porch supported by massive, battered, basalt rock piers. The porch is enclosed by a cut-out balustrade in the same design as that of the second-floor gallery. A green canvas awning stretched over a metal frame is attached to the house and extends over the porch. Multipaned French doors open from the porch as well as from the second-floor gallery. Fenestration includes multipaned paired casement windows. The facade's gable face is defined with vertical pine-plank cladding embellished with scalloped trim along the lower edge. The home's secondary facade faces north and is dominated by a one-car garage set beneath the front porch. Multipaned casement windows illuminate the first and second floors, and multipaned French doors open from the second-floor gallery to second-floor bedrooms. The west elevation of the house features a gable peak clad in vertical pine-plank cladding, and a second-floor gallery porch that extends over a one-story sunporch. The sunporch projects 12 feet from the house and is illuminated by rows of multipaned casement windows. A flat roof covering the sunporch is distinguished by a scalloped cornice board and projecting, decorative, scroll-sawn rafter tails. A small, one-story bay with a shed roof projects from the west elevation next to the sunporch. The rear, south elevation of the Koerner House is dominated by a first-floor addition constructed in 1924. The addition is clad in stained pine shiplap siding, and features a multipaned bay window. The roof of the addition is flat forming a deck and extension of the second-floor gallery porch. Designed as a continuation of the second-floor gallery balustrade, a flat, cut-out balustrade encloses the deck. A window box ledge supported by decorative brackets extends from beneath a multipaned casement window next to the addition. Second-floor fenestration located on the rear, south elevation includes multipaned casement windows.

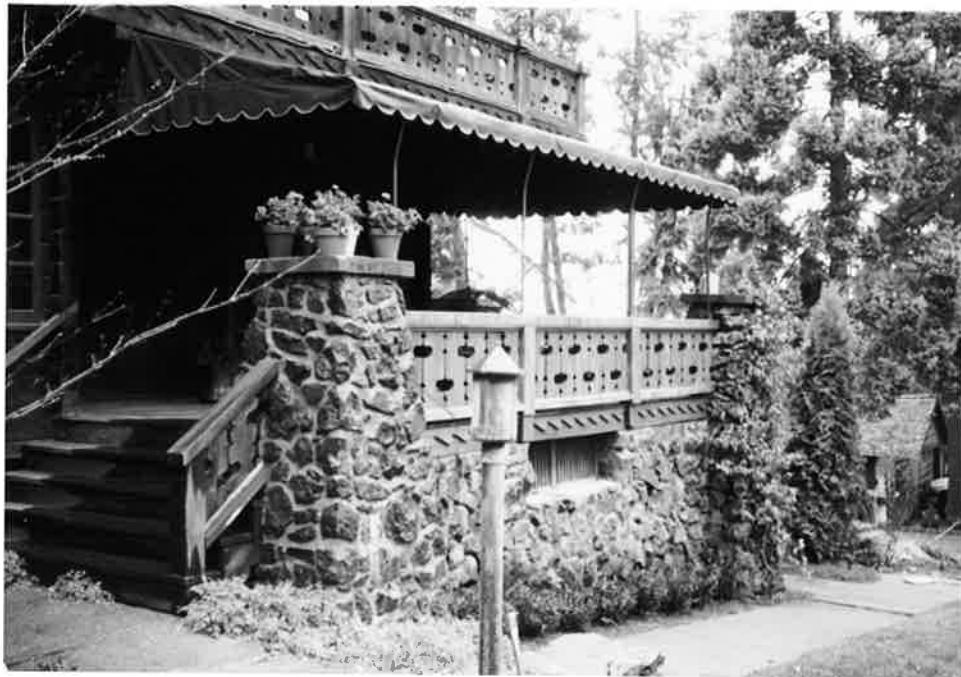
Photo 5: East facade porch with basalt rock piers. Photos taken in 1998.

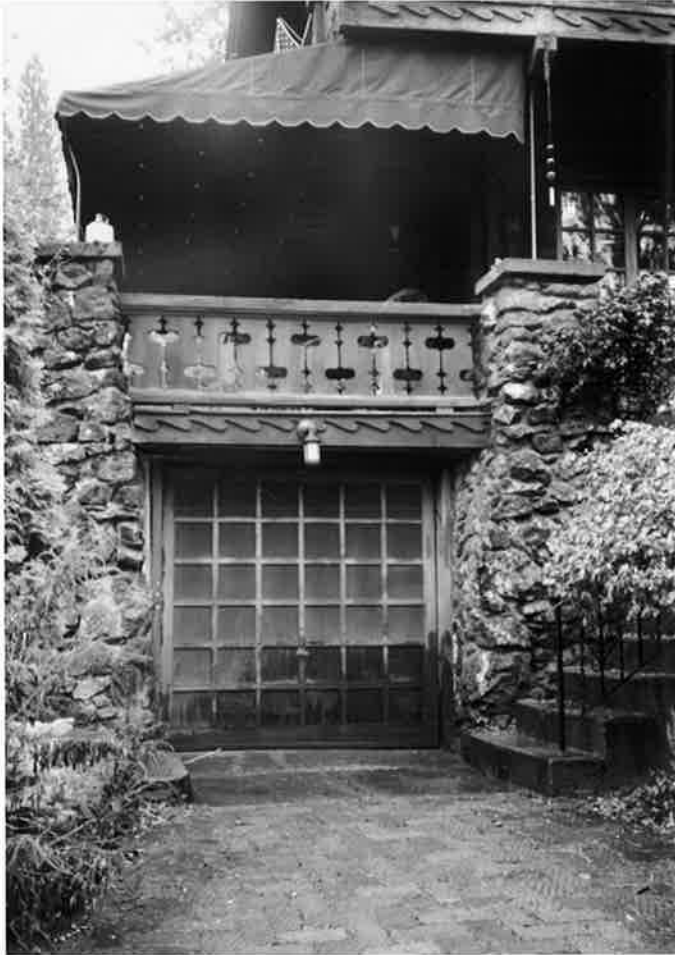
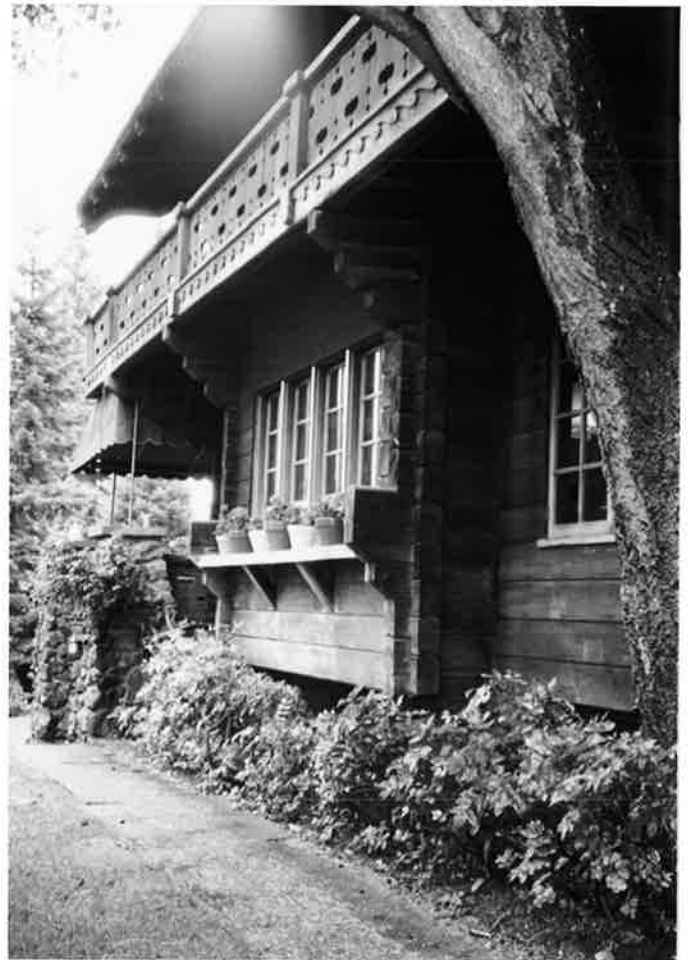
Photos 6 and 7: North facade ground-level garage opening and north facade with second-floor gallery. Photos taken in 1998.

Due to extensive fire damage sustained in 1952, the original French doors of the garage were replaced with a paneled, electric-powered, automatic door. By 1970, the roof's original hand-sawn wood shingles had been replaced with cedar shakes. Due to damage caused by tree roots, a doorway leading to the cellar was covered with a small, one-story addition that projects slightly from the home's west elevation. The addition is covered with a shed roof and houses garden tools. In 1972, the solarium was rebuilt to serve as a library-TV room, and was finished with multipaned windows and rough-cut exterior pine

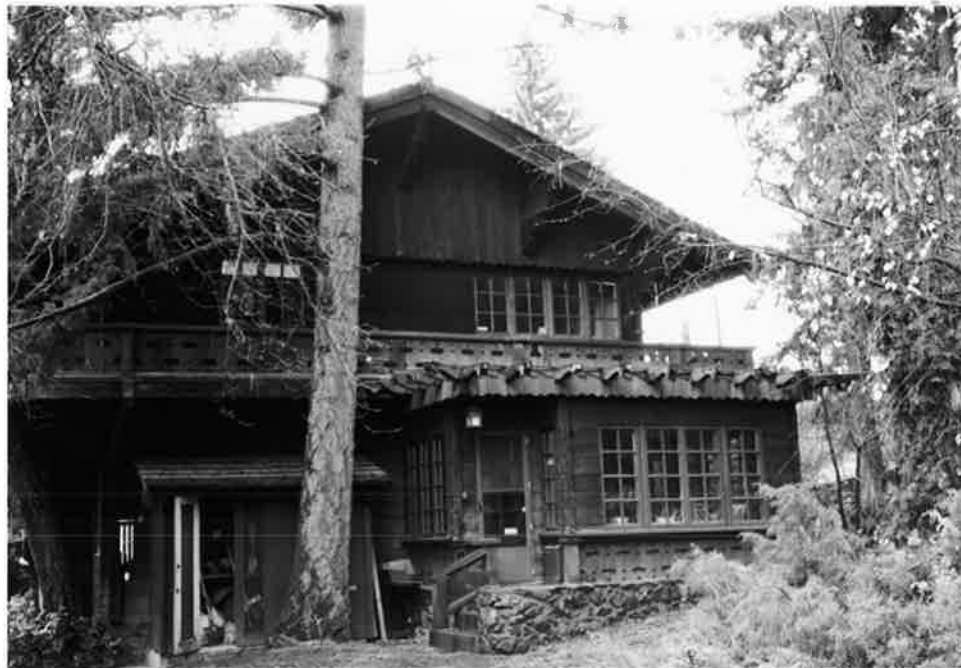
Photos 8 and 9: Northwest corner of house and west elevation with sunporch and second-floor gallery/deck. Photos taken in 1998.

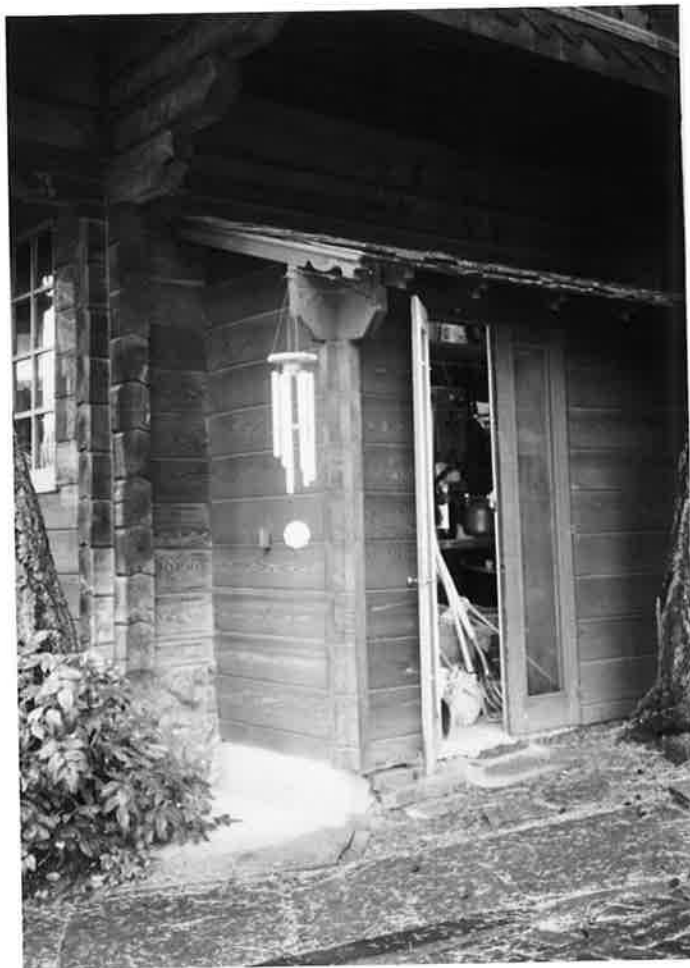
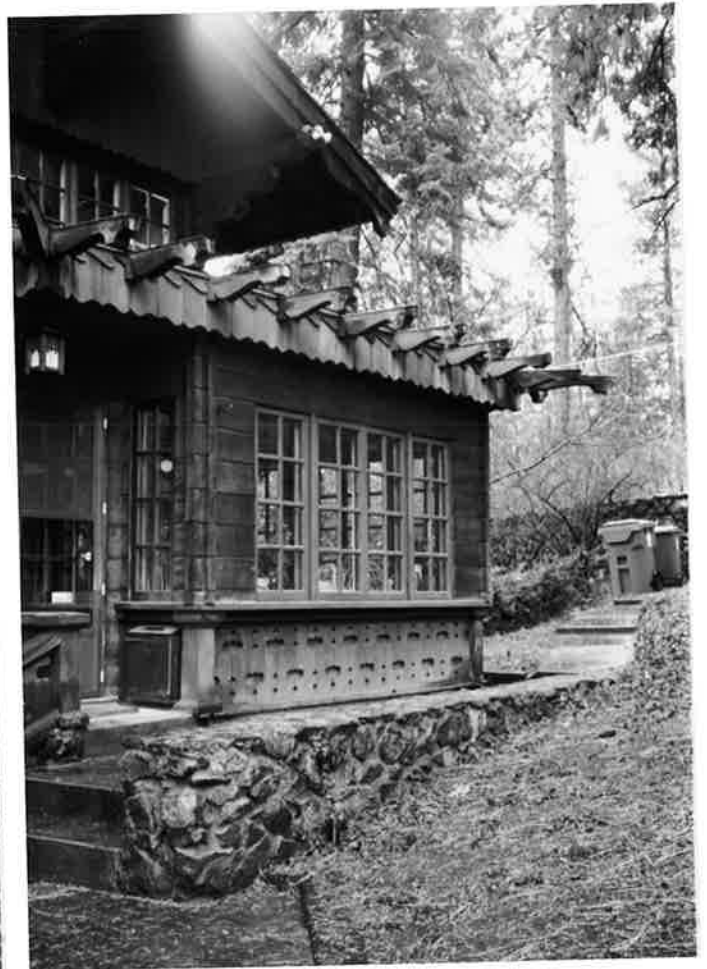
Photos 10 and 11: West elevation tool/garden shed and sunporch. Photos taken in 1998.

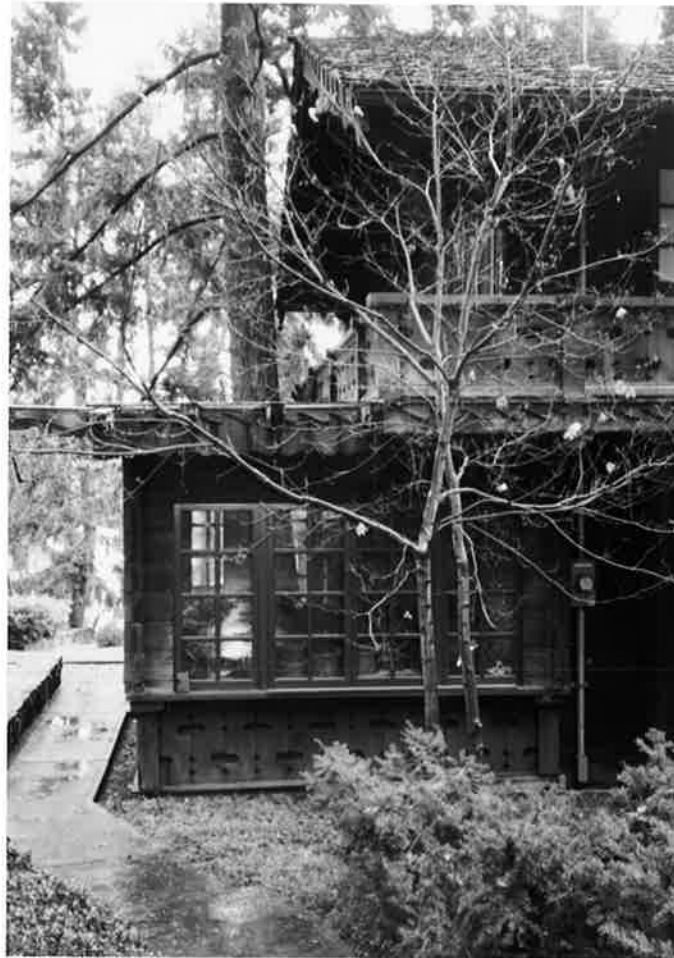
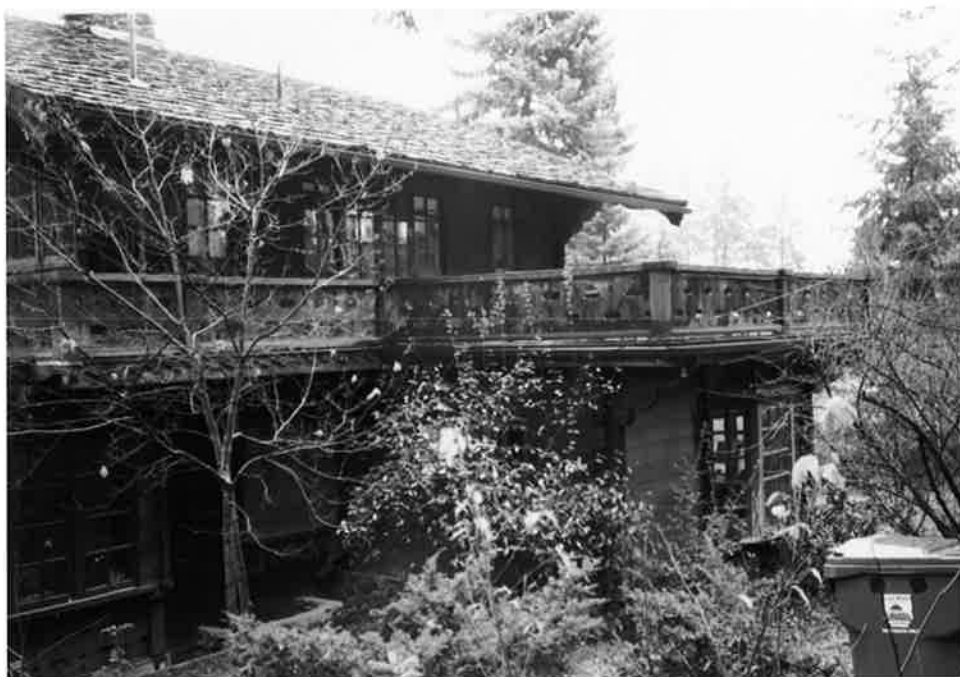
Photos 12 and 13: South, rear elevation with first-floor addition. Photos taken in 1998.

The Koerner House is well-preserved and retains excellent integrity found in original exterior rough-cut pine shiplap siding, decorative cut-out porch and gallery balustrades, multipaned casement windows, and French doors. Black and white photographs taken in the 1920s depict original first-floor plan, interior woodwork, dining room wall partitions, built-in window seat and inglenook, brick hearth and fireplace, hardwood floors, and Craftsman-style ceiling lights located at the intersections of boxed ceiling beams. The photographs also reveal a glass-enclosed solarium with an interior brick floor, water fountain, and goldfish pond. The solarium was constructed in 1924 and attached to the south, rear elevation of the house.

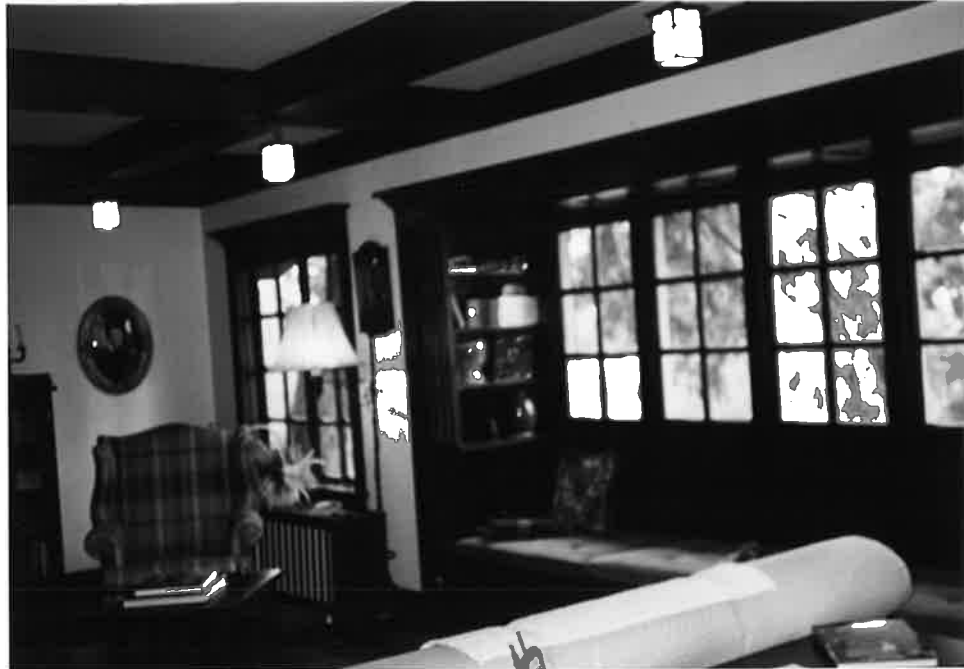
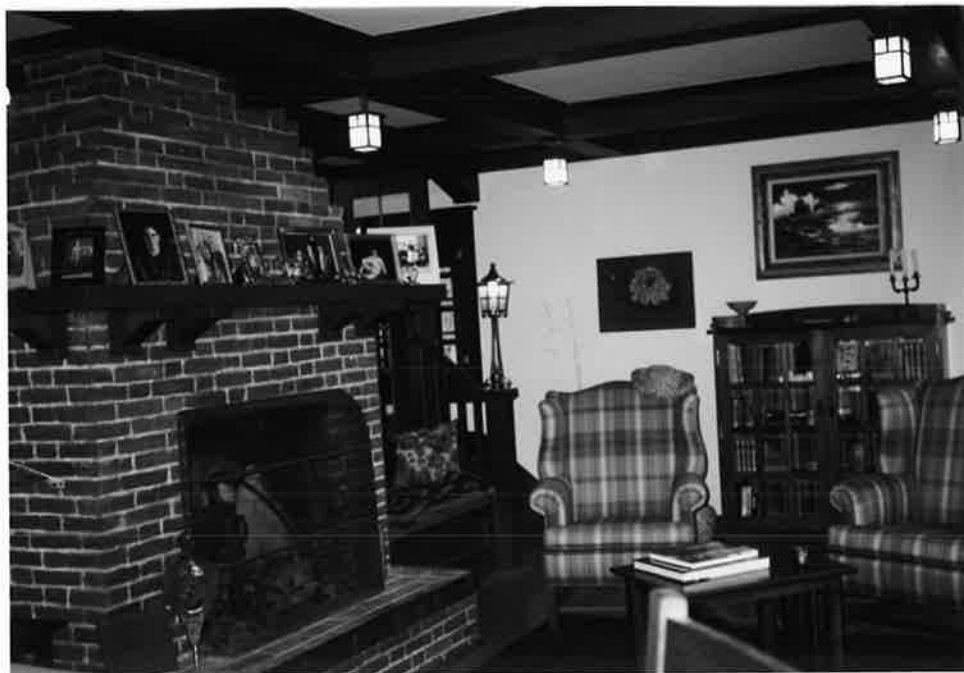
Photos 14 and 15: First floor interior living room and fireplace. Photos taken in 1998.

The interior space of the Koerner House comprises a sunporch, family room, living room, dining room, kitchen, three bedrooms, a full bathroom, and a powder room. Multipaned French doors open from the front porch into the home's spacious living room that measures 14 feet wide by 28 feet long. The living room and dining room are dominated by fir woodwork with a black walnut finish. The rooms' eight-foot high ceilings feature decorative crown molding, and are intersected by massive boxed beams. The focal point of the living room is an interior brick fireplace with a raised hearth and a massive, bracketed wood mantel. The base of the hearth is protected by two strips of hammered iron, and original andirons embellish the firebox. An inglenook located next to the fireplace contains a built-in seat. The north wall of the living room is illuminated by a row of divided light

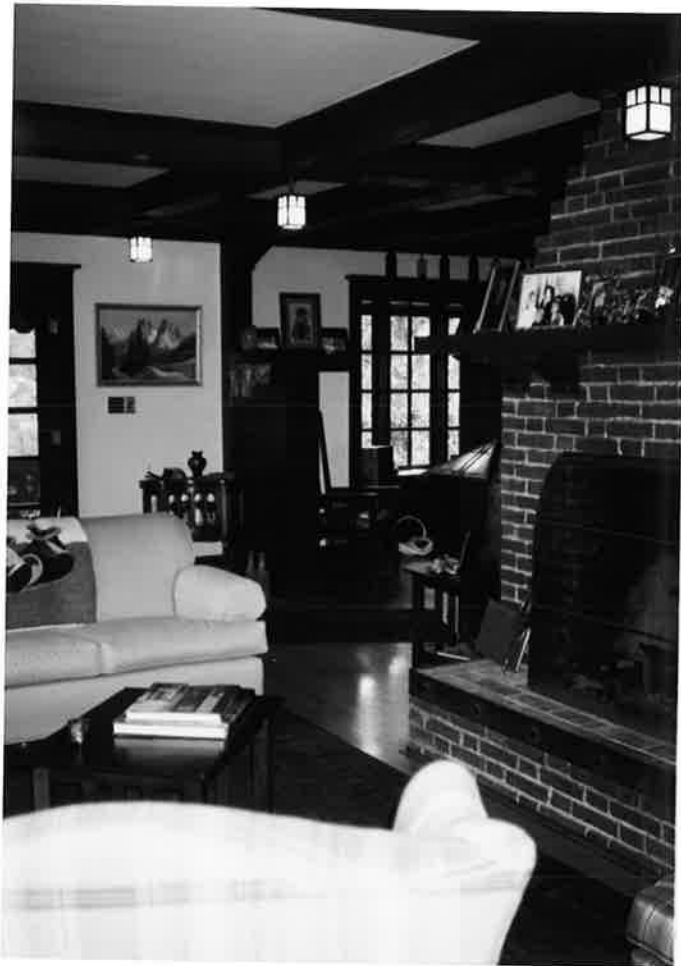
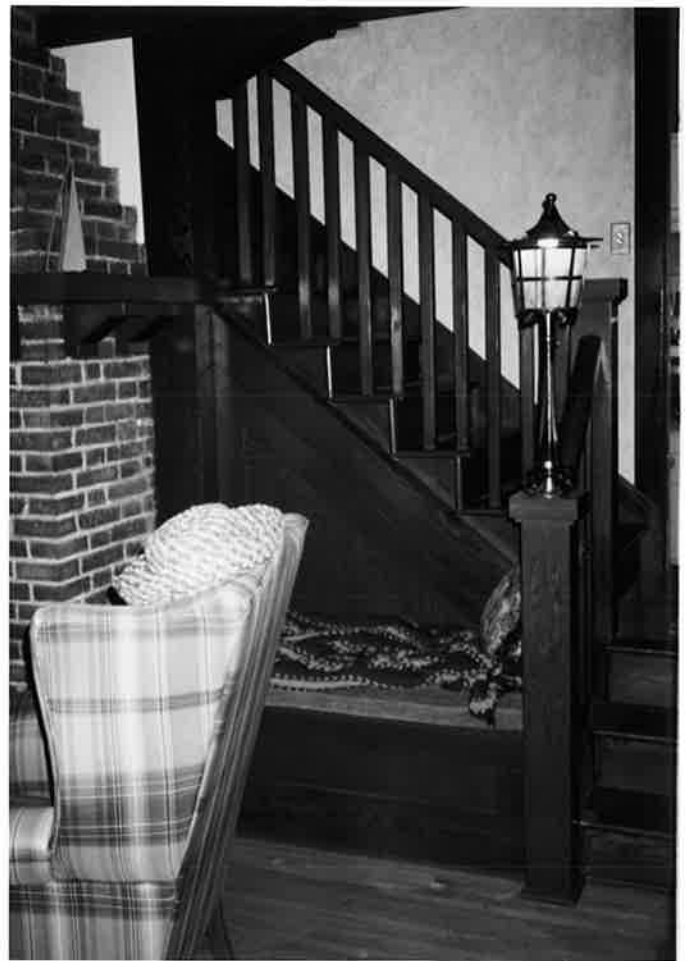
Photos 16 and 17: First floor interior living room and stairway to second floor. Photos taken in 1998.

The interior of the Koerner House was remodeled in 1941. The second-floor bathroom walls and floor were re-tiled, and the fixtures (toilet, washbasin, bathtub) were replaced with bathroom fixtures manufactured from 1930-1940. An interior wall that divided the south bedroom from the nursery located in the southwest corner of the house was removed. Wall-to-wall carpet was laid over the fir-planked floors. On the first floor, dark stained woodwork including platerails, brackets, dining room wall partitions, and built-in window seat was removed. The woodwork was replaced with painted pine featuring an "antique ivory" finish. The inglenook was removed, and the fireplace bricks and mantel were covered with 3/8-inch plywood sheeting also finished in "antique ivory." The stairway was replaced with a balustrade and newel post constructed of Swedish steel.

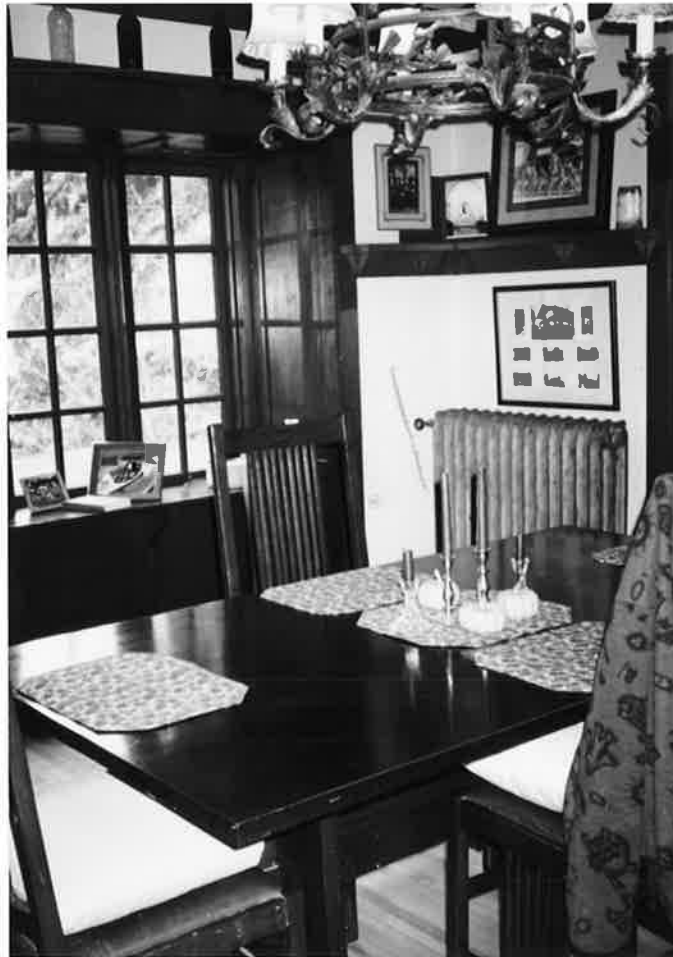
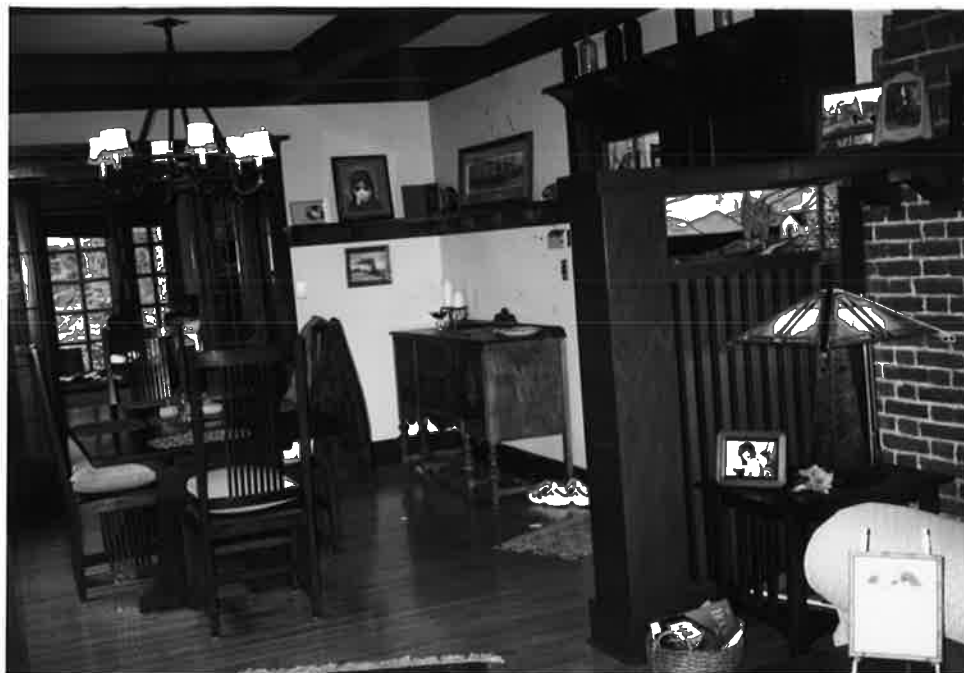
Photos 18 and 19: First floor interior dining room. Photos taken in 1998.

casement windows located above a 12-foot long, built-in window seat flanked by built-in bookshelves. The entry from the living room to the dining room is flanked by two partial-wall partitions with wood slats capped by decorative stained-glass panels. The dining room features an east-wall bay window and bracketed plate rails. The dining room opens south to an addition with a bay window, powder room, and decorative woodwork. Leaded-glass doors lead from the living room and dining room to the kitchen. Located in the southwest corner of the house, the kitchen features original painted pine cabinets, and opens to a west-wall sunporch. The sunporch floor is covered in fir planks while the kitchen, living, and dining room floors are covered in narrow strips of solid maple flooring. A turned staircase located between the kitchen and living room leads to a bathroom and three bedrooms on the second floor. Woodwork on the second floor is painted pine except for red fir-finished closet doors located in the master bedroom. Second floor ceilings measure eight feet, and part of the fir-planked floor is covered with wall-to-wall carpet. The basement features storage space, a laundry room, and a workshop area with nine-foot high ceilings. The basement floor is composed of poured cement. The original circa-1912 hot water boiler continues to warm the house with gas-fired hot water heat.

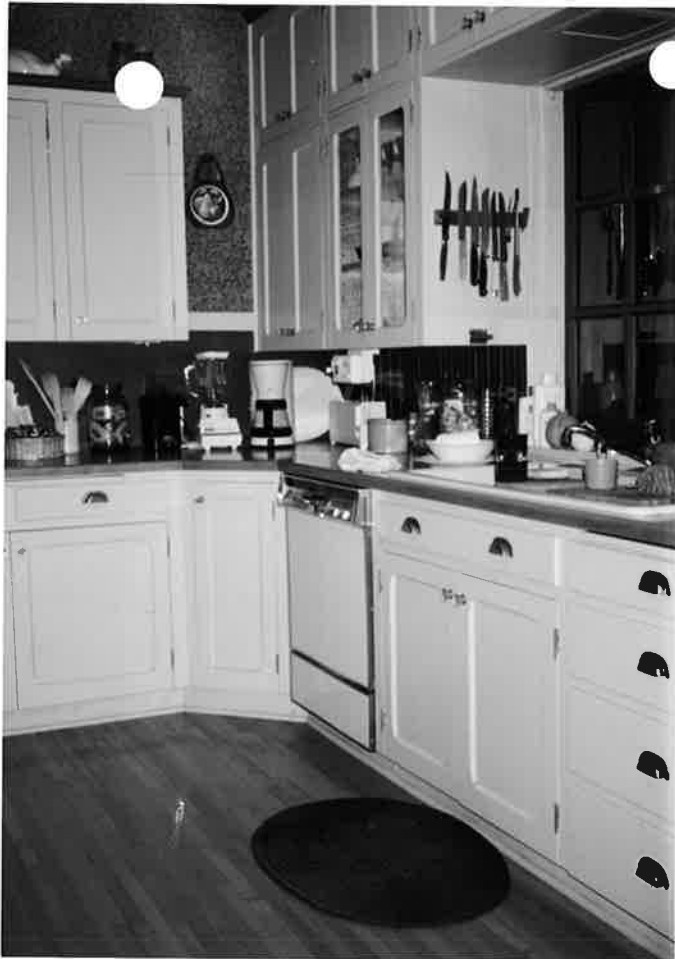
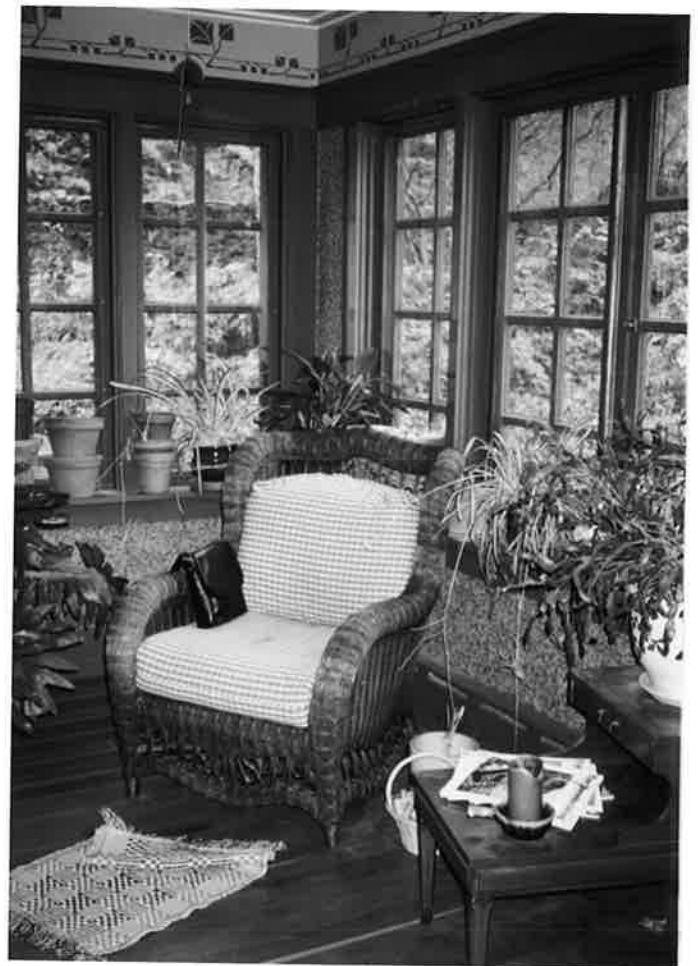
Photos 20 and 21: First floor kitchen and west-wall sunporch. Photos taken in 1998.

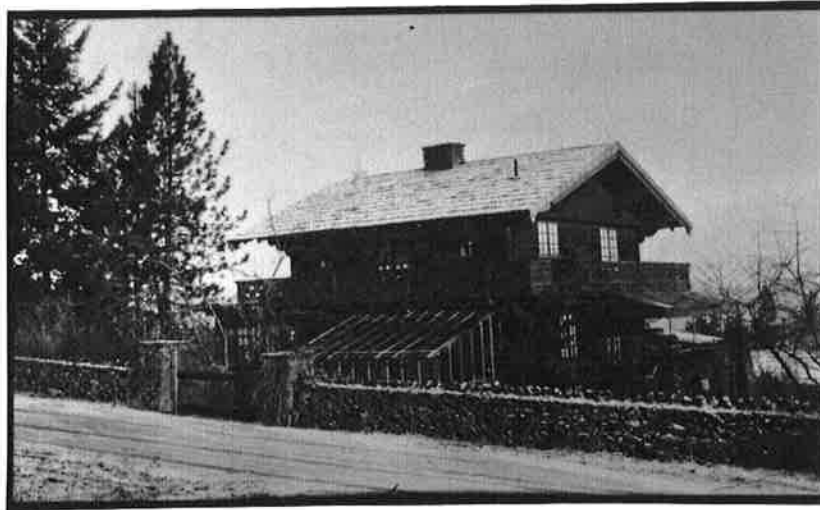
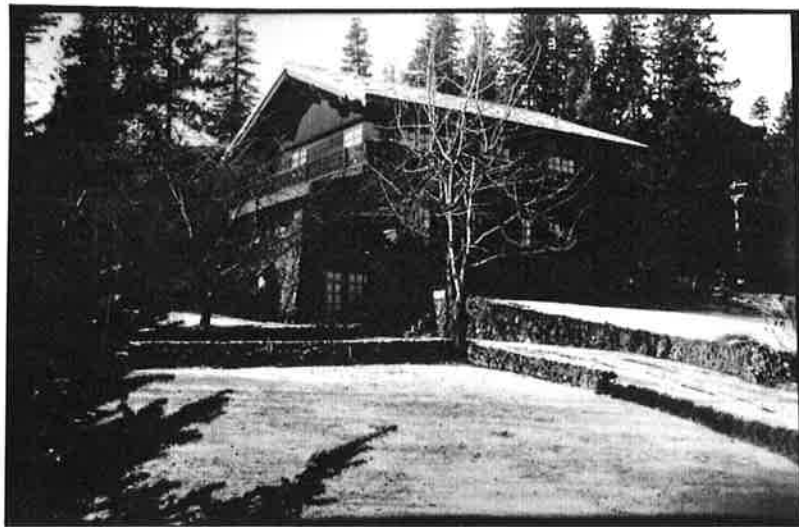
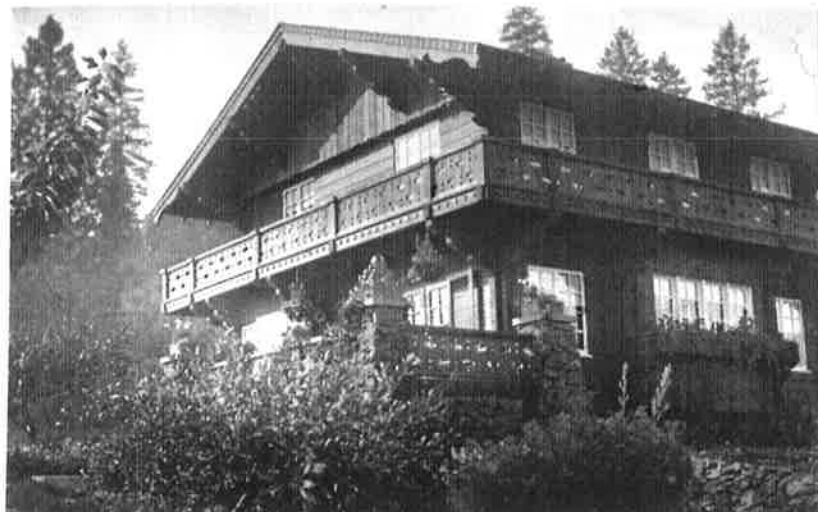
Photos 22, 23 and 24:

South, rear elevation and northeast corner photos taken in 1920s.

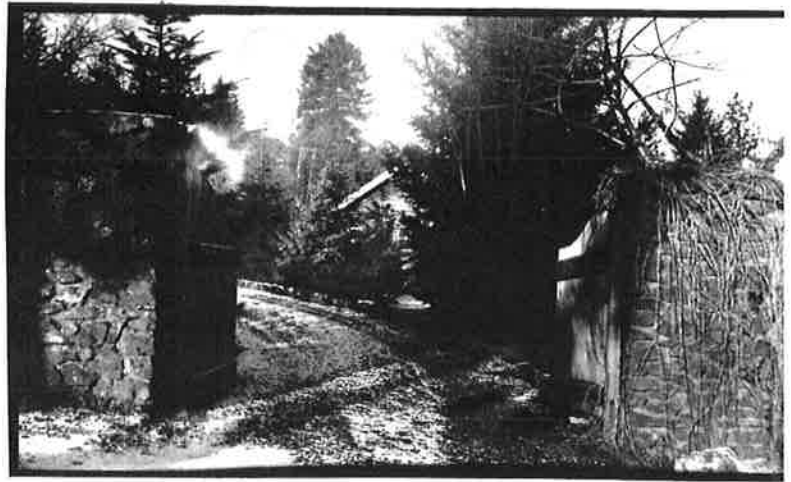
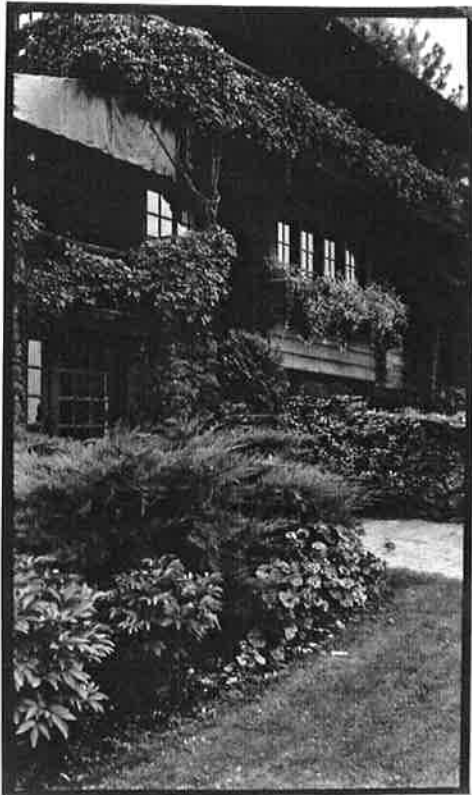
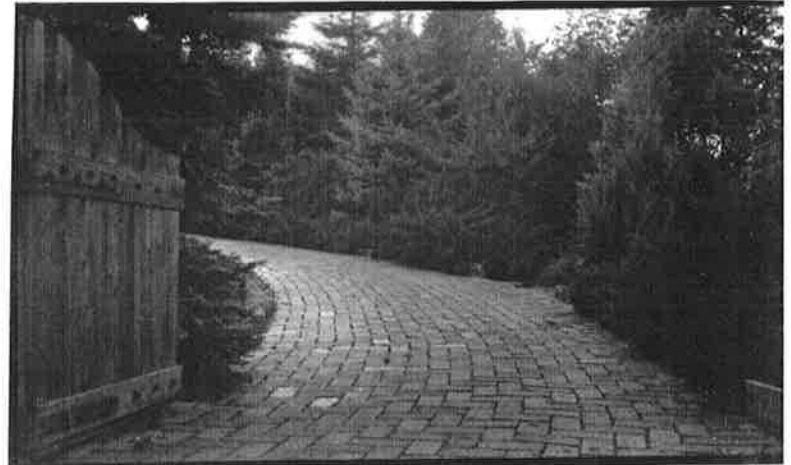
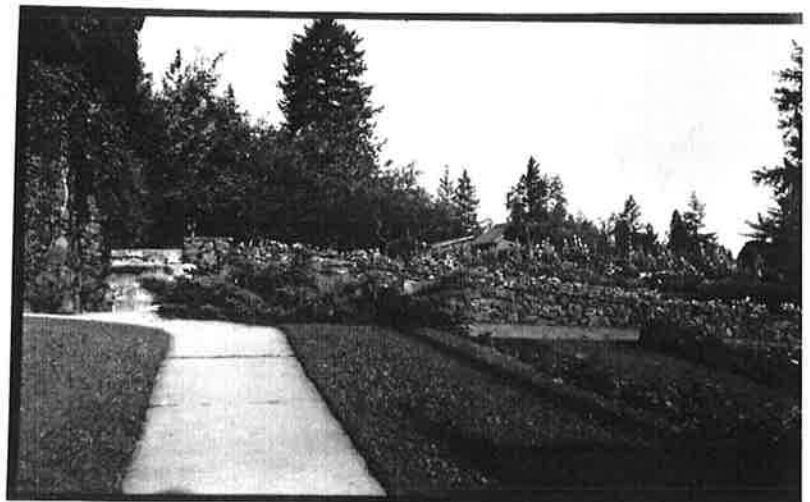
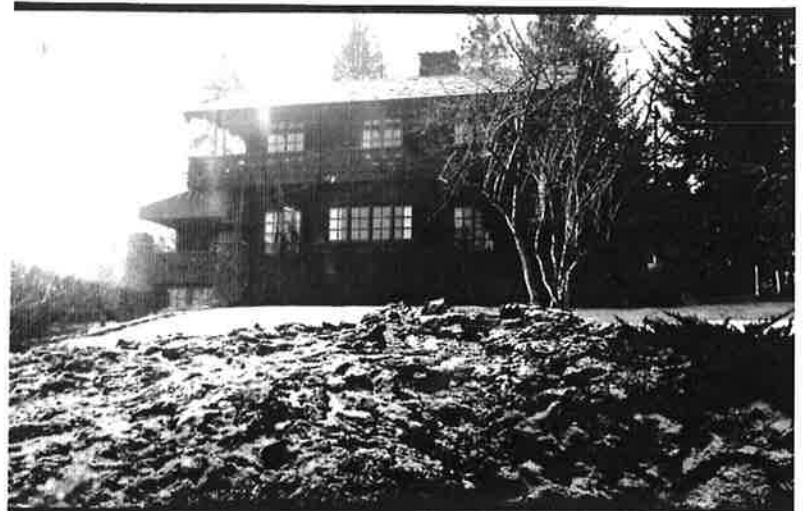
Photos 25, 26, 27, 28, 29:

Circa-1920s photos picturing north facade, gates, drive, lawn and approach to French doors opening to garage space beneath first-floor porch.

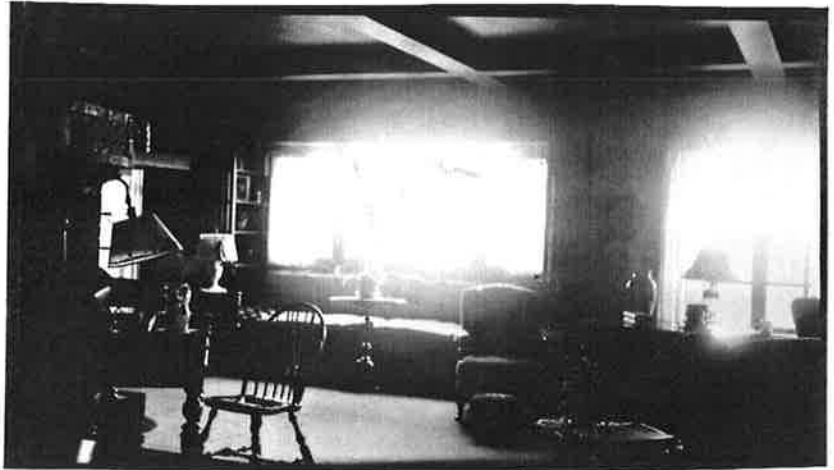
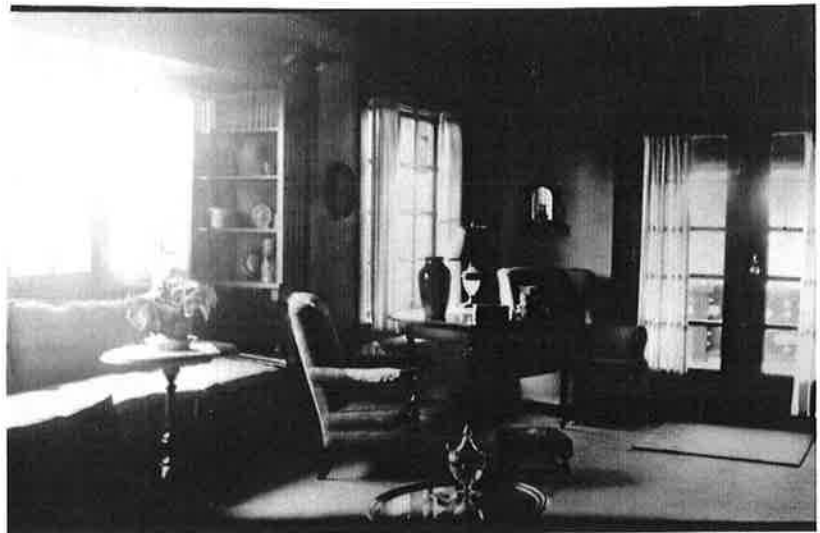
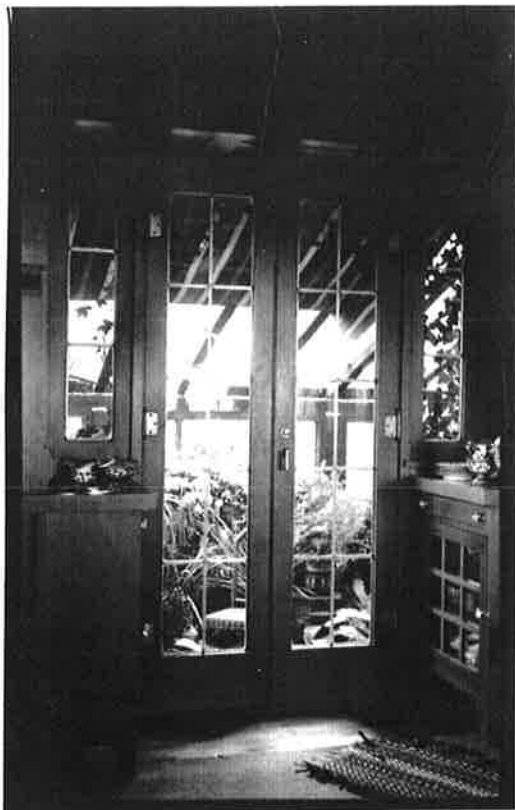
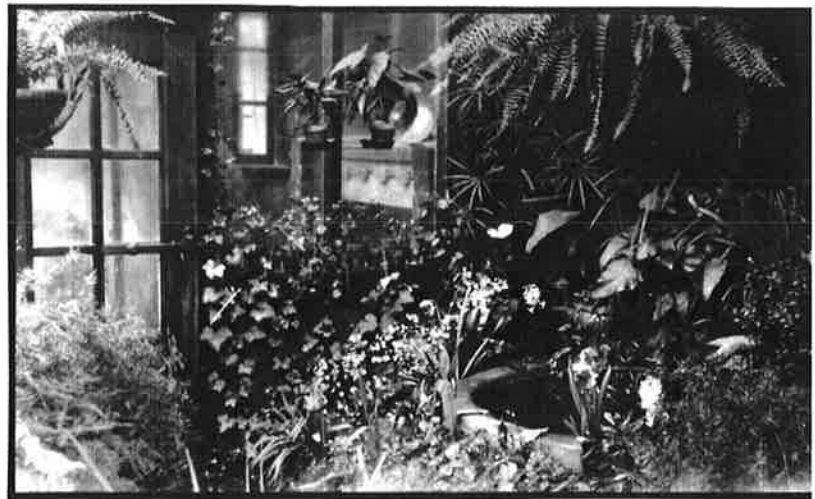
Photos 30, 31, 32, and 33:

Circa-1920s photos of living room,
entry into solarium, and fountain.
