Otis Hotel
Spokane County, Washington

7. Narrative Description

Present Exterior Appearance

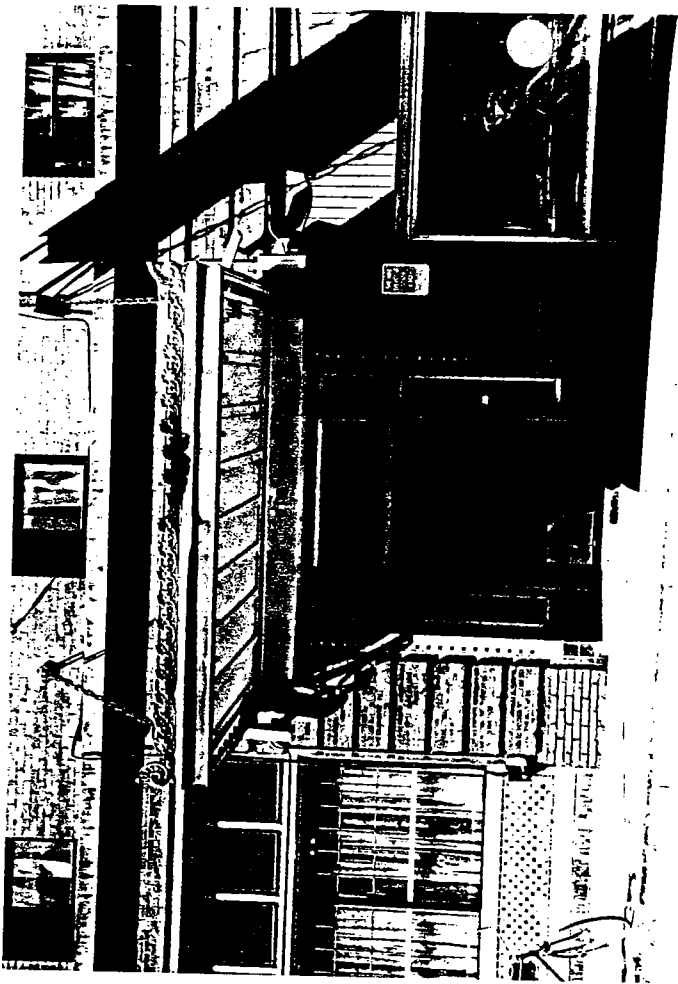
2

2. Otis Hotel
Spokane County, WA
Stephen Emerson
May, 1998
W. 212 Dawn, Spokane, WA
Hotel lobby entry, looking west
3. Otis Hotel
Spokane County, WA
Stephen Emerson
May, 1998
W. 212 Dawn, Spokane, WA
Storefront and lobby entry, looking southwest
4. Otis Hotel
Spokane County, WA
Stephen Emerson
May, 1998
W. 212 Dawn, Spokane, WA
North and east facades, looking southwest
5. Otis Hotel
Spokane County, WA
Stephen Emerson
May, 1998
W. 212 Dawn, Spokane, WA
North facade, looking southeast

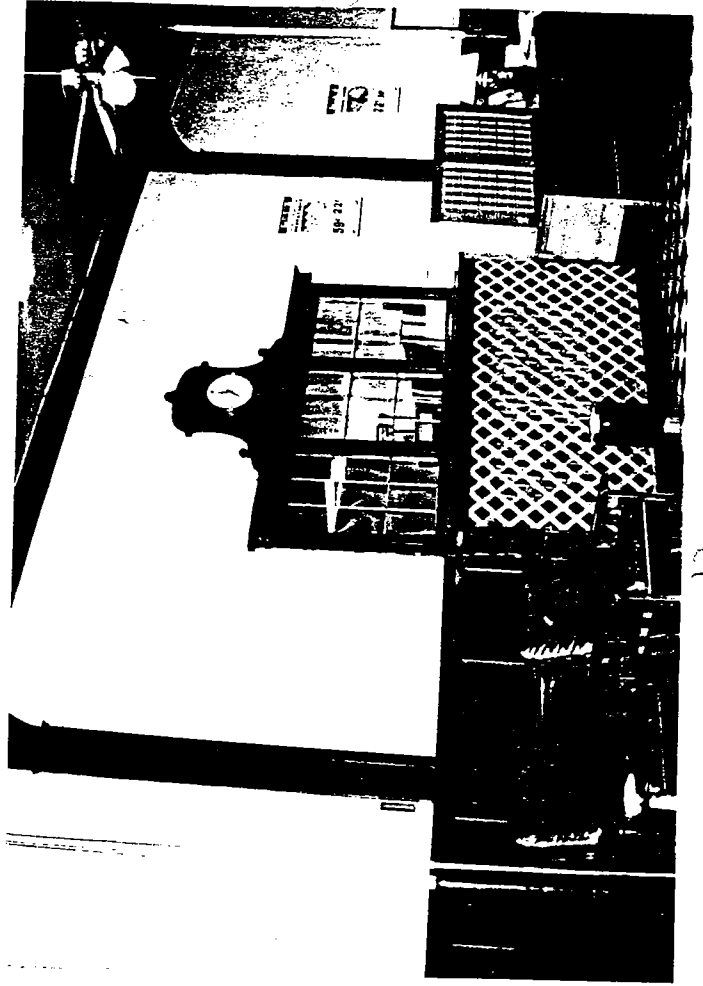
12

10. Otis Hotel
Spokane County, WA
Stephen Emerson
May, 1998
W. 212 Dawn, Spokane, WA
South and west facades, looking northeast
11. Otis Hotel
Spokane County, WA
Stephen Emerson
May, 1998
W. 212 Dawn, Spokane, WA
Lobby entry alcove, looking northeast
12. Otis Hotel
Spokane County, WA
Stephen Emerson
May, 1998
W. 212 Dawn, Spokane, WA
Lobby, mantle and clock, looking southwest
13. Otis Hotel
Spokane County, WA
Stephen Emerson
May, 1998
W. 212 Dawn, Spokane, WA
Lobby, looking east

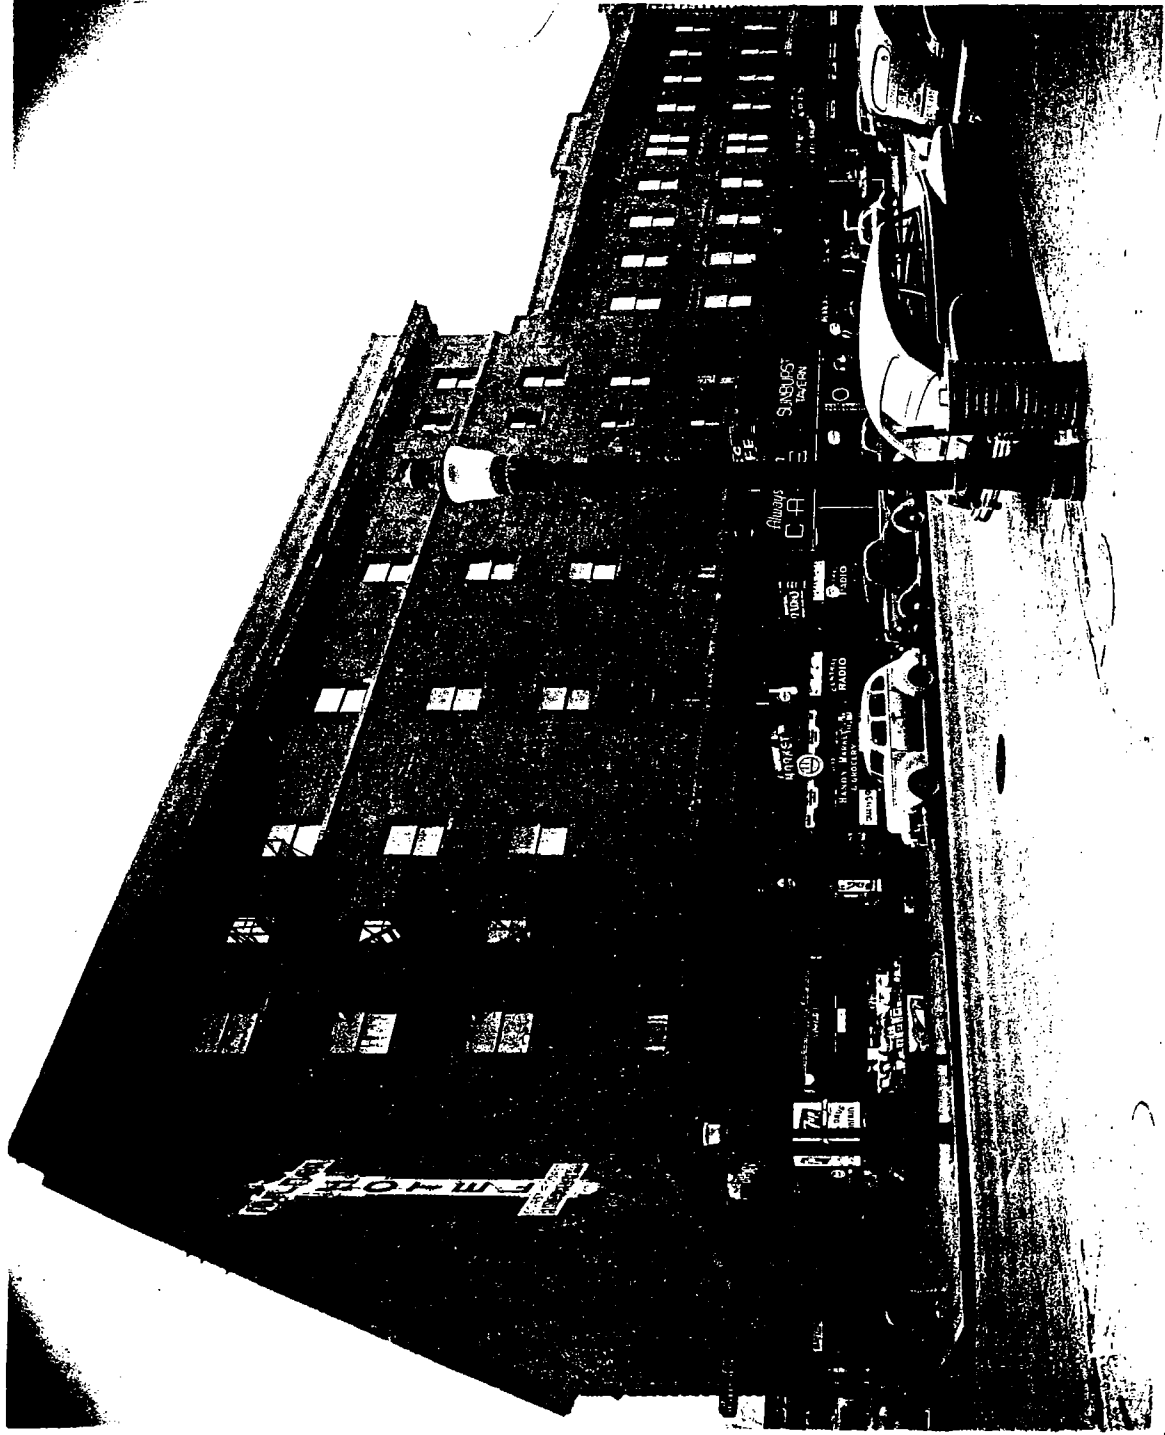
FIRST, WEST-1100-(MADISON TO
JEFFERSON)

During the 1930s, Spokane came upon hard times like the rest of the country and cheap lodging was in demand. By 1941, when economic recovery was interrupted by American involvement in WWII, the Atlantic Hotel had become the Milner Hotel. A photograph taken in 1947 indicates that at that time the building retained features of the upper floors that are still visible today, including the large sign at the northeast corner. Storefronts of the north facade still retained their original configuration of five separate shop spaces with recessed entry bays and glass display windows. Advertising and veneering, however, were already evident, and would eventually significantly alter the appearance of the storefronts.

Looking west on First from
Madison, 1947.
