Spokane Register of Historic Places Nomination

Historic Name: Genesee Block
And/Or Common Name:

Street & Number: 819-821 W. Riverside Avenue
City, State, Zip Code: Spokane, Washington 99201
Parcel Number: 35183.0605 & 35183.0606

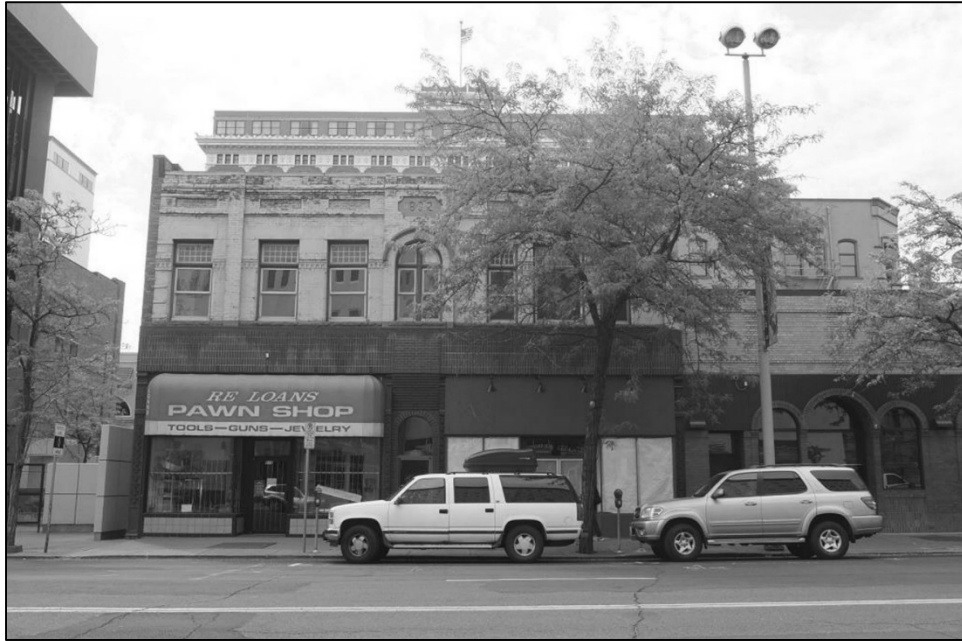
North Façade.

The north elevation of the Genesee Block is the main façade of the building. The lower story of the building consists of a central main entrance (819 ½) flanked by two commercial storefronts: 819 to the east; 821 to the west. 819 has a main entryway consisting of a single recessed door made of metal and glass surmounted by a transom. On either side of this entryway are large fixed glass storefront windows sitting atop a tile water table. The storefront entrance is covered with a vinyl awning that reads, "RE Loans Pawn Shop; Tools-Guns-Jewelry." 821 has an angled recessed double door main entrance consisting of metal and glass doors surmounted by a transom. On either side of this entrance are large fixed pane glass storefront windows with three lights on either side. The water table is made of lightly textured stucco covering brick. The flooring is square tiles. In between 819 and 821 is a non-original brick veneer that arches over the entrance of 819 ½ and covers the space between the lower and upper stories. Remnants of the original façade can be seen on the narrow decorative pilasters on either side of the storefronts as well as on the granite door sill. These decorative cast iron columns feature geometric flowers oriented vertically on the column. The entrance to 819 ½ consists of a single glass and metal door that opens to a staircase leading to the second story. Above the door is an arched transom surrounded by brick. Above the arch is brick inlaid in a stepped pattern that leads to a wall plane of six rows of soldier bond brick pattern that separates the first from the second story. Above this brick veneer is a band of masonry.

The second story of the main façade features mostly original elements including its original brick, which is deteriorating in places. There is a central arched window that slightly projects from the wall plane. An arched masonry band is located above this window. There is a decorative inlay above this central window that reads "1892." Three windows sit on either side of the central bay. These windows consist of double hung vinyl sashes surmounted by vinyl transoms with sandwich muntins to give the appearance of multi-lights. Ornamental details on the second story of this façade include a dentil line, as well as a patterned roofline with rectangular inlays along the cornice. Two brick pilasters are spaced asymmetrically; the one to the east is situated between the last

easterly bay and the one to the west is on the end of the building. The roof is flat with a raised parapet. On the roof is a central skylight and two triangular skylights on the east and west sides.

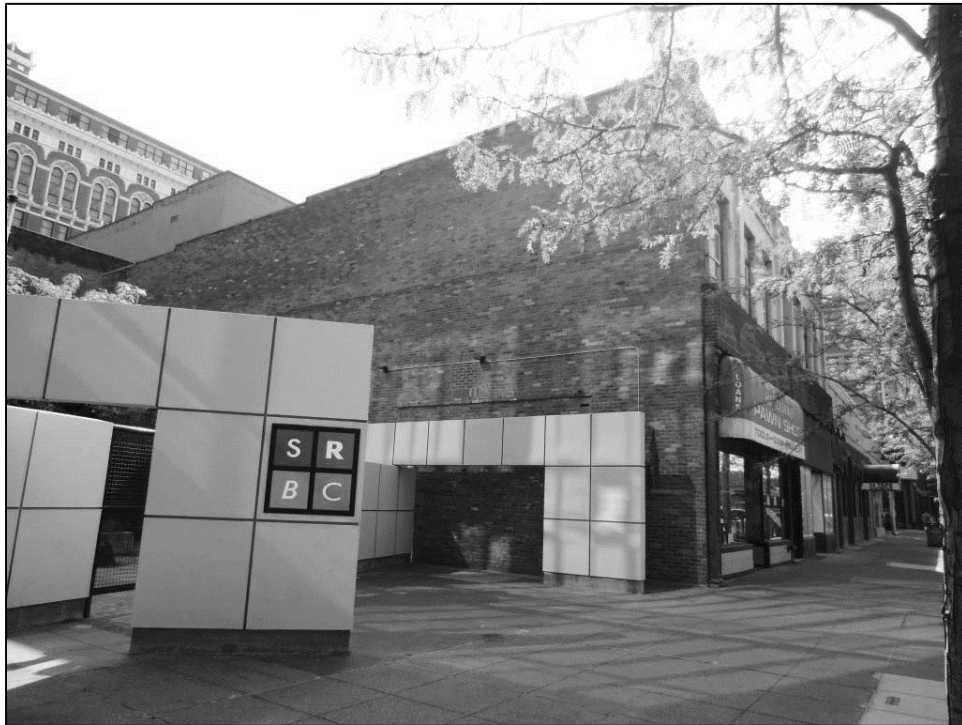
East façade.

The east elevation is devoid of any architectural features or fenestration. In 1967 the Pacific National Bank building adjacent to the Genesee to the east was demolished. Today this façade features ghost marks of a large vehicle-size door opening on the northern part of the facade. Above these ghost marks is a modern light fixture rod that is fastened to the building and holds two outdoor track lights, this is connected to electrical boxes and lights that are placed within the wall plane and are surrounded by small corbeled brick walls. Four metal posts are also fastened into this façade and are part of the Spokane Regional Business Center courtyard installation.

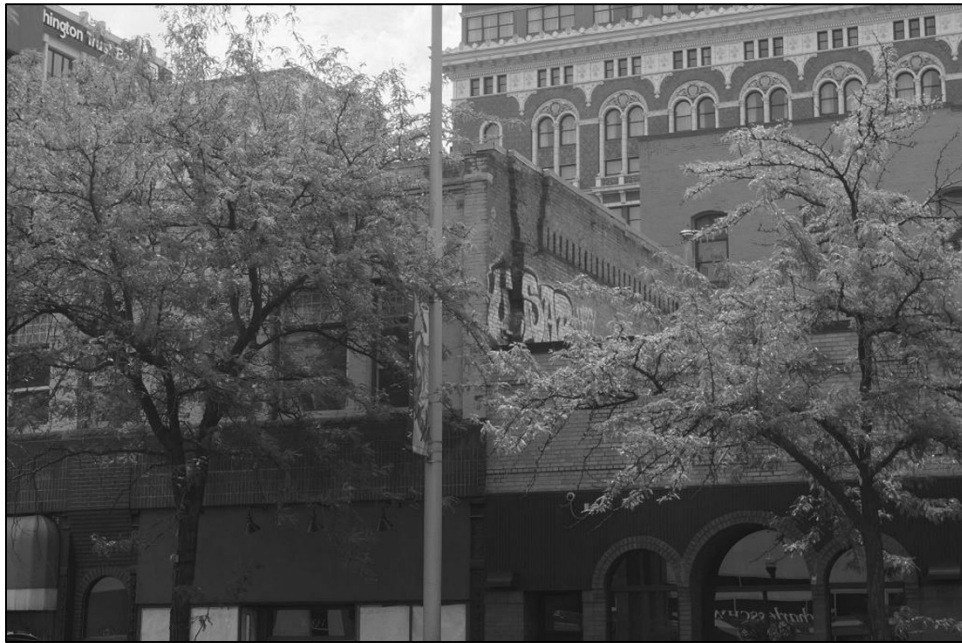
Detail of northwest oblique.

The west elevation is attached to 825 W Riverside Avenue. The second story of 819-821 is exposed and the exterior siding has decorative castellated brickwork underneath the roofline. There are no windows or doors on this façade.

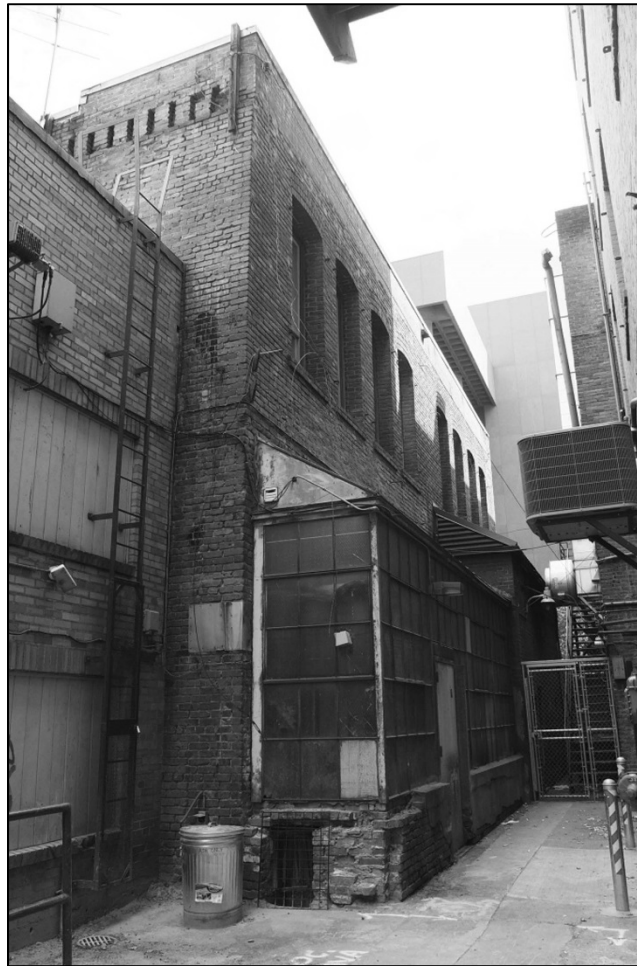
South Façade.

The rear of the building (south elevation) consists of two main bays with non-original one-story shed-roof enclosed additions. The addition on the west end of the building features a brick water table over which sits a large multi-paned glass window that has been boarded over with plywood on the interior. The shed roof is covered with standing seam metal. There is a door within this addition. The addition on the east end of the building is accessed through a chain link gate and features a brick exterior with a small window opening that has been boarded over with plywood and a door. The roof is standing seam metal. The second story of the south façade consists of eight windows with non-original vinyl sash windows.

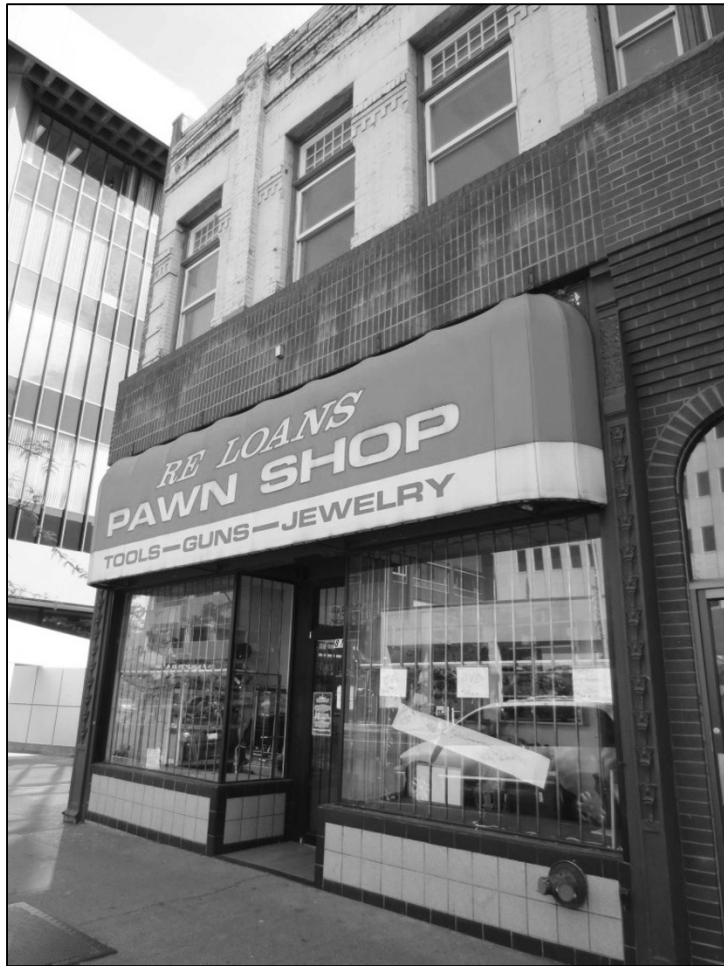
Storefront of 819.

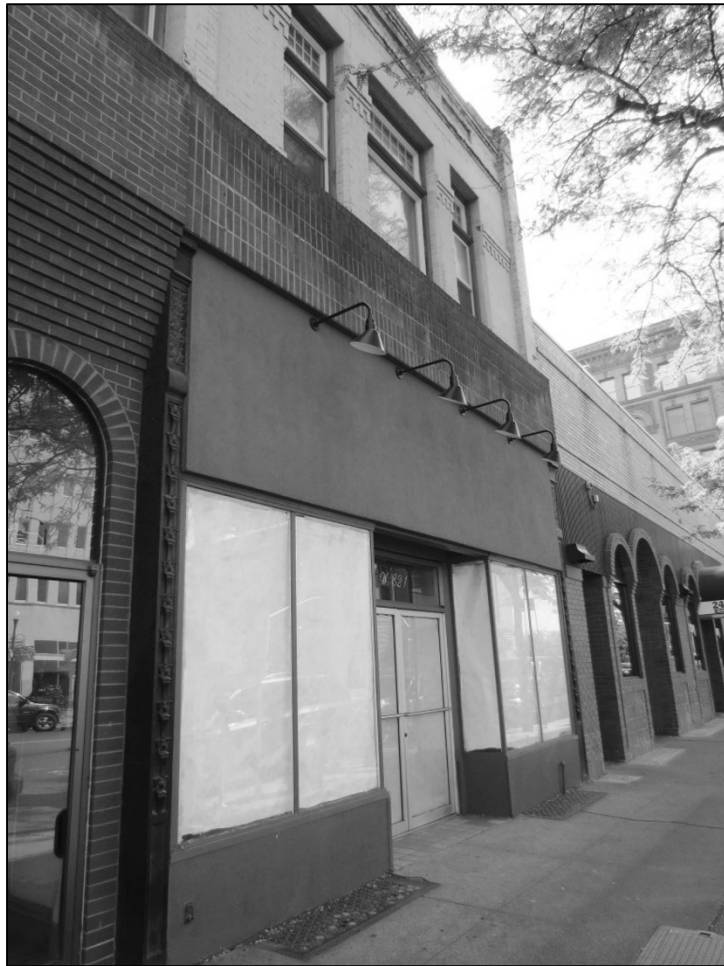
Storefront of 821.

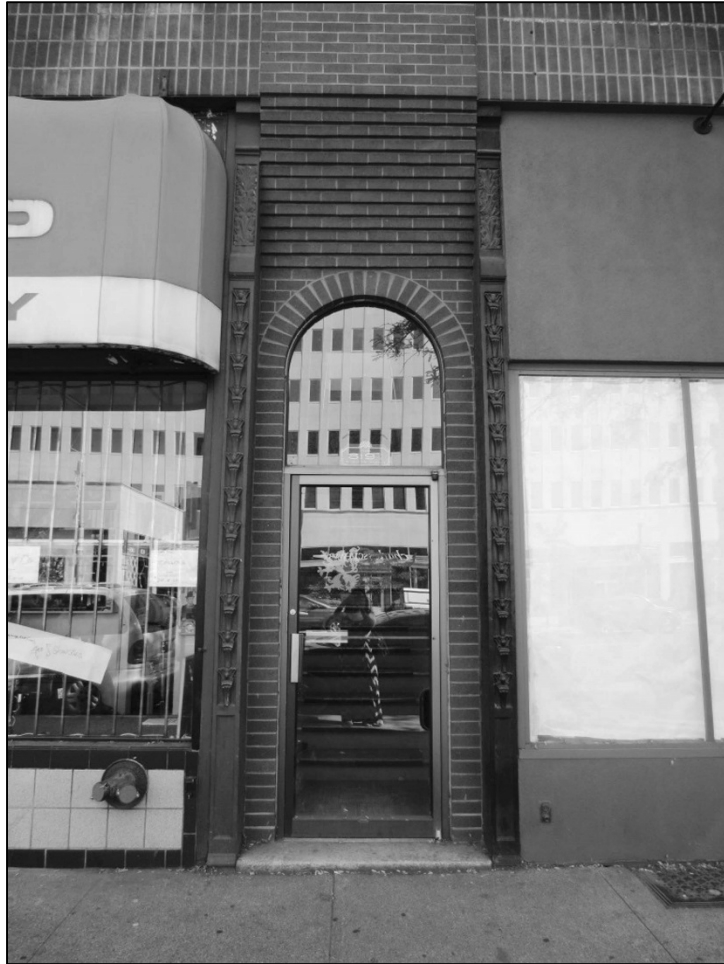
Entrance to 819 1/2.

The interior of 819 ½ is accessed through a long staircase at the center of the building. At the top of the staircase are two doors on either side of the landing. Both doors are wood with glass panels and surmounted by transom lights. The door on the east side of this hallway platform leads to the east unit which is one large room that has been largely demolished. Any interior partition walls have been removed, and debris from the demolition covers the wood floor. The ceiling has been torn down, exposing non-original insulation, the non-original HVAC system and a variety of electrical wires. Non-original light fixtures and air conditioning vents hang from the ceiling by wires. The wall that divides the east unit from the west side of the building is lathe and plaster. The east unit wall is brick that has been painted. At the north end of the room, there are three vinyl windows with transoms and a fourth window that is half exposed. The wall between the east and west units was constructed in a way that it divides the fourth window (central window); a portion of the window is visible in both units. The windows have wood moldings that appear to be original. The south end of the east unit has four vinyl windows, also with wood surrounds. There is a bathroom and shower on the east wall of the east unit. The walls have been removed to the studs and the bathroom has been demolished. A triangular skylight with a contemporary window is visible in the center of the eastern portion of the east unit. There is also an opening within the ceiling to accommodate a rectangular skylight on the west wall of the east unit. This skylight, which lies directly south of the stair landing, can also be seen in the west unit.

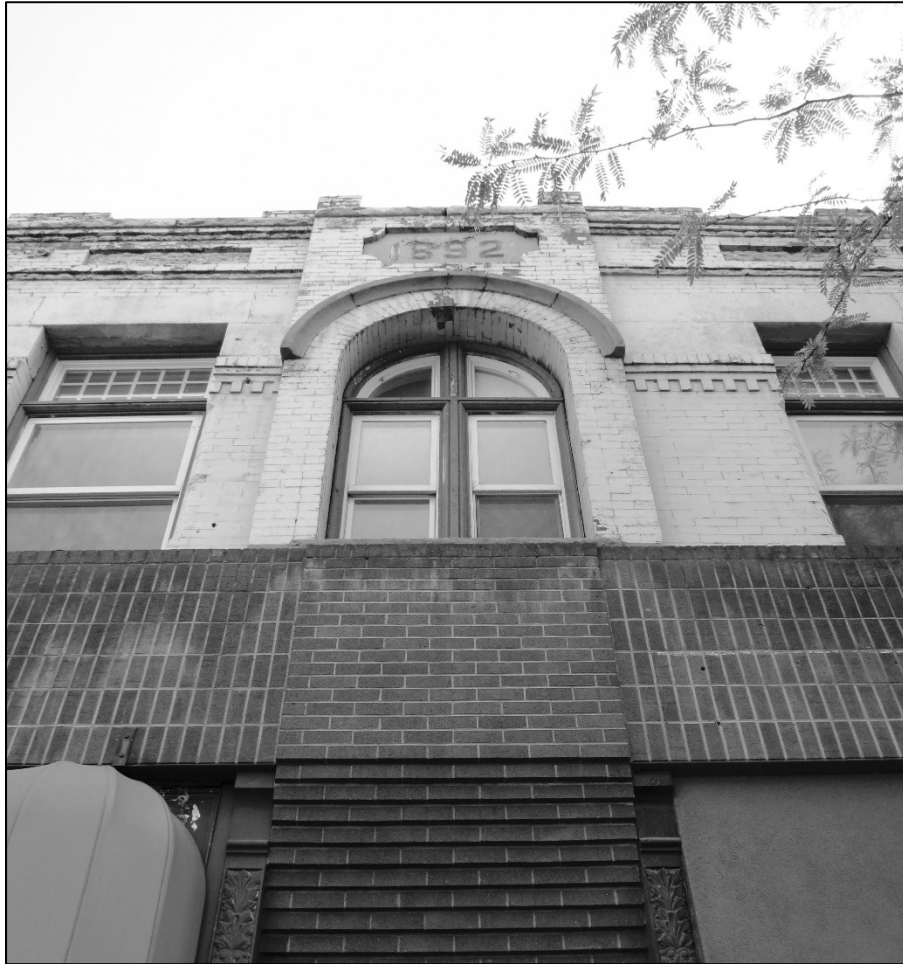
Detail of "1892" on second story of north façade.

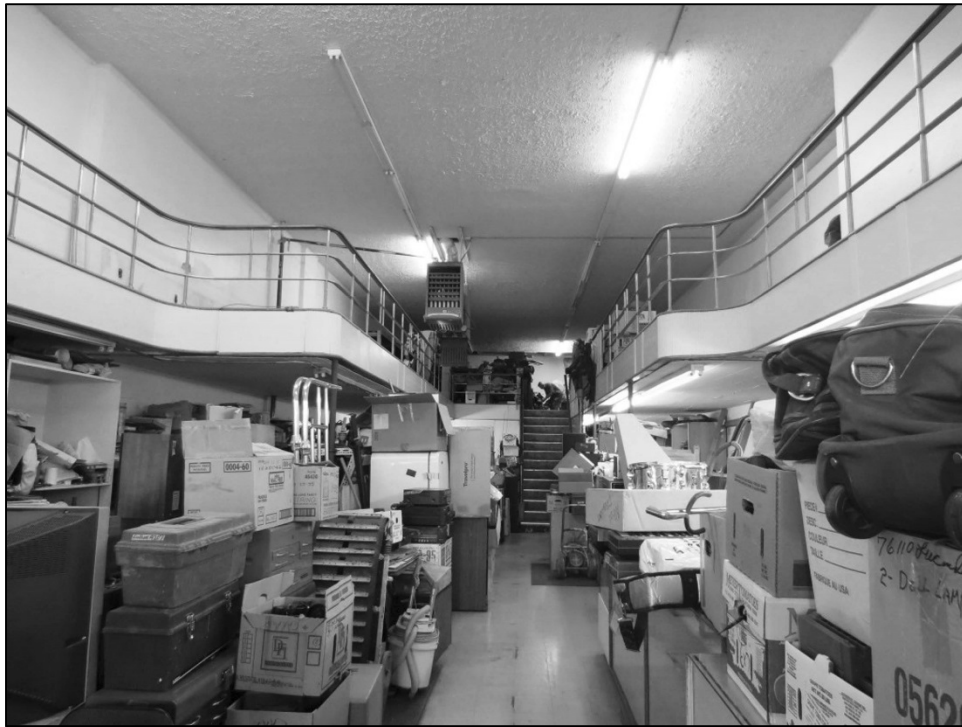
Interior of 819 looking south.

The interior of 819 includes some of the original features from its 1940 conversion to a beauty shop. The room is large with vinyl tile flooring and a staircase that leads to the mezzanine which has Art Moderne-style curved railings that extend to the front of the store. Round metal poles support the mezzanine and the original Art Deco etchings within the cornice beneath the railings are still evident. The room maintains its original 16-foot ceiling height, however, the ceiling has been textured. Original wood built-in cabinets are found along the west wall. The storefront windows are accessed from behind the glass showcase counters, as walls were constructed with large pane glass windows to prevent access to the windows as you enter the store. The upper section of the storefront has vertical metal windows but they have been boarded over and are currently obscured by the vinyl awning sign. The upper section can also be accessed on the mezzanine level by two doors on either end of the storefront. The flooring in this area has been demolished and consists of the ceiling tiles from the storefront window area beneath it. The wall that overlooks the interior of the store was originally part of the mezzanine with

a railing and a central clock which have since been removed. At the rear of the mezzanine on the south end of the store are skylight windows that have also been boarded over. Beneath the mezzanine toward the southwest part of the store there is a large storage room and a door that leads to the basement.

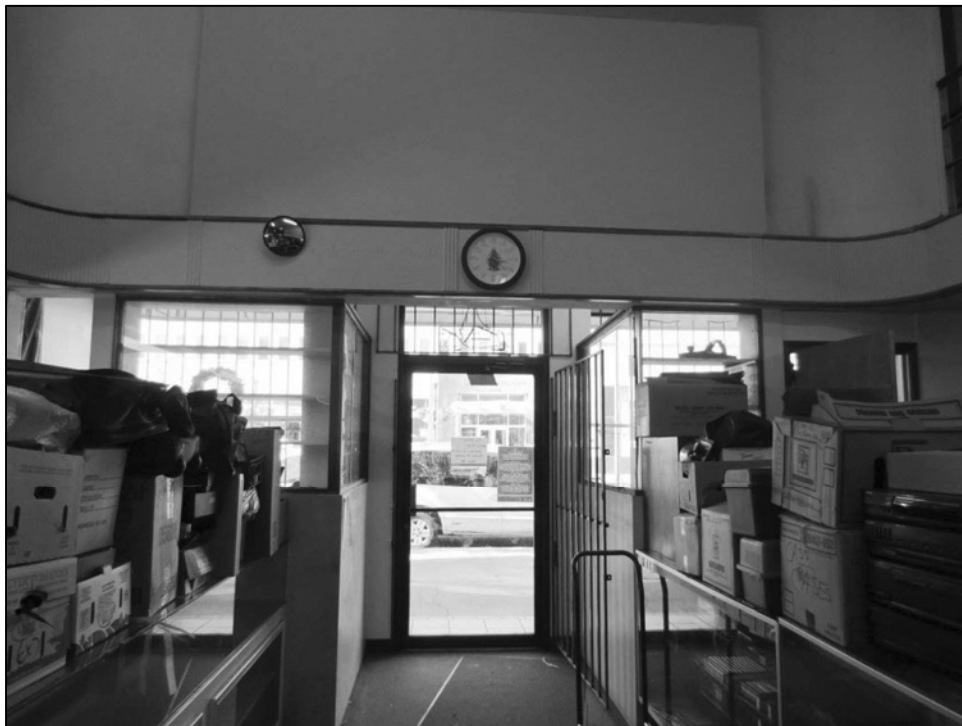
Interior of 819 looking north.

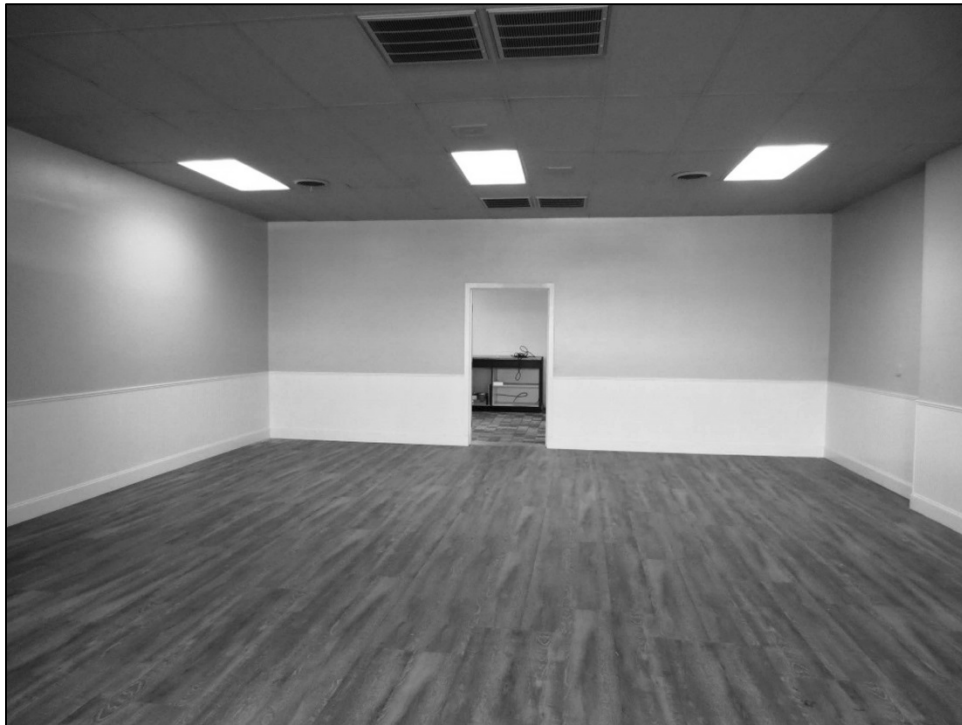
Interior of 821 looking south.

The interior of 821 features a large show room with composite wood floors and painted drywall with wainscoting. The storefront windows include built-in showcase tabletops. The dropped ceiling with tiles and recessed light panels hide the heating, ventilation, and

air conditioning (HVAC) system and original tin ceiling behind it. The tin ceiling is in remarkably intact condition and extends throughout much of the space. A door on the east wall leads to the basement. There is another door on the south wall of the room that opens to a service room with a counter, sink, cabinets, and a partition wall that leads to the restroom. At the south end of this service room is another sink and a small room that is part of the rear addition; however, the interior has been boarded over. A door on the south wall leads to the exterior as well as access to the basement.

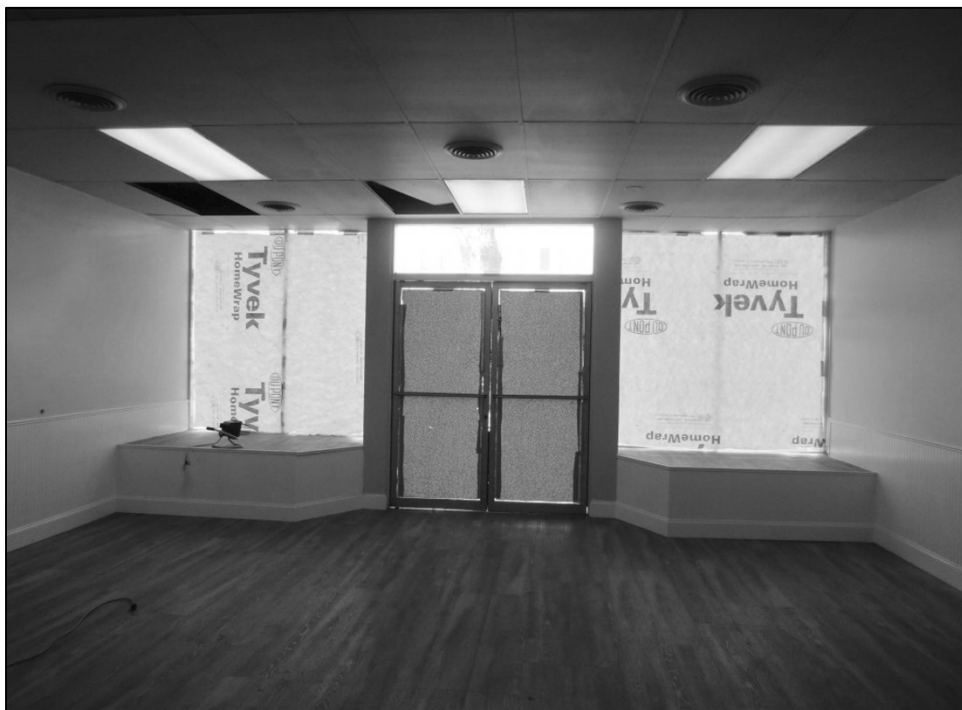
Interior of 821 looking north.

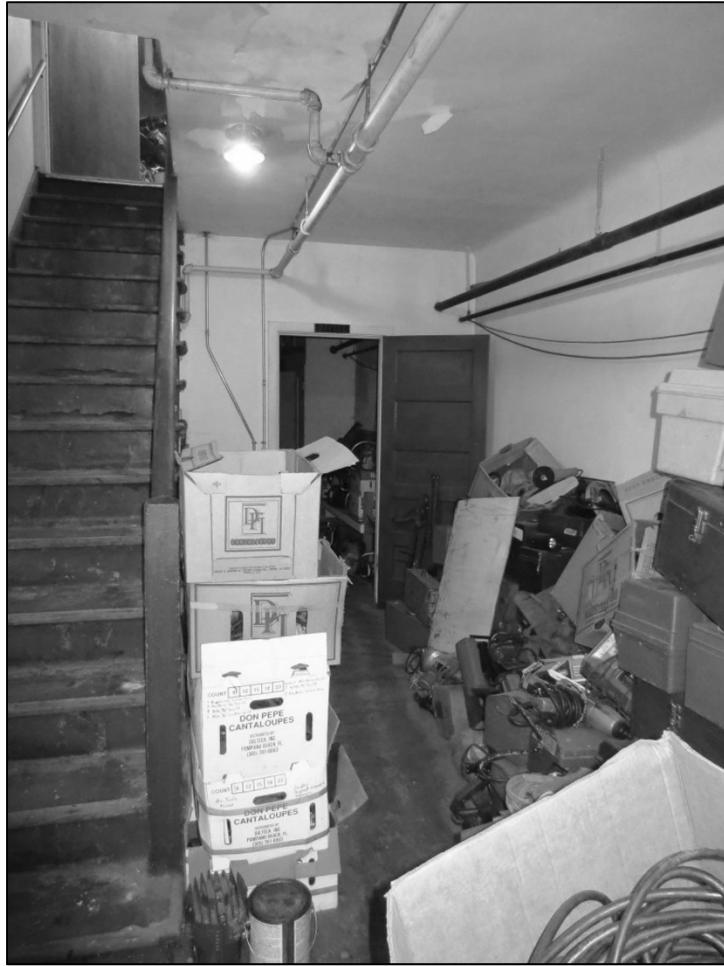
Basement in 819.

The basement in 819 is partially finished with drywall and built-in cabinets. The basement in this half of the building is partitioned into six main rooms that have a concrete floor and wood cabinets. The north, east, and south walls of the basement are exposed basalt and brick. The two northernmost rooms contain the original coal hopper and boiler system along with a vaulted ceiling that sits underneath the commercial storefront sidewalks. The ceiling has a metal door that opens onto the sidewalk above. On the west wall of the boiler room are the original electrical panels for the store from the 1940s and 1950s. To the south of these rooms is a large space with four small storage closets on the west wall. There is a bathroom and a closet south of this. Behind the stairwell are two rooms, one with a sink and one with the original safe from the beauty shop. The southernmost section of the basement features a basalt wall with an entrance that leads to a narrow room. Two window openings that have been infilled with brick and stone along the wall that partitions the main basement with this narrow room.

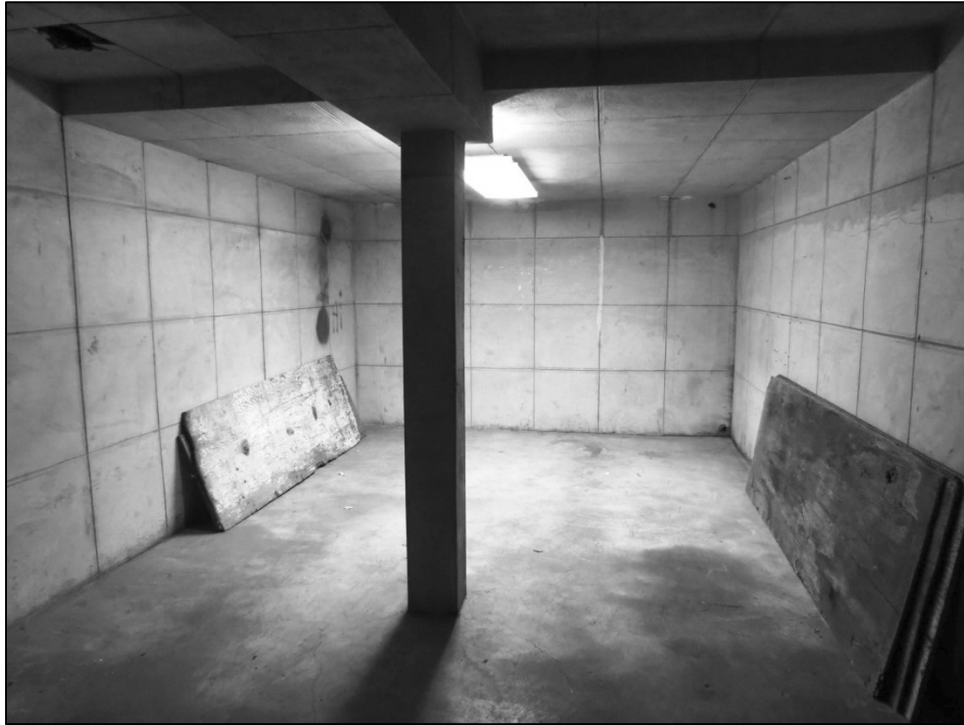
Corkboard room in basement of 821.

The basement in 821 is partitioned into five main rooms accessed by a hallway. These rooms were mostly used for storage space by previous tenants. The basement overall is unfinished with exposed basalt and inlaid brick walls on the south, west and north walls. Behind the stairway is an unfinished room with a bathroom. Similar to the southernmost section of 819, there is also a basalt wall with an entrance that leads to a narrow room. To the north of the stairway are two interior rooms, one is covered in wood paneling with wood shelves; the other room is made of corkboard. There is a small name plate on the floor of the entrance of this room that reads,

“Nonpareil Corkboard
Manufactured by
Armstrong Cork & Insulation Company
Pittsburgh, PA.
Installed by
D.E. Fryer & Company
Distributors
Seattle-Tacoma-Spokane”

Although there is no date for when this corkboard room was installed, nonpareil corkboard insulation is typically used for fur vaults, as well as other goods. It is assumed

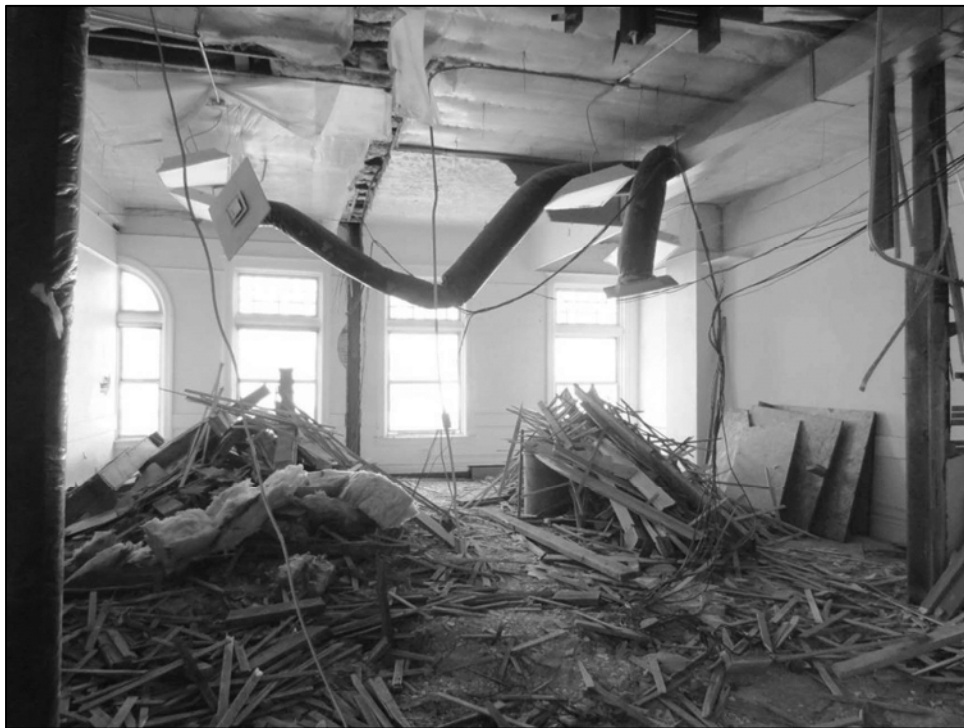
819 1/2 east half looking north.

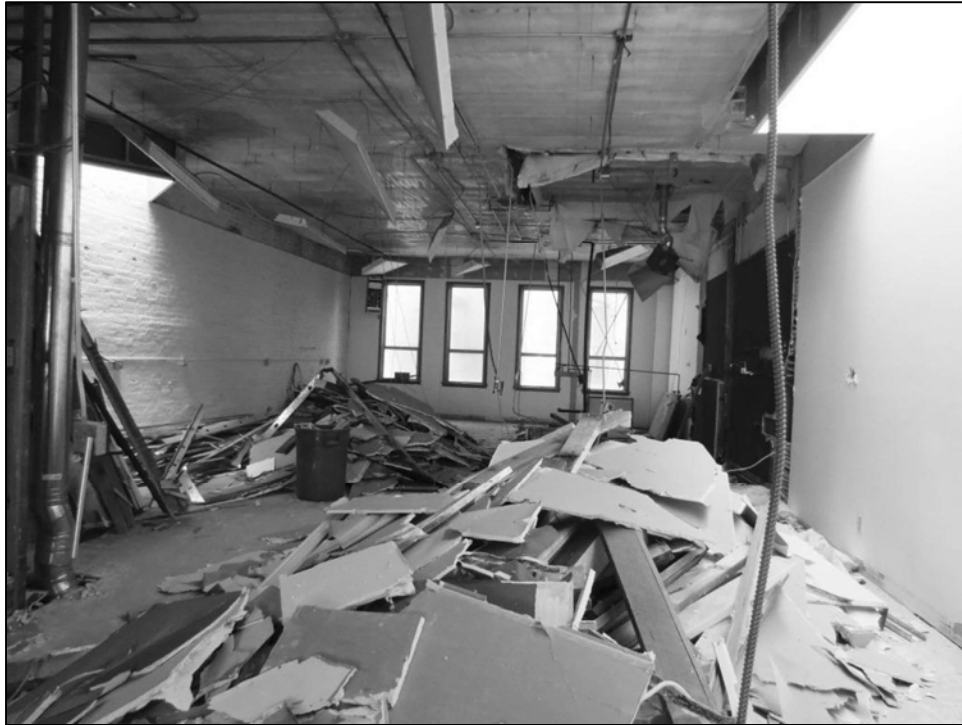
819 ½ east half looking south.

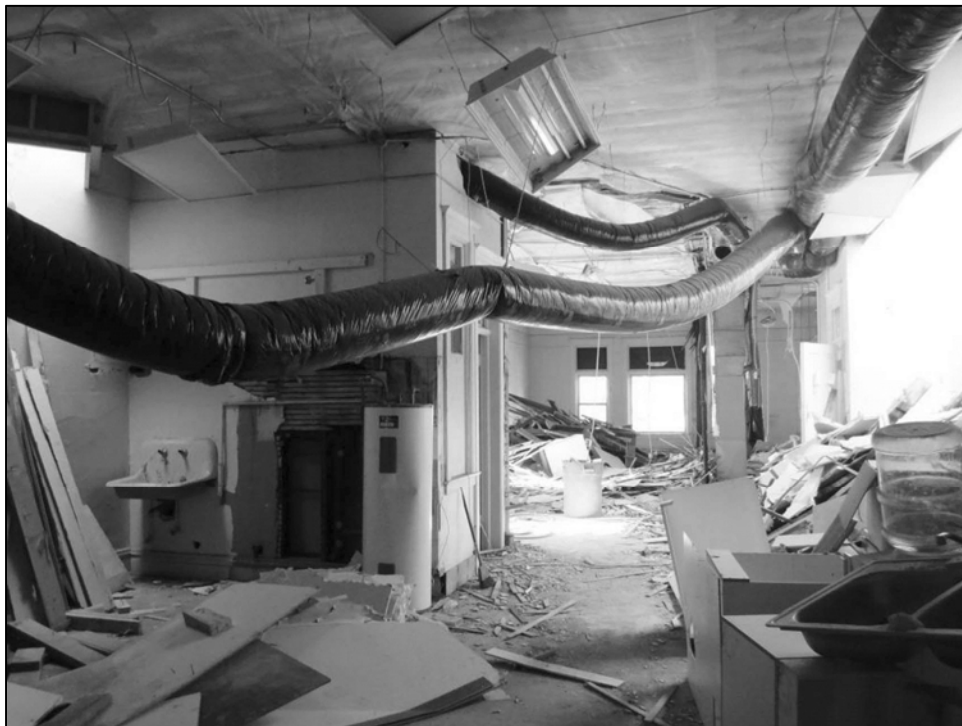
819 ½ west half looking north.

Across the hall is a second unit that has also been largely demolished. Similar to the east unit, the west unit has vinyl windows on the north and south walls. There are also two vinyl sash windows with wood molding on the west wall. There is a bathroom that has been partially demolished on the west wall. Some of the walls and wood molding remain. The bathroom has a door with a transom window and a narrow window next to the door. Inside the bathroom is a bathtub and shower, toilet, and sink. Outside of the bathroom is a water tank and a sink. Much like the east unit, this room has demolition debris covering the floor and the ceiling wires and HVAC system have been exposed. The room is in a state of disrepair. On the south end of the west unit is a wood platform in front of the south wall and windows. The south windows have been covered with Styrofoam shutters. There is a triangular skylight in the western half of the west unit and the central rectangular skylight above the eastern portion of the unit. A washing machine and dryer sit along the east wall.

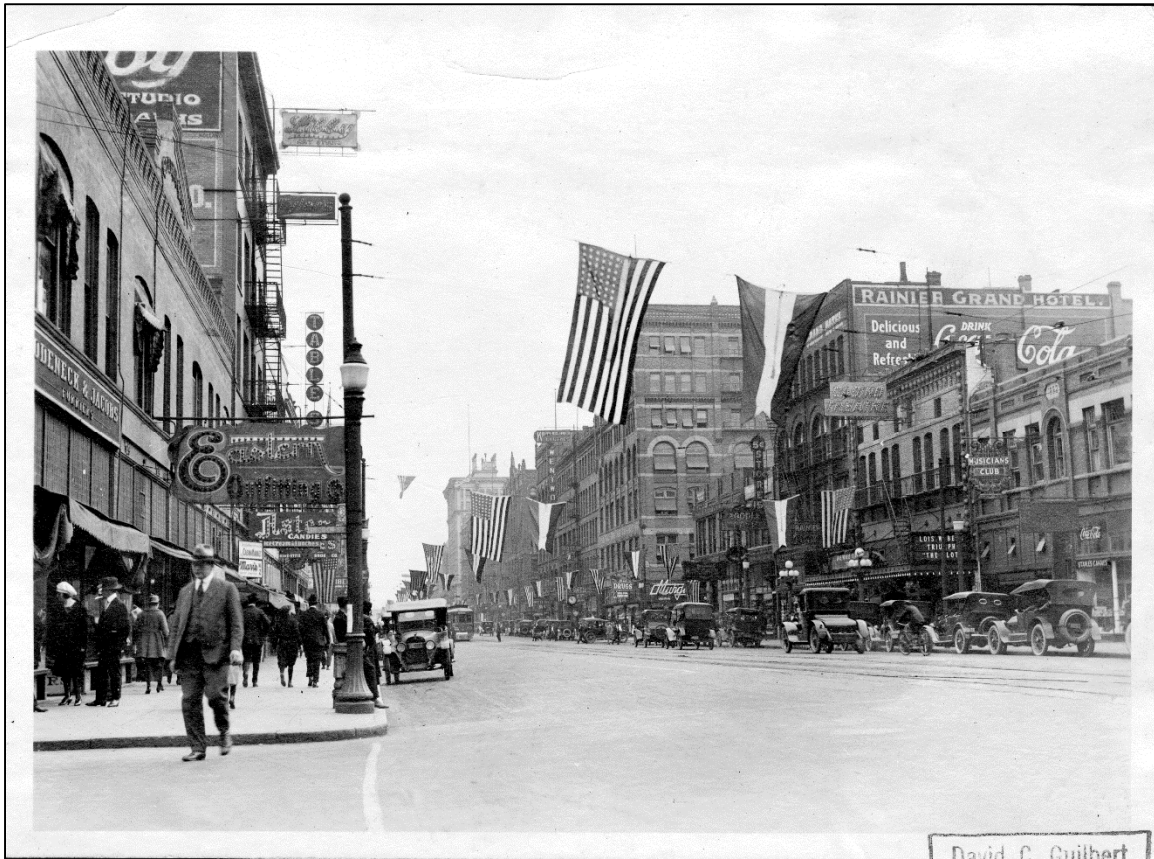
Photo of Riverside Avenue looking southeast in 1921.
Photo courtesy of the Museum of Arts & Culture, Spokane.

A historic photograph from 1921 shows part of the exterior of the north façade. From this photograph, it appears the storefront of 819 had pivoted windows above the storefront entrance. The storefront of 821 appears to have had classical columns supporting the recessed porch roof. 821 also had clerestory transom windows above the entrance to the storefront.

Visual observation indicated other alterations to the building that include the non-original brick on the main façade that has changed the original central entryway to include an arch, whereas the 1921 photograph indicates the entrance was squared; the enclosure of the office space on the mezzanine storefront in 819; the boarding over of the skylights at the rear addition of 819 (ground floor addition); the addition of the vinyl awning over 819’s storefront; the retiling of the water tables on the main façade of 819; the addition of
