Spokane Register of Historic Places Nomination

WILLIAM O. BRADLEY HOUSE

Street & Number City, State, Zip Code Property Tax Parcel Number 1703 W. Ninth Avenue Spokane, WA 99204 25244.4401

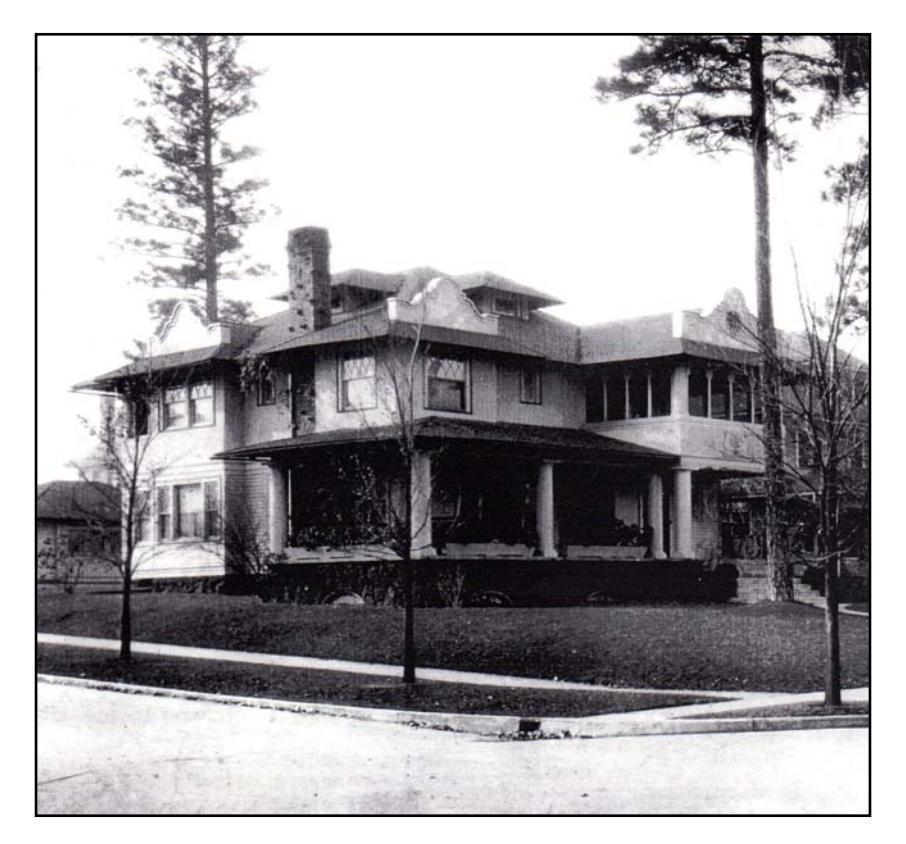
Bradley House in circa 1915

An early photograph of the Bradley House was taken in circa 1915, a few years after the house was built in 1909. The photograph confirms the existing Bradley House is well-preserved and matches its original 1909 design with very few exterior modifications. Notice the sun porch located on the second floor, southeast corner of the house, was *not* enclosed with windows when the photograph was taken. The circa 1915 photograph also pictured the existing double-car garage behind the house. The garage is not pictured in a 1910 Sanborn Fire Insurance footprint map, making the built-date of the garage between 1910 and 1915.

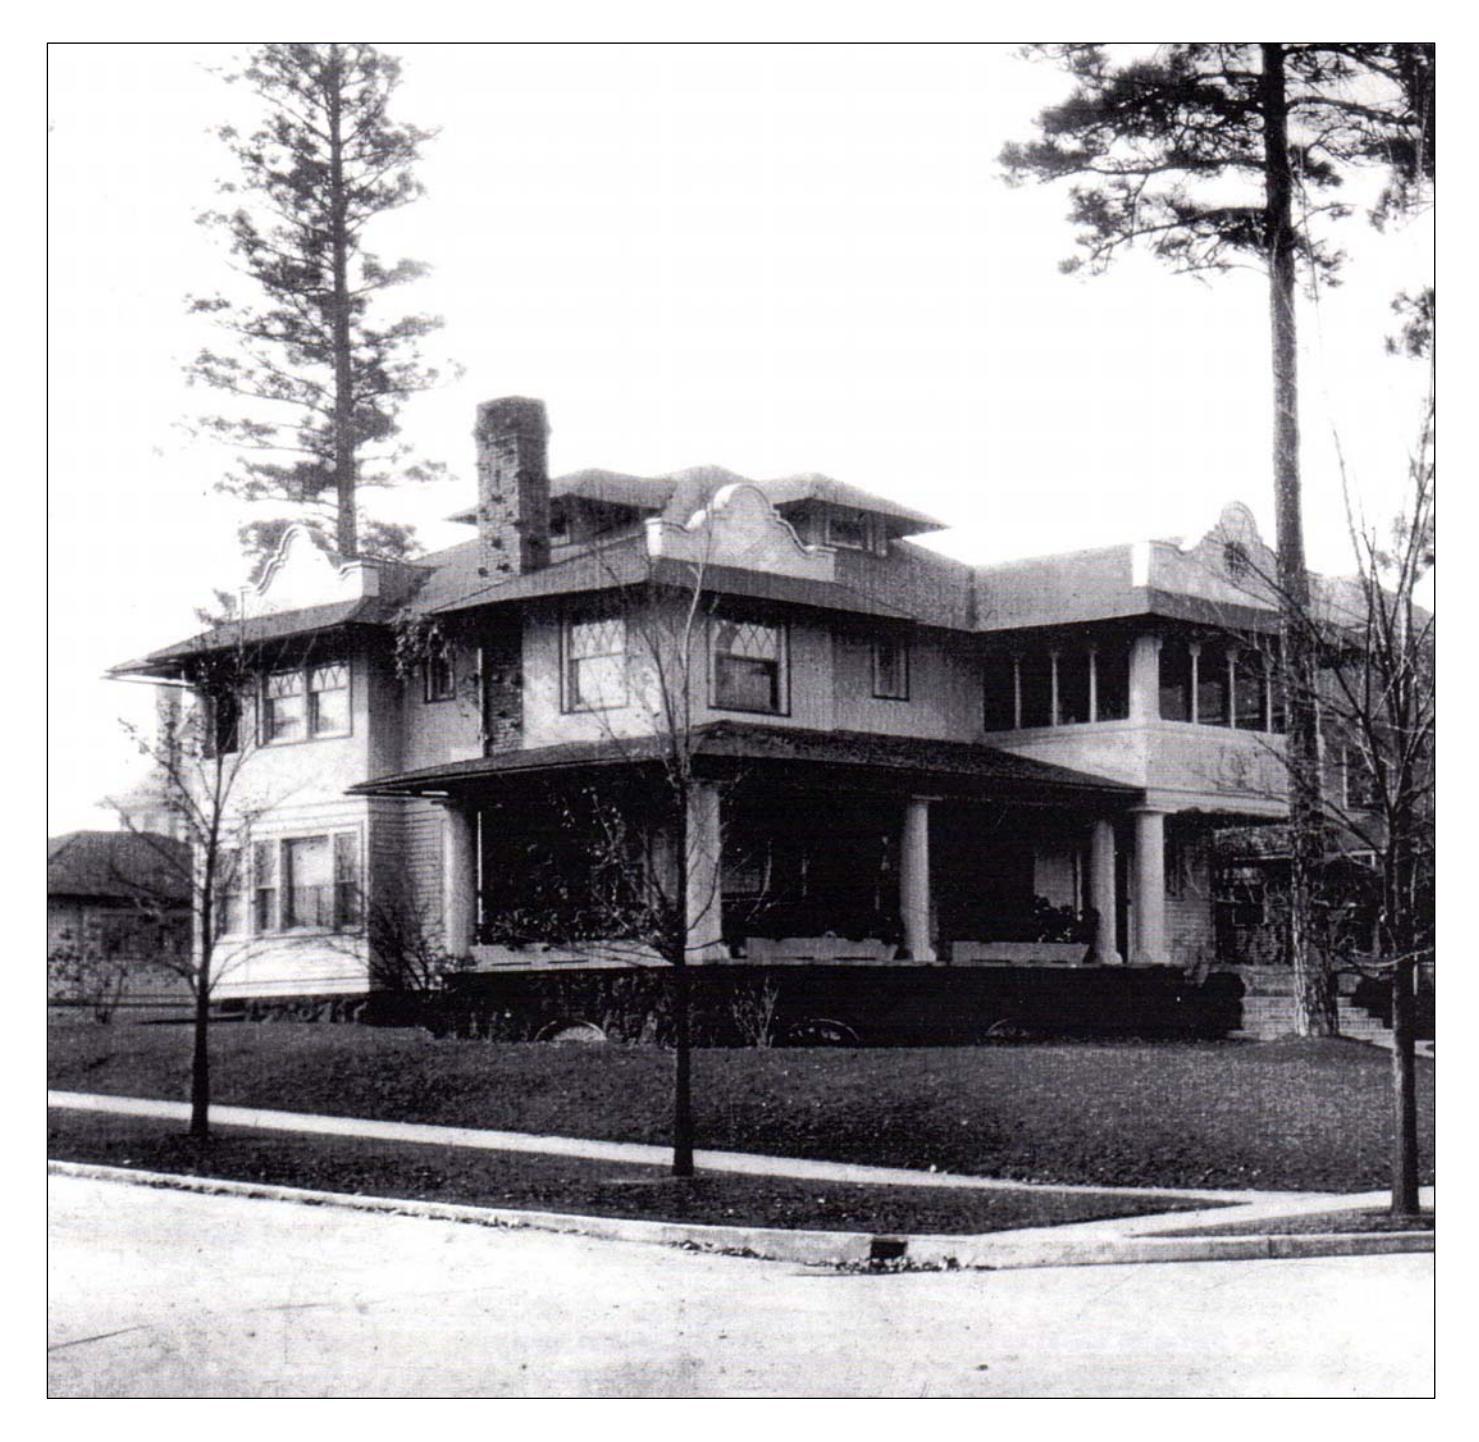
1703 W. Ninth Avenue Spokane, WA

Photo taken in circa 1915

1988 An exterior planter box was repaired and repainted, and new planter boxes were made and painted for the front porch to match the existing planter box and those in the circa 1915 photograph of the house.

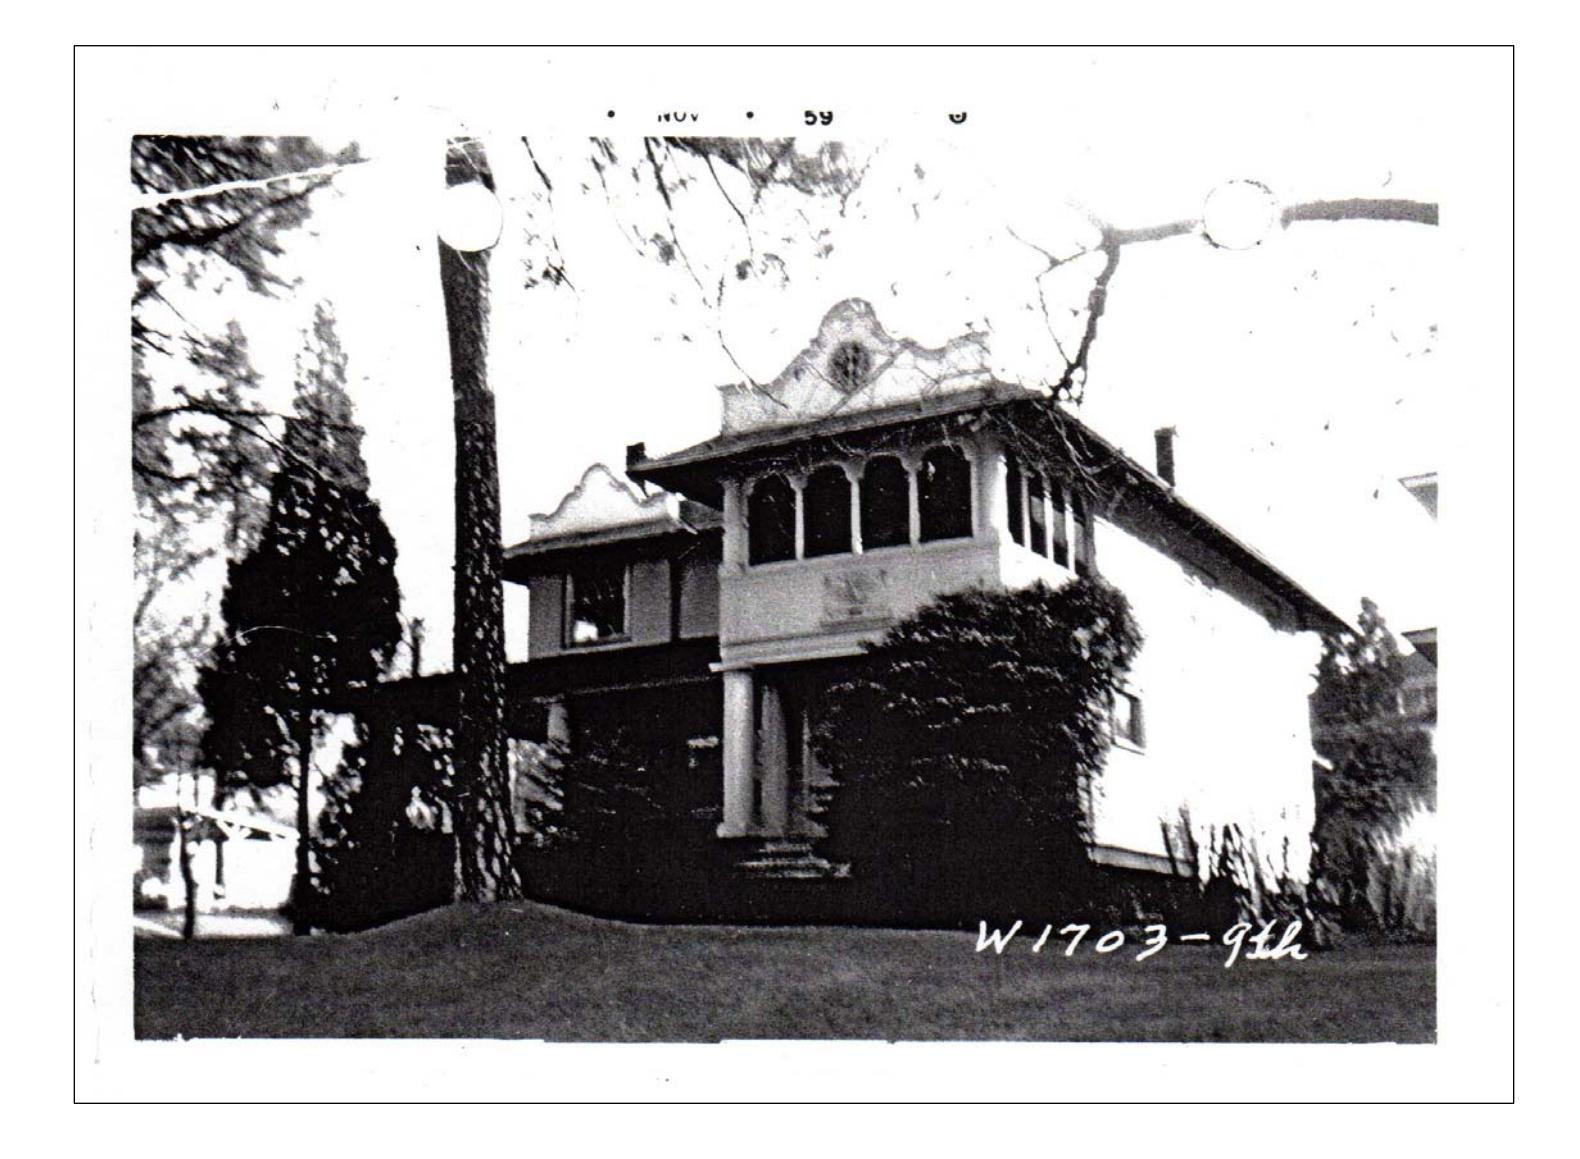
1703 W. Ninth Avenue

Source: 1959 Spokane County Tax Assessor Photo

1970s The sleeping porch was enclosed with aluminum-frame sliding rectangular windows that replaced the original arched windows, which were pictured in a 1959 Spokane County tax assessor photograph. The sun porch (rear southeast corner of second floor) was enclosed with aluminum-frame sliding windows. Some of the

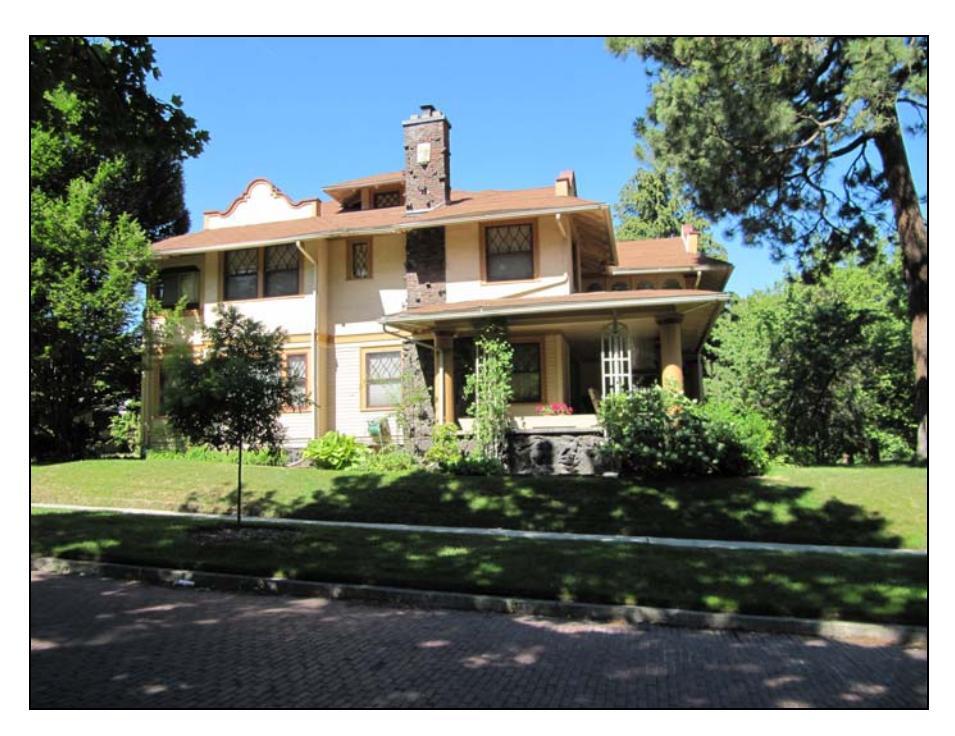
East face in 2015

Highly visible as it faces Ash Street, the east face of the house is considered a secondary facade. It features a continuation of the home's low-pitched hip roof, widely overhanging eaves, exposed rafter tails, tongue-in-groove soffits, basalt foundation, horizontal narrow-width clapboard siding at the first floor, stucco cladding at the second floor, and a continuation of the single-story covered front porch as it wraps around the northeast corner of the house. A wide horizontal stringcourse separates the first floor from the second floor. A dormer with a low-pitched hip roof, wide eaves, exposed rafter tails, stucco cladding, and a fixed-pane window is located in the center of the east roof slope. A tall chimney rises from grade past the first and second floors and through the roof. The chimney is constructed of basalt stone-cobbled irregular clinker brick at the second floor and basalt stone rubble mix at the first floor. The home's foundation is made of basalt stone rubble mix. A bas relief sculpted American Indian head in profile is set in the chimney bricks near the top of the chimney. An 11-foot-wide, two-story bay with a parapet that appears to pierce the roof projects one foot from the planar wall surface of the house at the south end of the home's east face. The bay's roof parapet is shaped and matches the design, size, materials, and Mission Revival style of the home's two north facade shaped roof parapets. The east facade bay at the first floor features a tripartite window composed of center fixed-sash glazing flanked by two double-hung windows articulated with curved divided lights. Two larger double-hung windows with curved divided lights flank the bay. Second-floor windows include a window pair in the bay and a small casement window and larger double-hung window at the north end of the second floor. All windows are embellished with and repeat the same curved hourglassshaped divided light design featured at the Bradley House.

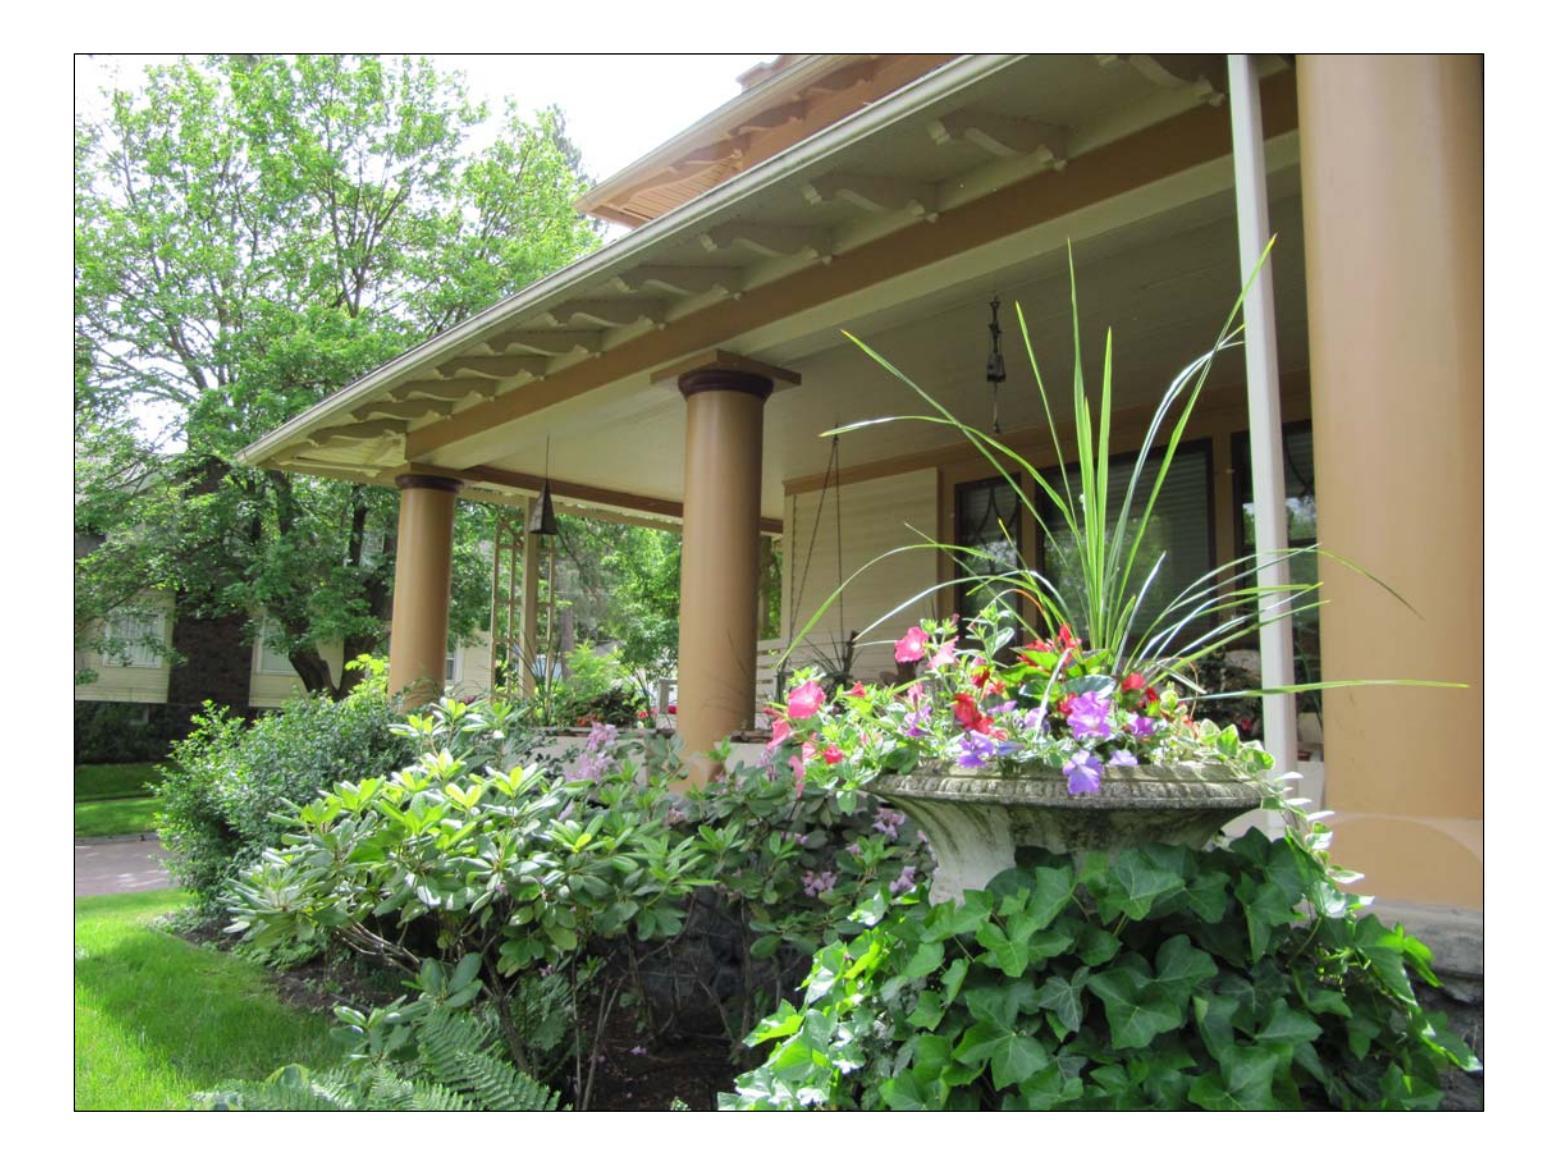
Front porch on north façade

The first-floor front porch is 8 feet deep, extends 34 feet across the full width of the house, and wraps around the home's northeast corner. The single-story porch is covered by a very low-pitched hip roof with unenclosed widely overhanging eaves. The porch ceiling and eave soffits are clad with original narrow-width, tongue-in-groove wood paneling. Decorative rafter tails are located under the porch's deeply overhanging eaves. Massive round classic Doric porch columns support the porch roof. The porch deck is constructed of poured concrete. As part of the original front porch design, large wood flower boxes line the perimeter of the porch. When the house was built, the large flower

boxes were built in place of a porch balustrade system. Wood trellises are located at the east and west ends of the front porch. An original wood front door with upper-leaf fixed "picture window" glazing is located just west of center on the north façade. A wood screen door protects the front door and is articulated with curved muntin/mullion designs influenced by the home's original windows. Located west of the front door is a small fixed-sash window with curved divided-lights. A large tripartite window is located adjacent east of the front door. The tripartite window has a center fixed-sash "picture window" and is flanked by two multi-paned, double-hung windows with curved, hourglass-shaped divided lights in the upper sash. Six concrete steps rise from a concrete walkway in the front yard to the front porch. The foundation under the porch and northwest bay is made of basalt rock, the first floor is clad in narrow-width horizontal wood clapboard siding, and the second floor is covered in stucco. A wide horizontal stringcourse separates the first floor from the second floor.

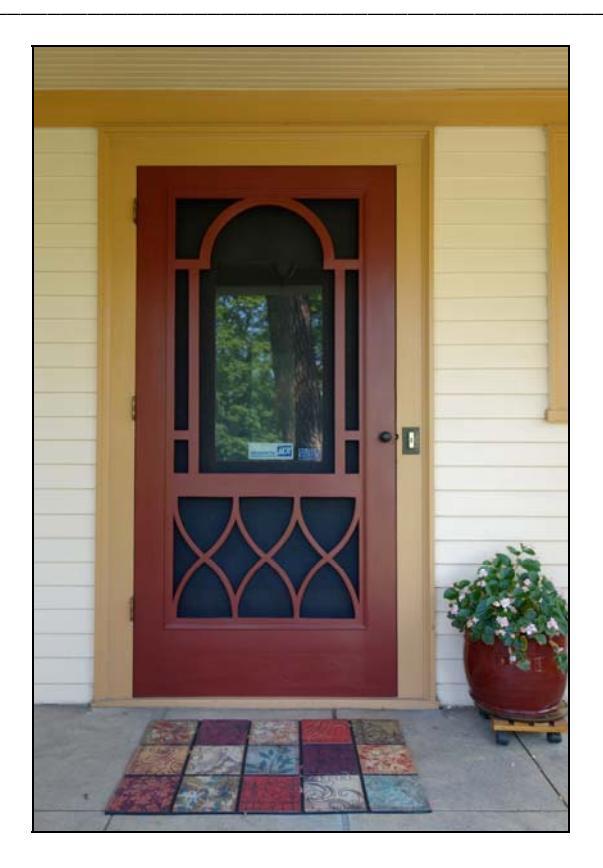
Front door on north façade in 2015

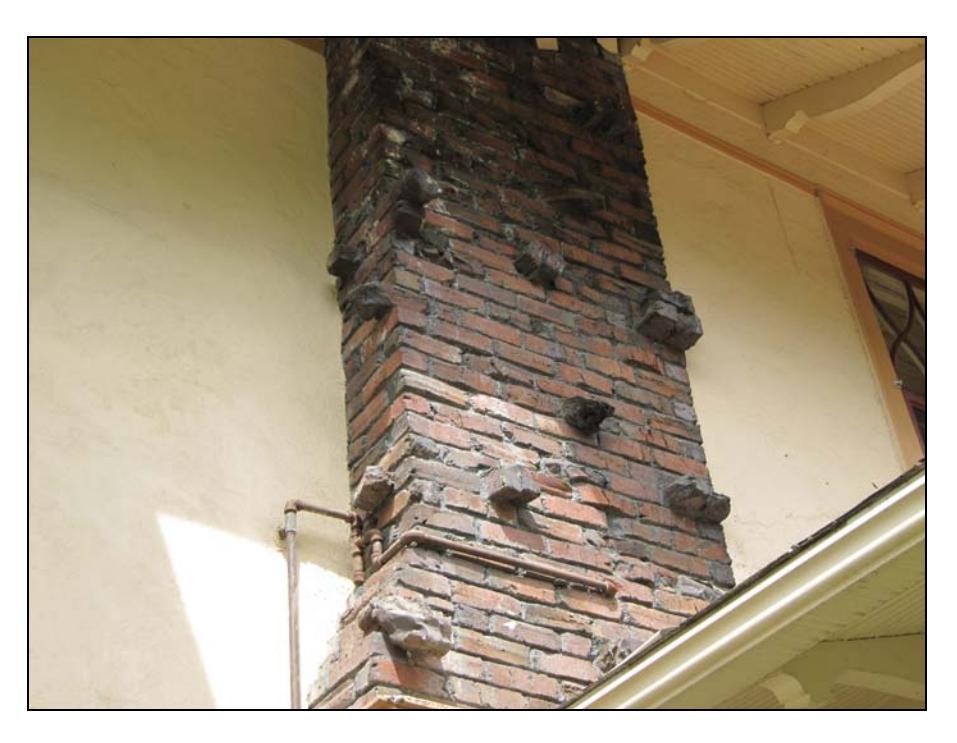
Cobbled clinker brick on east face in 2015

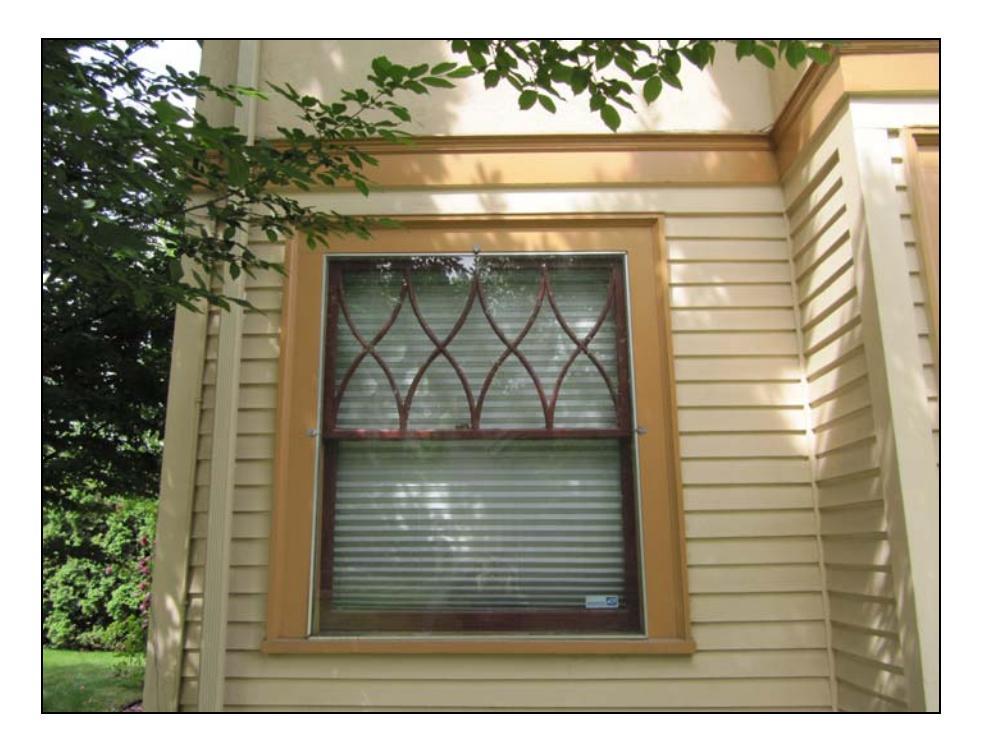
Window detail in 2015

Without a doubt the strongest feature of the Bradley House to possess high artistic values are the windows. Rarely seen in Spokane, the home's windows are a combination of fixed-sash and double-hung units with multi-paned divided lights. The lights are divided by wood muntin and mullion bars curved into sinuous hourglass shapes. The design is

repeated throughout the Bradley House not only in exterior windows but in interior glazing in doors, walls, and built-ins.

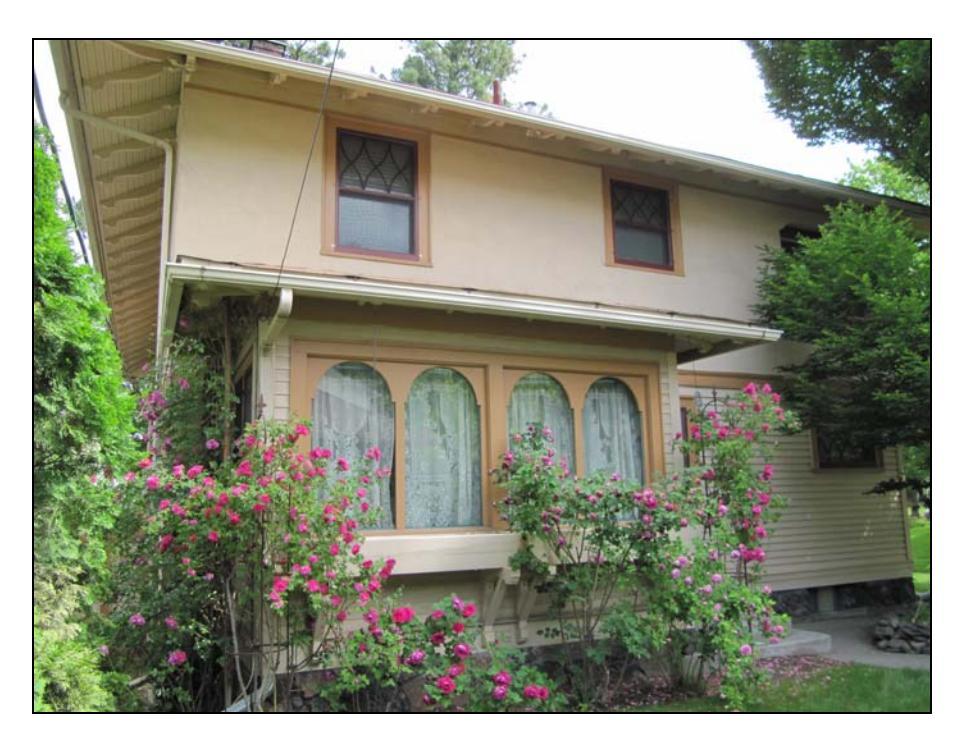
South rear face of house in 2015

The rear face of the house looks south onto a groomed back yard and two-car garage. The home's rear features a continuation of the low-pitched hip roof, widely overhanging eaves with exposed rafter tails, basalt rock foundation, first-floor clapboard siding, second-floor stucco cladding, and multi-paned windows that repeat the curved, hourglass-shaped divided-light design for windows on the house. An enclosed single-story back porch at the southwest corner on the first floor is 12 feet wide, 6 feet deep, and has an original paneled-wood back door with an upper fixed-sash glazed leaf. An original wood screen door protects and covers the back door. Four arched windows that match the arched windows in the north facade sleeping porch illuminate the back porch. An original fixed-sash window with curved divided lights is located west of the back door. A wood window box is anchored to the house under the windows. At the southeast corner on the second floor of the house is a sun porch with an original rolled tin floor. The porch was enclosed with contemporary metal windows in the 1970s.

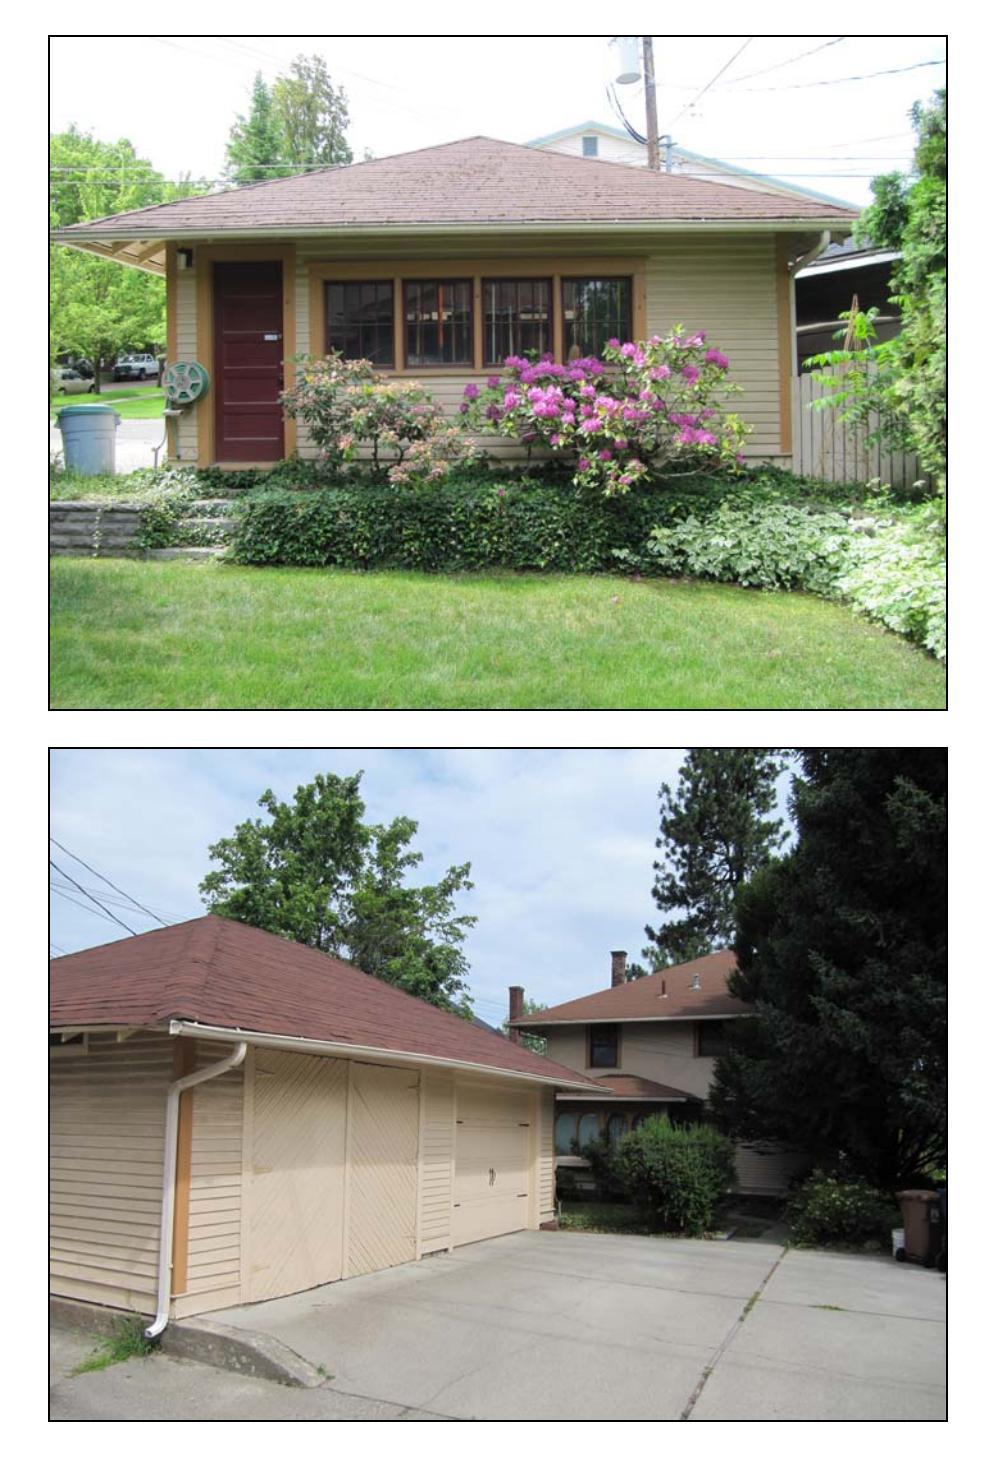
Garage at rear of house in 2015

A two-car garage is located behind the house in the southwest corner of the back yard. Leading west from Ash Street, a public alley parallels the property's south border at the south side of the garage and its paved driveway. Facing Ash Street, the east façade of the garage fronts the paved driveway. The garage is 26 feet wide and 20 feet deep, and is covered by a low-pitched hip roof. The double-car garage is composed of two single-car garages built at different times between 1910 and 1915 as adjoining side-by-side garages.³ When the north-end garage was erected after 1910 but before 1915,⁴ a broad low-pitched hip roof was built from the top of the hip roof on the previously built southend garage, and extended north to cover the newly built north-end garage-the new hip roof covers both garages. Matching the design and materials of the house, the roof on the garage has widely overhanging eaves and exposed rafter tails. The garage exterior is finished with narrow-width horizontal wood clapboard siding and exterior corner boards. Two garage doors open from the building's east facade. An original pair of carriage house doors is located on the south-end single-car garage. With no windows, the doors are made of narrow wood tongue-in-groove paneling laid diagonally on each door half to meet in the center. The north-end single-car garage features a contemporary aluminum overhead door with an inset panel design. An original wood 5-panel pedestrian door is located on the north side of the garage, which faces the rear of the Bradley House. A row of fixed-wood sash multi-paned windows are located adjacent west of the door. The interior of the south-end garage is used as a storage room/shop, and the north-end garage houses a single vehicle. The south-end garage interior is insulated and roughly finished with unpainted drywall, an upgraded electrical system, auxiliary wall heaters, and a

raised insulated floor. The interior of the north-end garage is unfinished and exposes the exterior north wall of the south-end garage. Regarded as a historic resource of the property, the garage *is nominated* to the Spokane Register of Historic Places with the Bradley House.

1910-1915 Two single-car garages were built at different times side-by-side in the southwest corner of the property. A single roof was constructed over both single-car garages when the north-end single-car garage was built after the south-end garage.

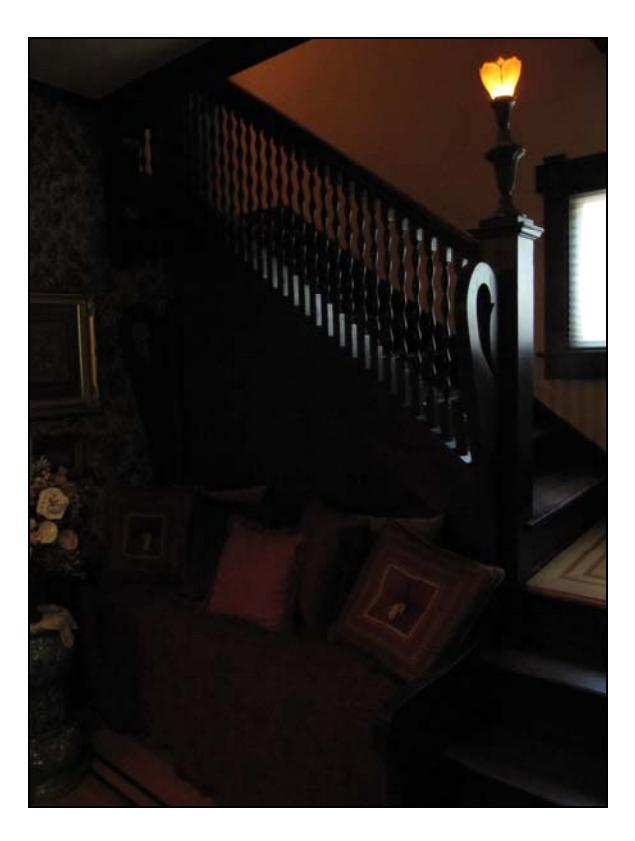
Reception hall stairs in 2015

A paneled and upper leaf-glazed south door in the vestibule opens to a formal reception hall at the first floor. The reception hall is distinguished by a formal staircase that winds and ascends to the second floor. A built-in bench seat is located in the ell formed by the staircase and the adjoining south wall at the first floor. The staircase has a closed stringer, closely spaced barley-twist balusters, a wide walnut hand rail, and a paneled, square newel post. Similar to a wing-back chair, the built-in bench seat has two wings made of ebony-finished fir, constructed with a curved hand-held grip design. The bench seat's south wing is attached to the south wall next to the bench seat, and the north wing is attached to the staircase's newel post. Illuminating the staircase, an original light fixture with a metal base and opalescent glass shade are anchored to the newel post's flat top. The reception hall ceiling is 9 feet, the fir woodwork is finished a rich ebony color, and the floor is made of oak hardwood with a triple-strip inlaid perimeter walnut border design (the coat closet and reception hall have double inlaid strips). An angled 5-panel fir door opens southwest into a formal library with ebony-finished fir woodwork. A plate rail, plate rail brackets, and vertical wood battens are featured in the library, and exactly match those in the dining room. A 5-panel fir door on the south wall of reception hall next to the library door opens south to an interior hallway, that leads further south through another door to an interior service hall designed for use by domestic help.

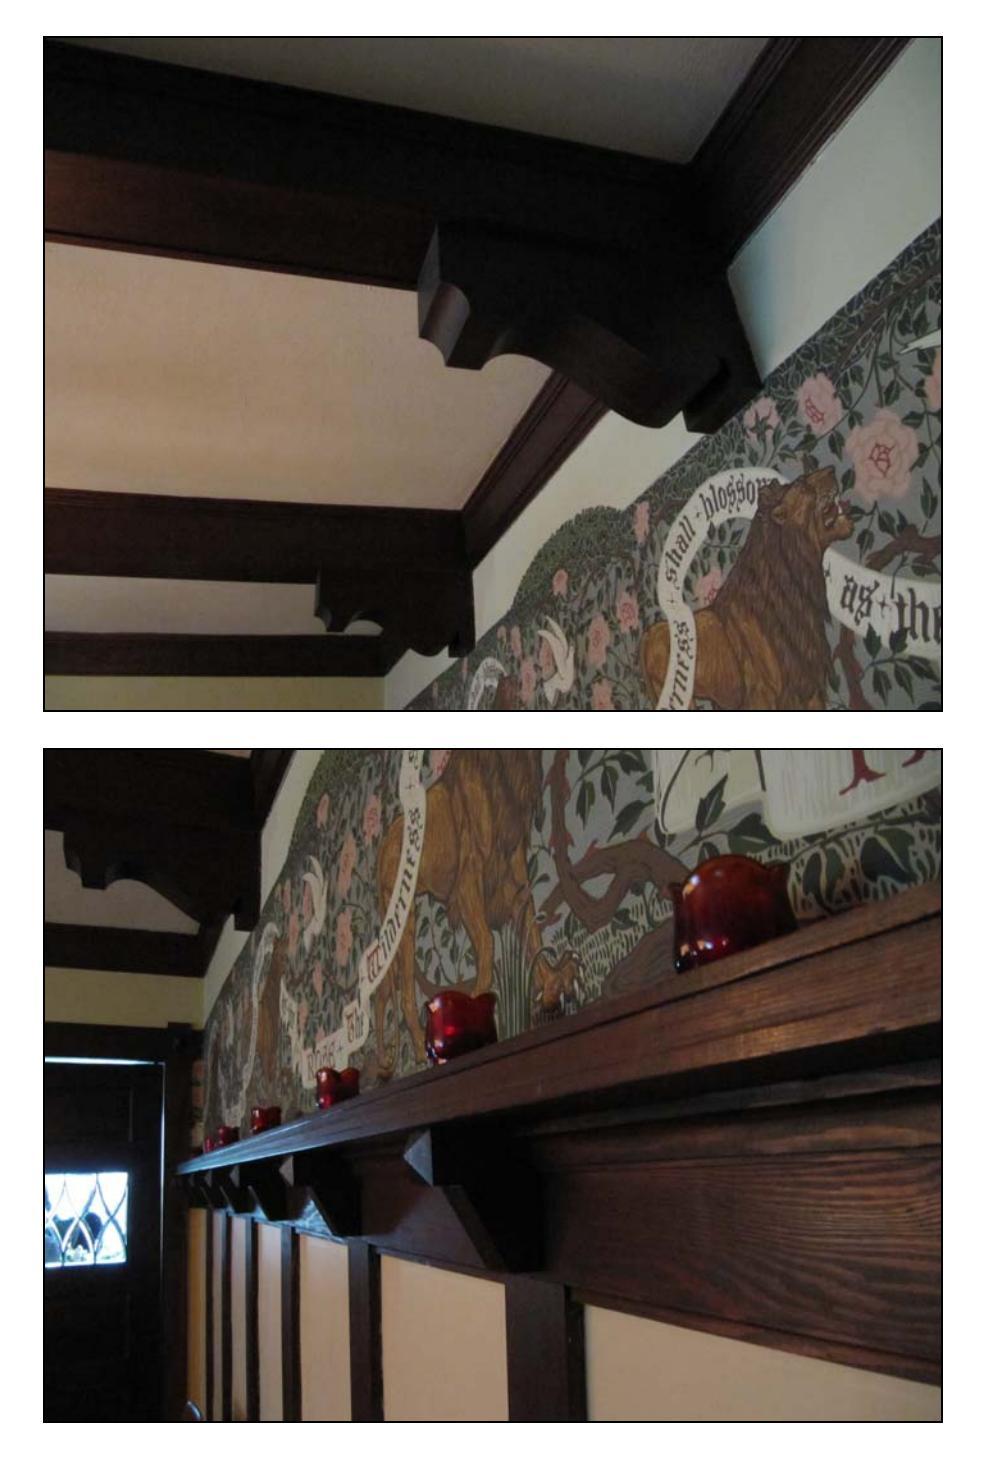
Ceiling brackets and plate rail in dining room in 2015

A pair of 7-foot-tall, ebony-finished, 6-paneled fir pocket doors slide open on the south wall of the living room to a formal dining room. The same size as the spacious living room, the large dining room has a 9-foot-high ceiling with boxed ceiling beams articulated with massive scroll-sawn brackets at the east and west walls, a perimeter plate rail and vertical wood battens that match the plate rail/battens in the formal library, a small nook in the southeast corner of the room (designed for use as serving space for domestic help), and a built-in buffet/hutch on the south wall. Like the woodwork in the vestibule, reception hall, and living room, the built-in buffet and hutch is made of ebonyfinished fir. It features buffet drawers, a mirrored back splash, and a hutch supported by short square pillars. The hutch has three multi-paned beveled-glass doors that replicate the home's curved multi-paned divided-light window design. The top of the built-in hutch is exposed and is backlit on the south wall by stained glass windows that replicate the same divided-light design as the hutch doors and windows in the home. A door on the south wall of the dining room opens to a butler's pantry, located in the south end of the house. The fir door has 3 panels with an upper-leaf divided-light beveled window, which repeats the home's curved multi-paned window design. The floor in the dining room is made of oak with three inlaid strips of walnut that surround the perimeter of the room. Inlaid Greek key designs at the corners of the inlaid oak floor accentuate the perimeter design.
