Spokane Register of Historic Places Nomination

Historic Name **MORGAN BLOCK**
Common Name Standard Building, Fairmont Hotel

Street & Number 315 W. Riverside Avenue, 314 W. Sprague Avenue
City, State, Zip Code Spokane, WA 99201
Parcel Number 35184.2901

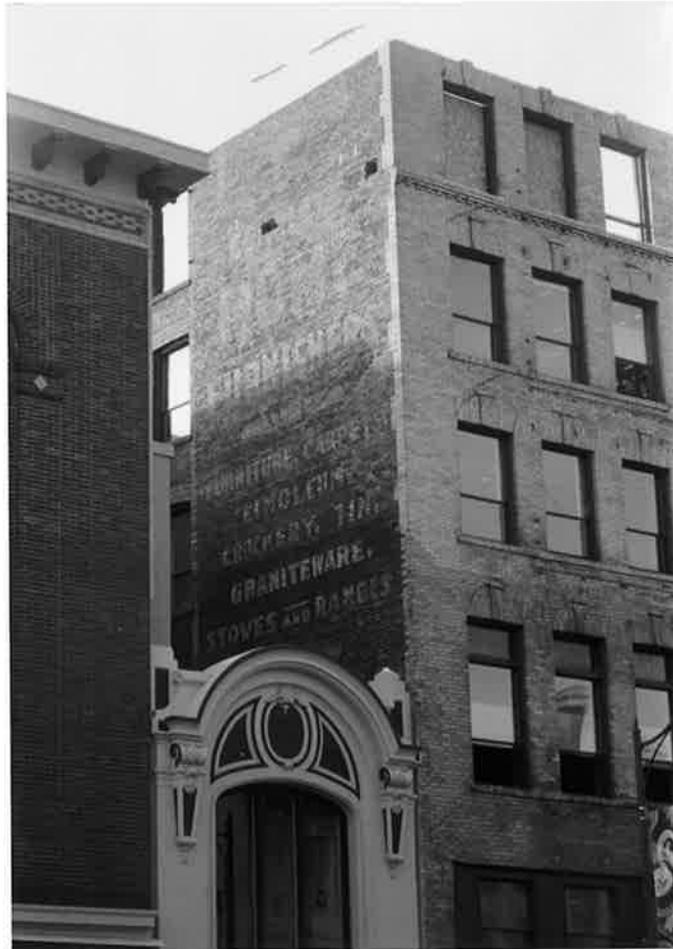
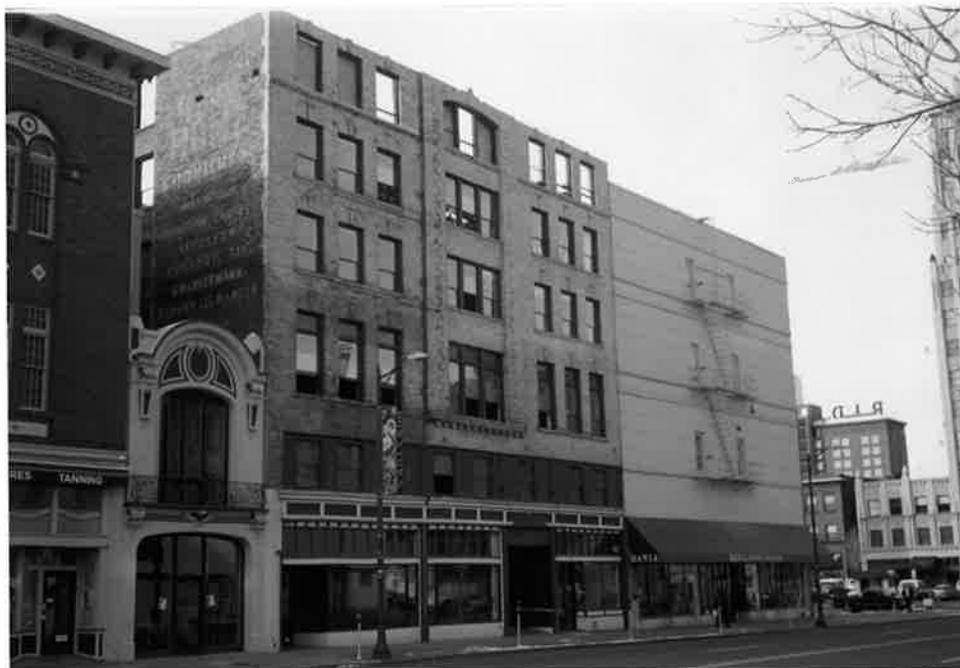
Photos 1 and 2

North facade of building and close-up of east elevation advertisement painted on brick wall of building; November, 2000 photos.

The six-story Morgan Block is constructed of 18-inch-thick load-bearing walls that are supported by a basalt stone foundation. The building rises more than 50 feet to remnants of the sixth floor which was severely damaged in a 1999 fire. Buff-colored pressed brick veneer clads the building’s north and south facades, and the building’s structural walls composed of common red brick are partially exposed on the east and west elevations. The south elevation has five stories, and the north elevation has six stories due to a drop in grade. Above street level, the building’s brick facade design is the same for the north face and for the south face of the building. The facades are evenly divided into three vertical bays separated by brick pilasters. Each facade has a center bay that projects out 12 inches from the wall plane and features tripartite window units on each floor above the second floor. A segmented arch embellished with decorative brick quoins and a large center keystone cap the tripartite window unit on the sixth floor. A brick course outlines and surrounds the center bay. A corbelled-brick window sill forms the base of the bay under the third-floor windows. The facade’s remaining windows on the third, fourth, fifth, and sixth floors flank the center bay and are embellished with brick flat arches and decorative keystones that mark the center of each arch. The partially visible east and west elevations of the building feature segmentally arched windows arranged in a

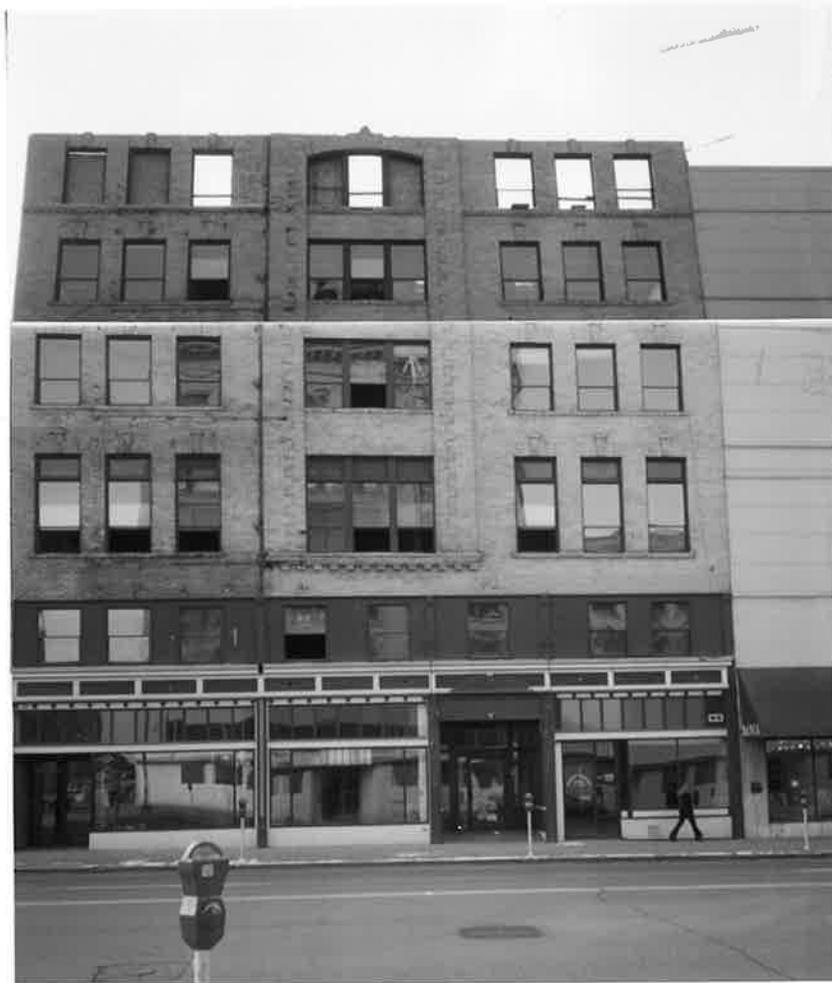
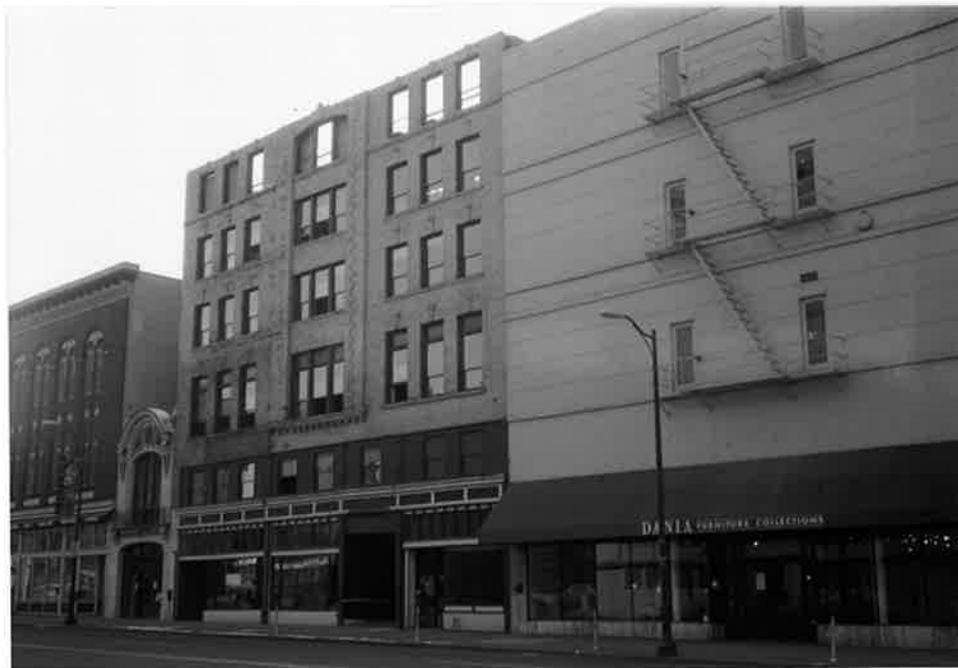
Photos 3 and 4

North facade of building in November, 2000.

The street-level facade on the north face features a contemporary storefront design implemented in 1989-1990. The design includes concrete bulkheads, metal-framed plate-glass windows, transom lights, and metal-framed glass doors. The street-level facade on the south face is comprised of contemporary brick-veneer bulkheads, metal-framed plate-glass windows, and glass doors. The space where transom windows were once located above the plate-glass merchandise windows is covered with wood paneling.

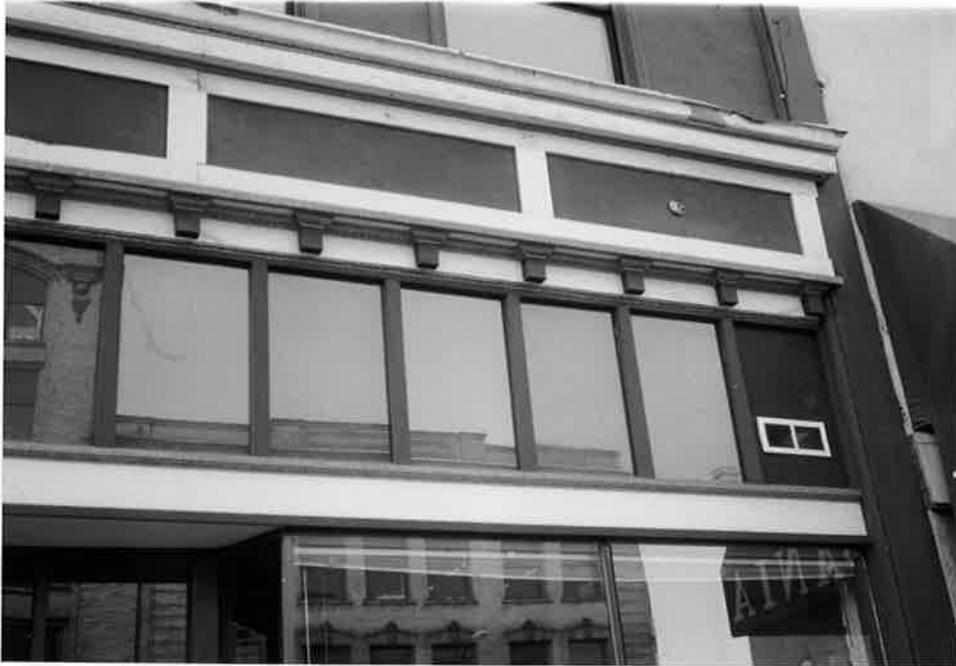
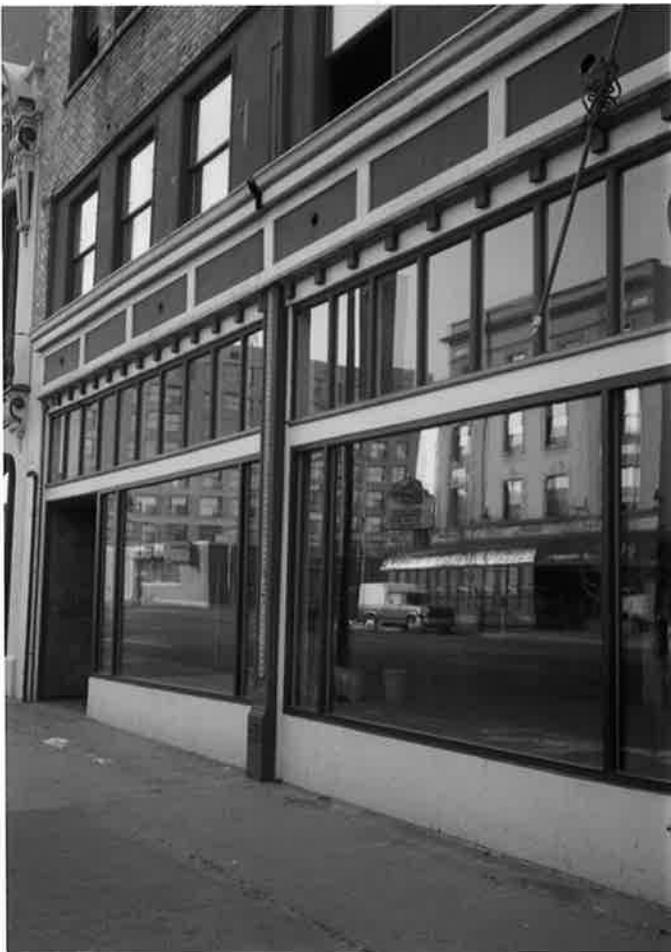
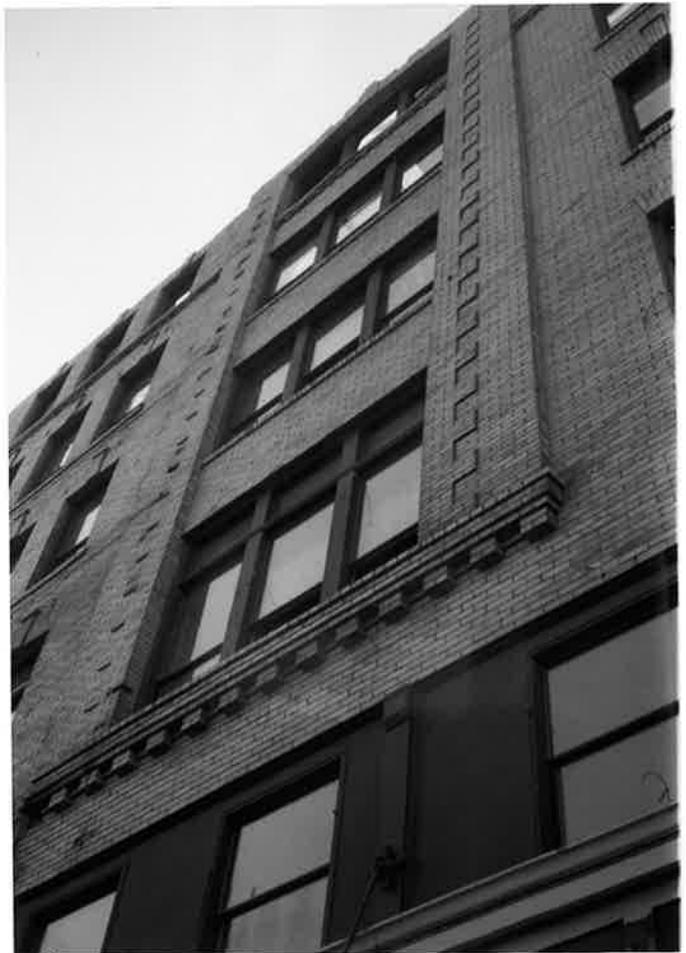
Photos 5, 6, and 7 North facade of building in November, 2000.

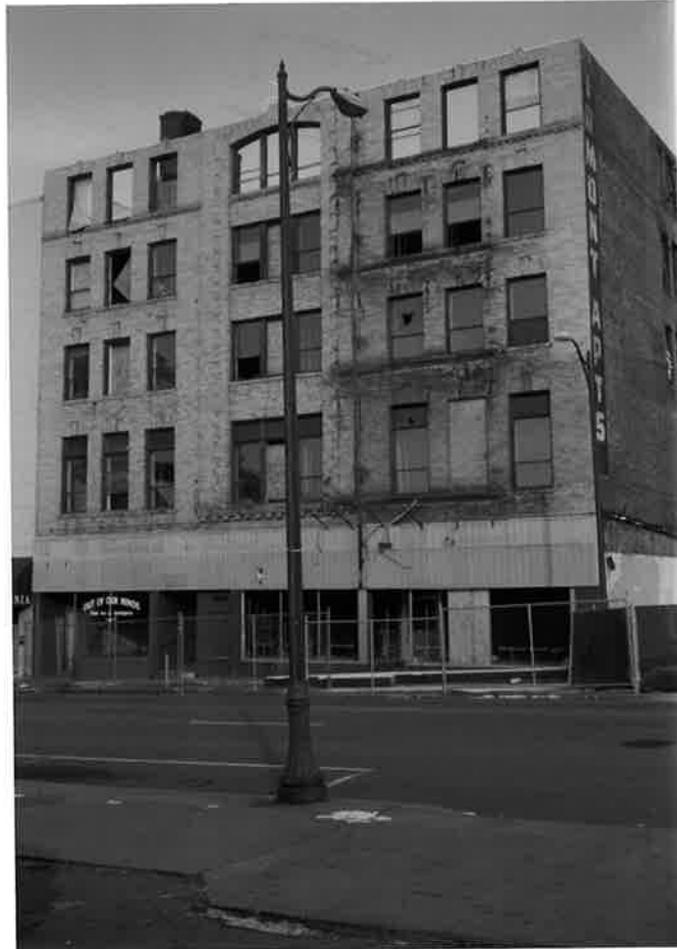
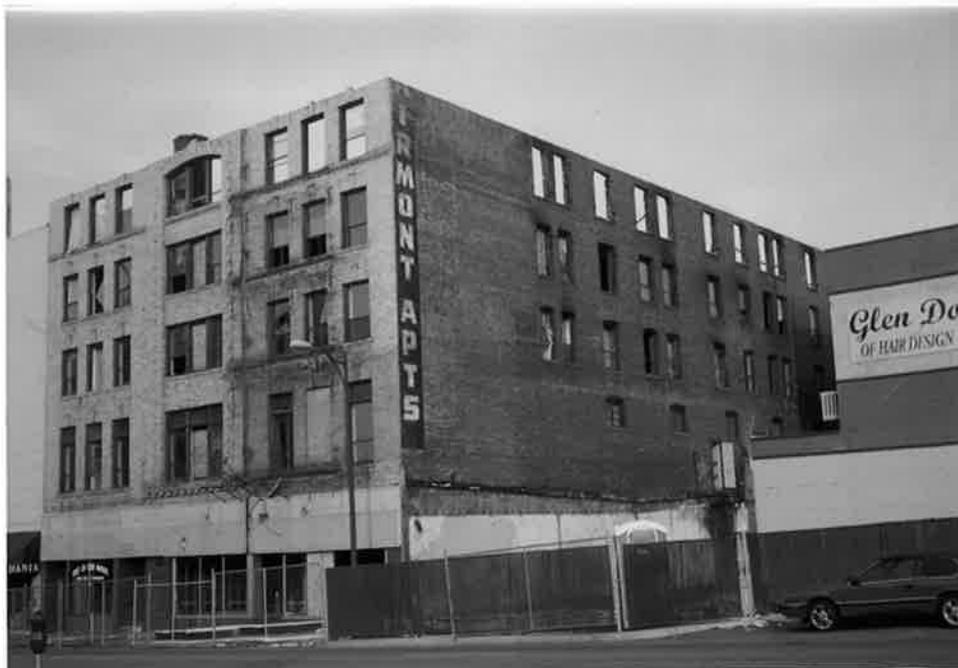
Photos 8 and 9

South facade of building along Sprague Avenue; November, 2000 photographs.

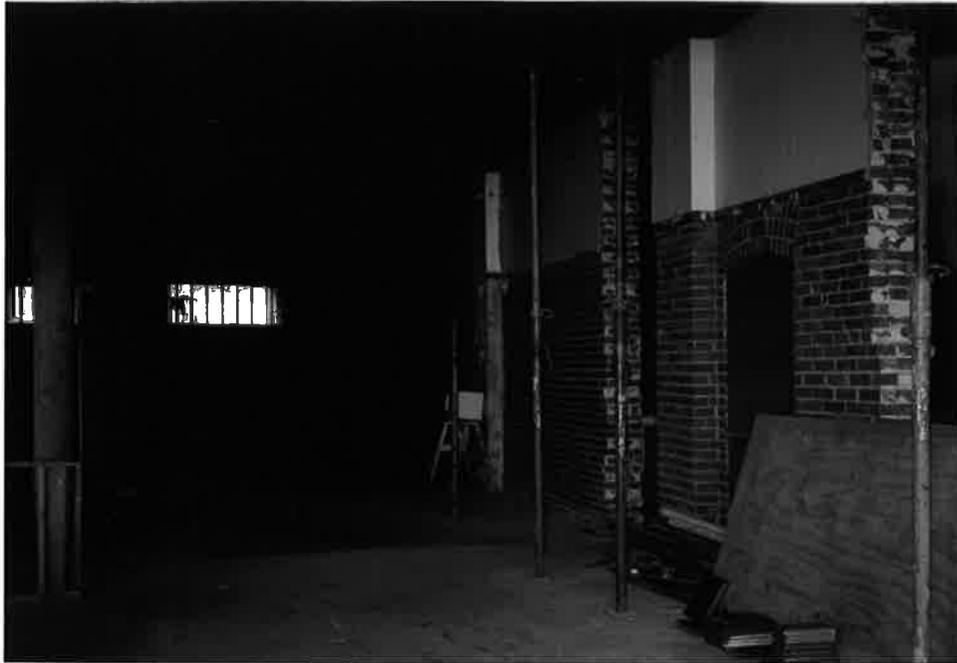
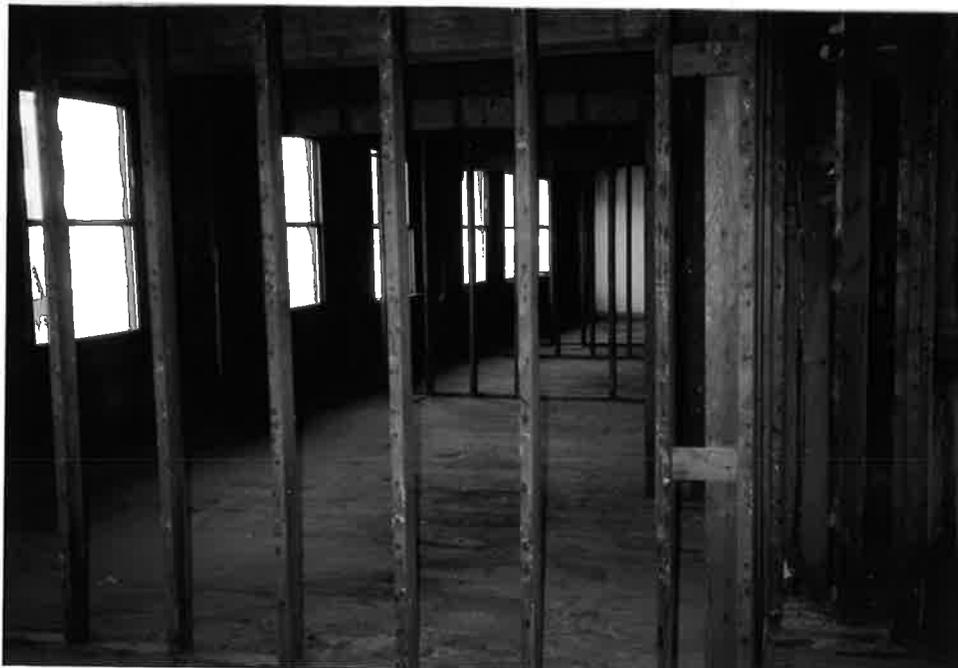
Photo 10
Photo 11

First floor interior looking south.
Second floor looking northeast.

The interior of the Morgan Block was extensively damaged due to a fire in 1999. The entire building was gutted except for remnants of original staircases located on the first, second, third, fourth, fifth, and sixth floors and remnants of wood framing that supported the interior walls. The building's two light wells and two elevator shafts are still in place, and an original terrazzo floor exists on the first floor.

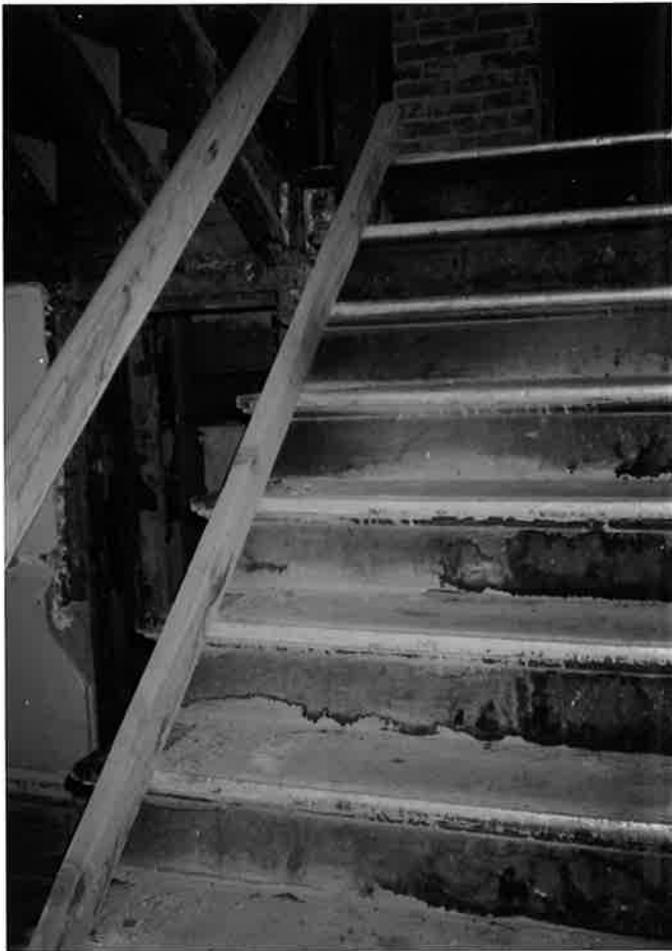
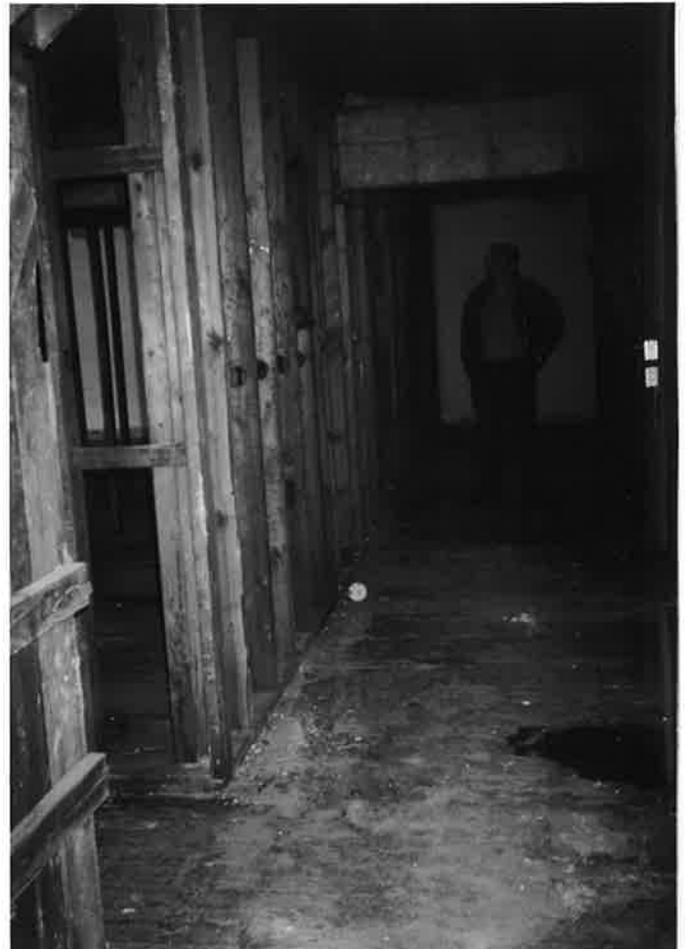
Photo 12
Photo 13

Stairs from first-floor lobby area to second floor.
Second floor (representative of third, fourth, fifth, and sixth floor
plans.

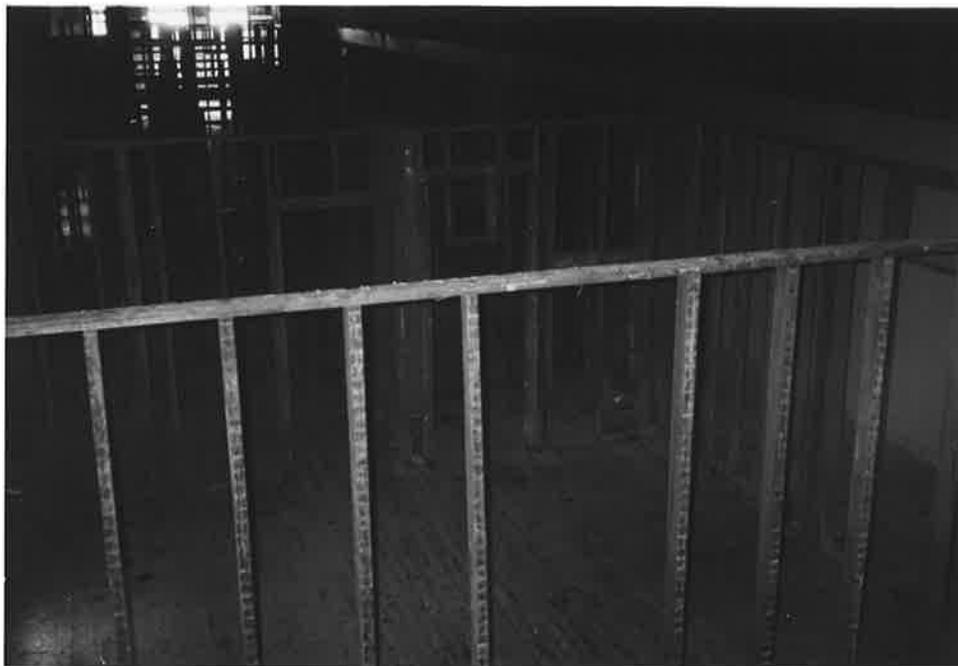
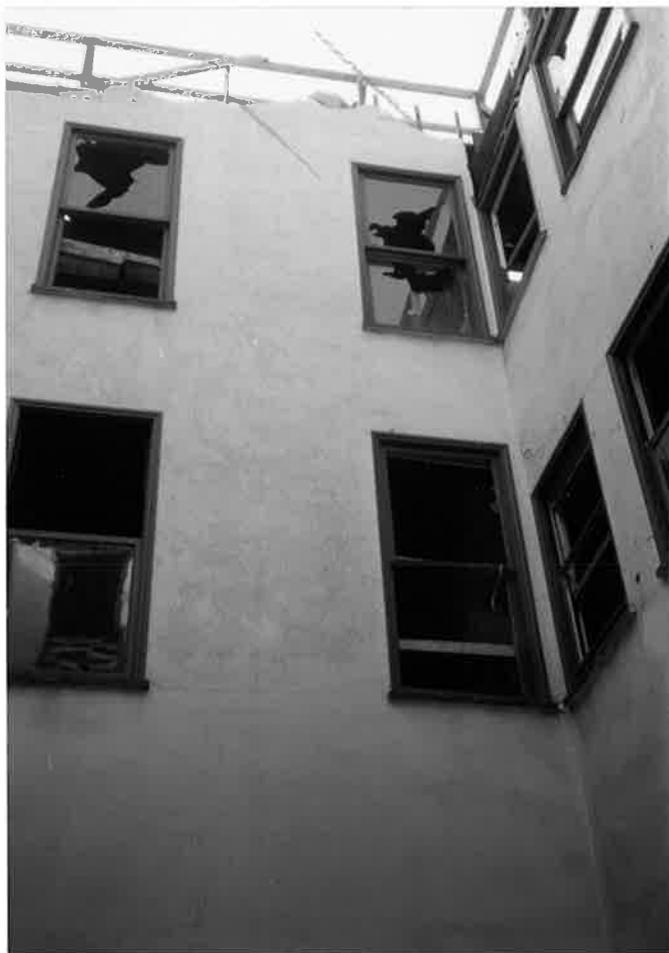
Photo 14
Photo 15

Third floor looking south.
Interior light well looking up to sixth floor.
