# Spokane Register of Historic Places Nomination

Historic Name **Cascade Laundry/United Trucking Building**  
And/Or Common Name **Riverwalk**

Street & Number 1003-1007 East Trent Avenue  
City, State, Zip Code Spokane, Washington 99202  
Parcel Number 35174.0224

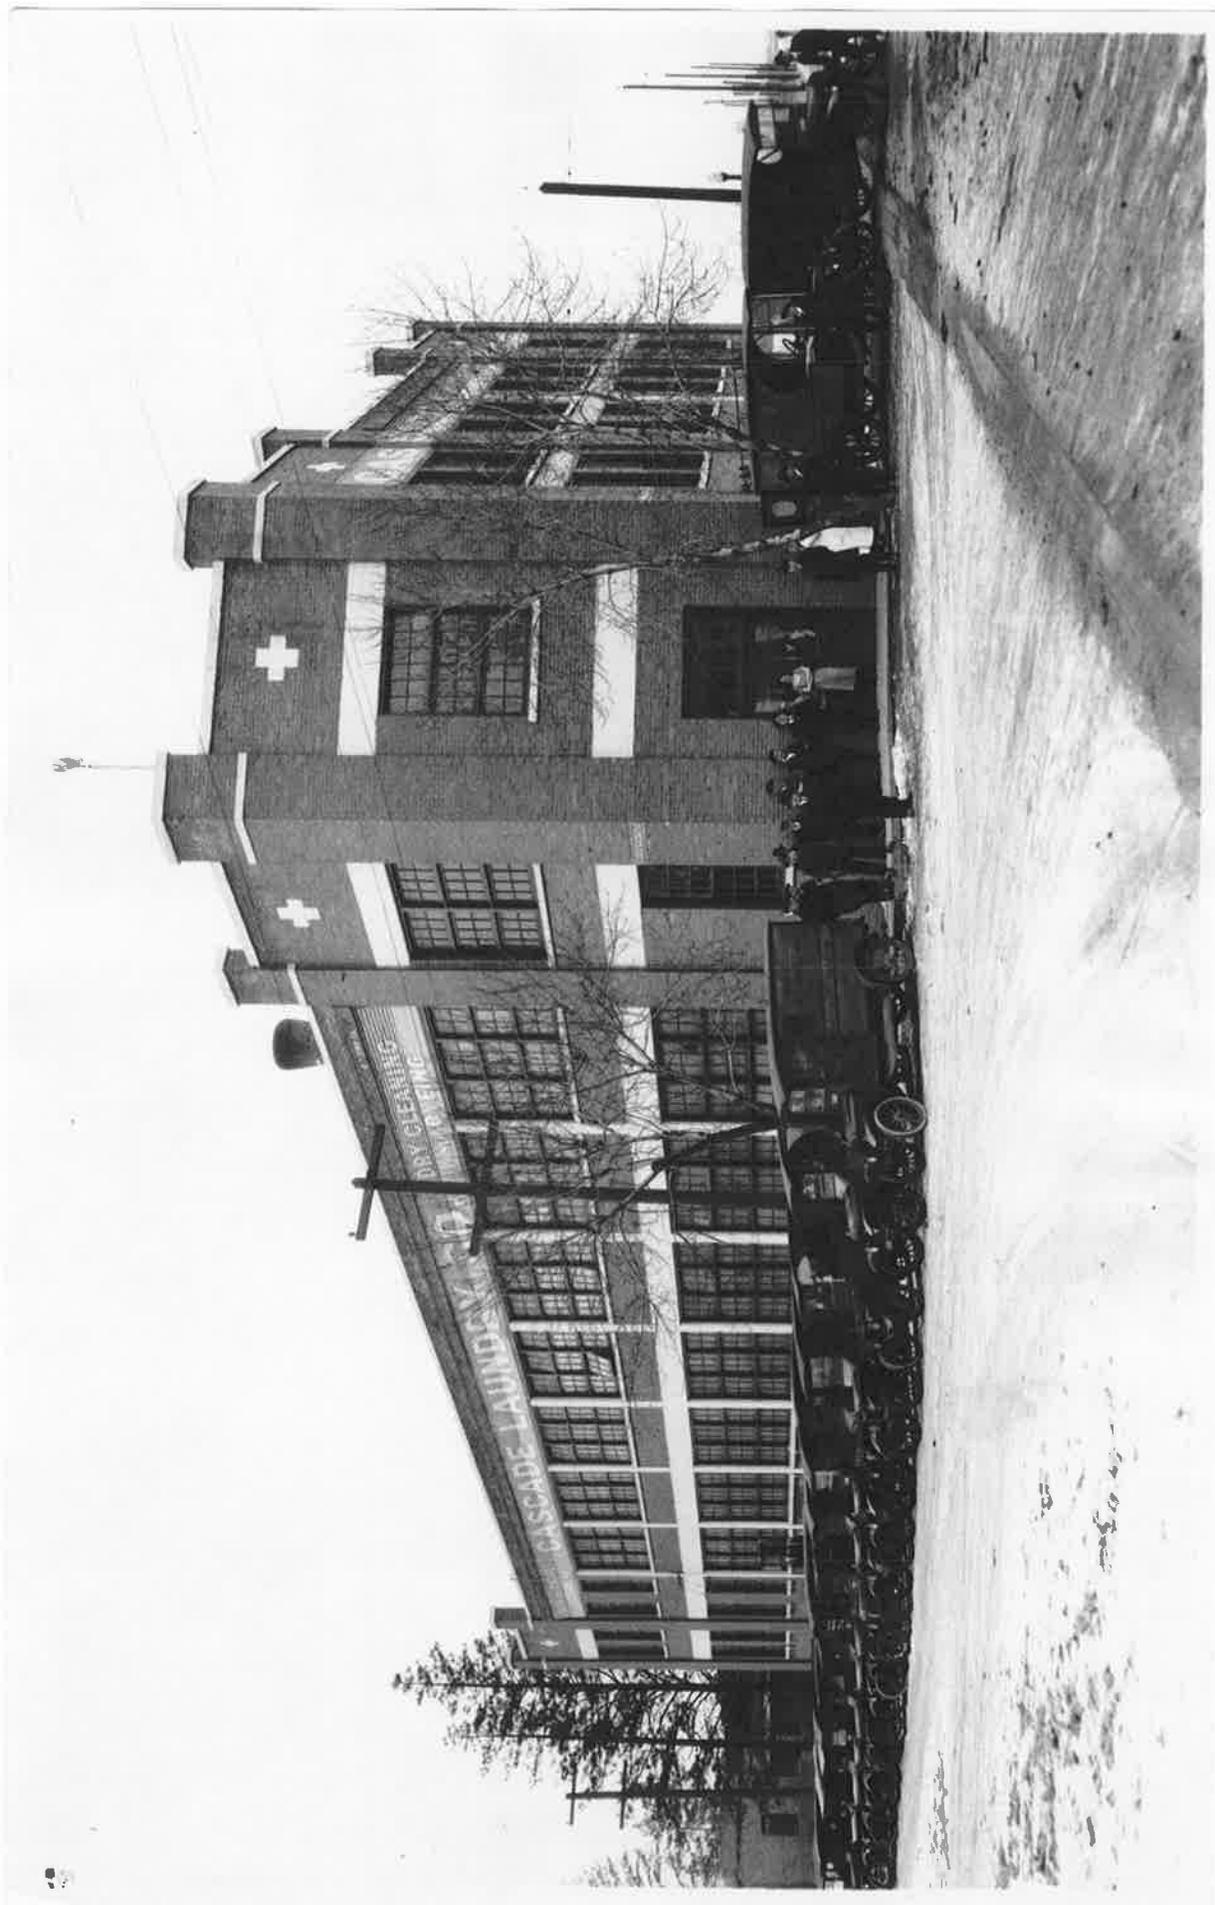
CA 1918

A ca. 1916-1918 photo (L83-113.122 @ NW Museum of Art and Culture) depicts the building with original sash. Several significant changes are evident. First the ground floor bays were multi-light wood sash windows that terminated in concrete sills about five feet above grade. The wall below was brick with the concrete posts dividing the bays extending from grade to the 2<sup>nd</sup> story (as presently configured). In the first bay (from southwest corner), a vertically-oriented window occupied the western half of the bay, the eastern half was brick. The second bay was occupied by a window bay with a higher sill of concrete rather than the existing brick sill. It also appears that the site grade was lower at the south end than it is today. Bays three to eight were configured identically. Bay nine was divided identically to the configuration of the second floor windows above. Bay ten was on both the ground and the second floor was divided into two windows by what appears to be narrow concrete post. The sash of both the ground and second floors was steel and divided horizontally into three sections, each with a projecting pivot. Each section had four columns and two rows of lights. It is apparent that the recently removed sash on the west, north, and east facades was not original and likely installed in ca. 1940 when the building was converted for trucking use. (The wood sash in the northeast corner of the ground floor appears to have the same configuration as the sash depicted in the 1916-18 photograph.) This 1940s conversion also resulted in the ground floor bays on the west side being converted from windows to shop doors. The windows and lower brick wall sections were removed down to grade with the exposed concrete posts and beams as the elements framing the door openings.
