NATIONAL REGISTER OF HISTORIC PLACES
INVENTORY - NOMINATION FORM

COMMON
The Review Building

STREET AND NUMBER
S.E. Corner of Monroe Street and Riverside Avenue

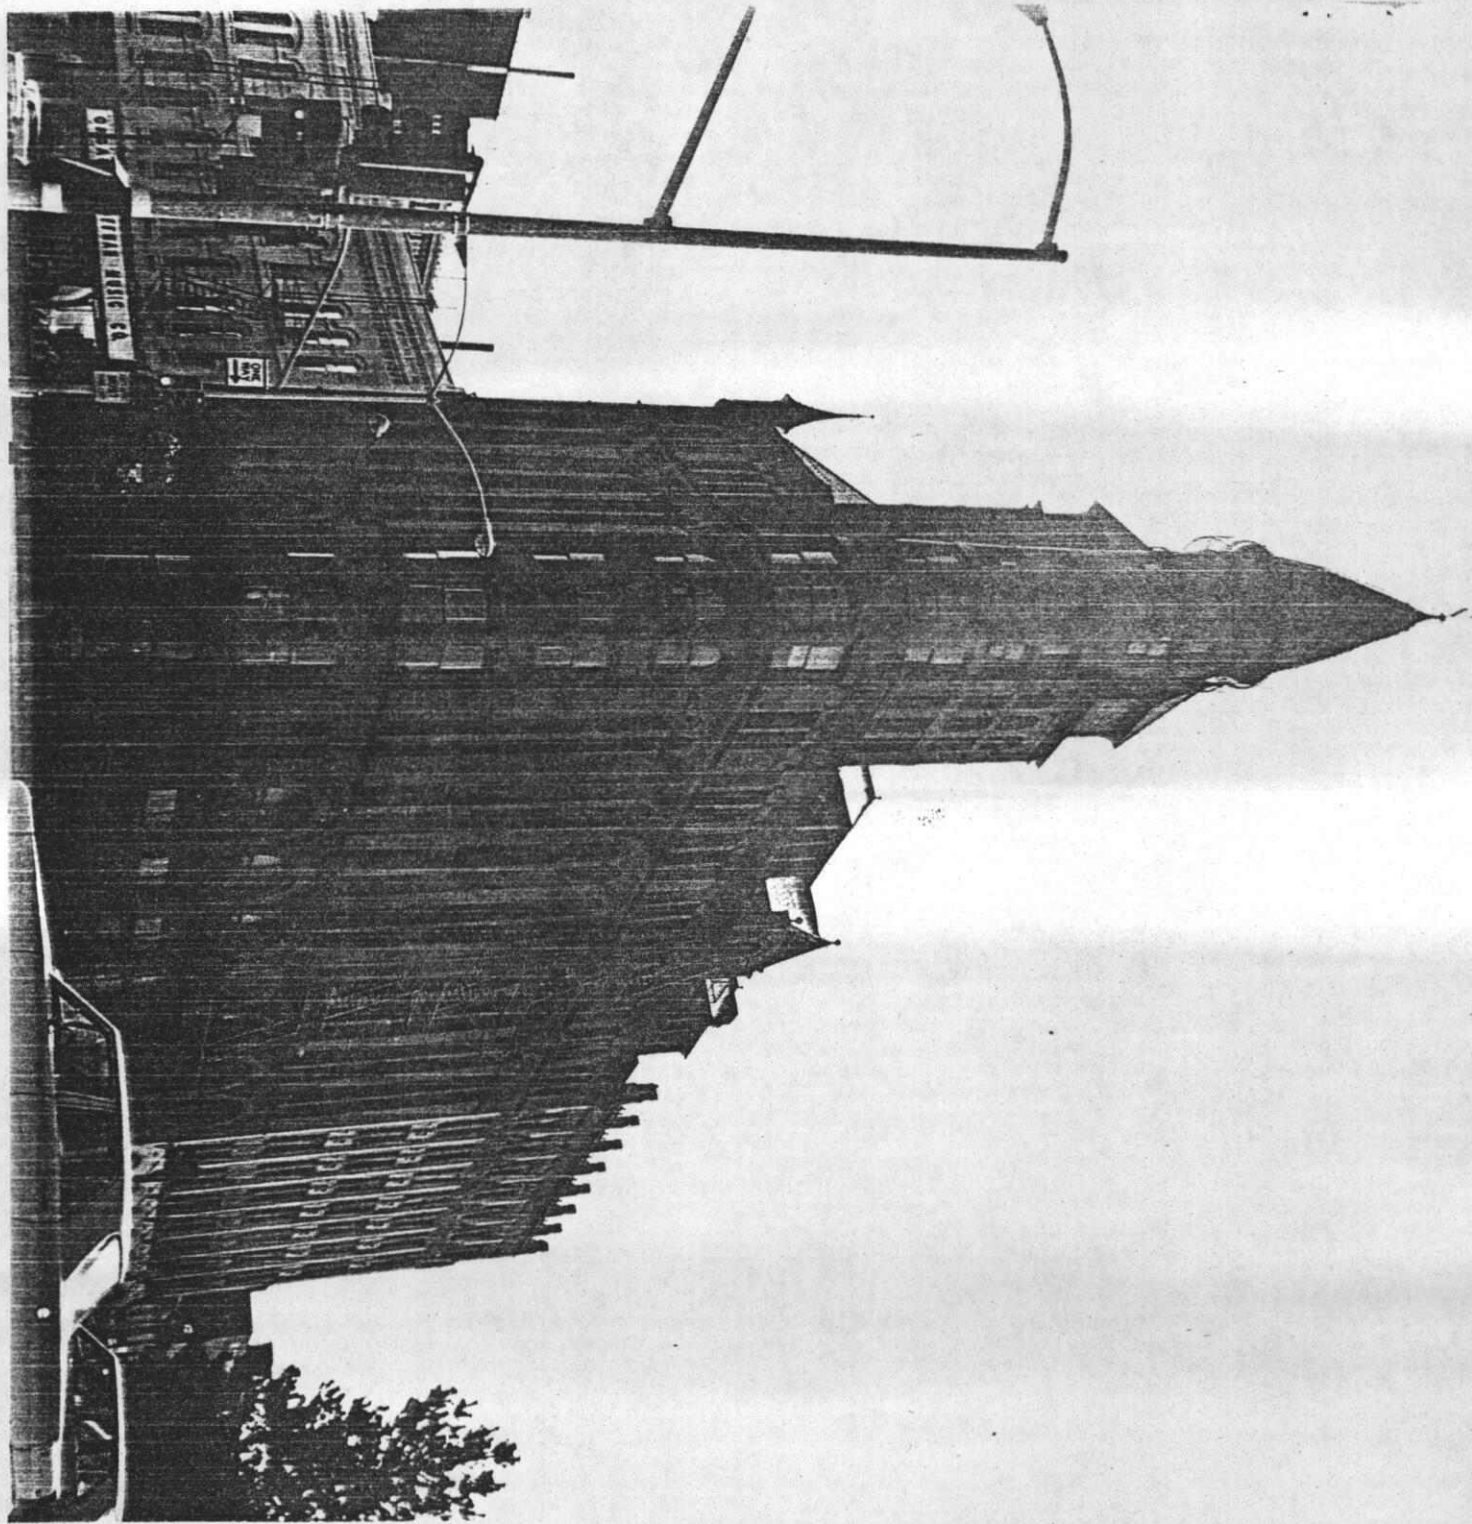
View to the south, Riverside Avenue facade

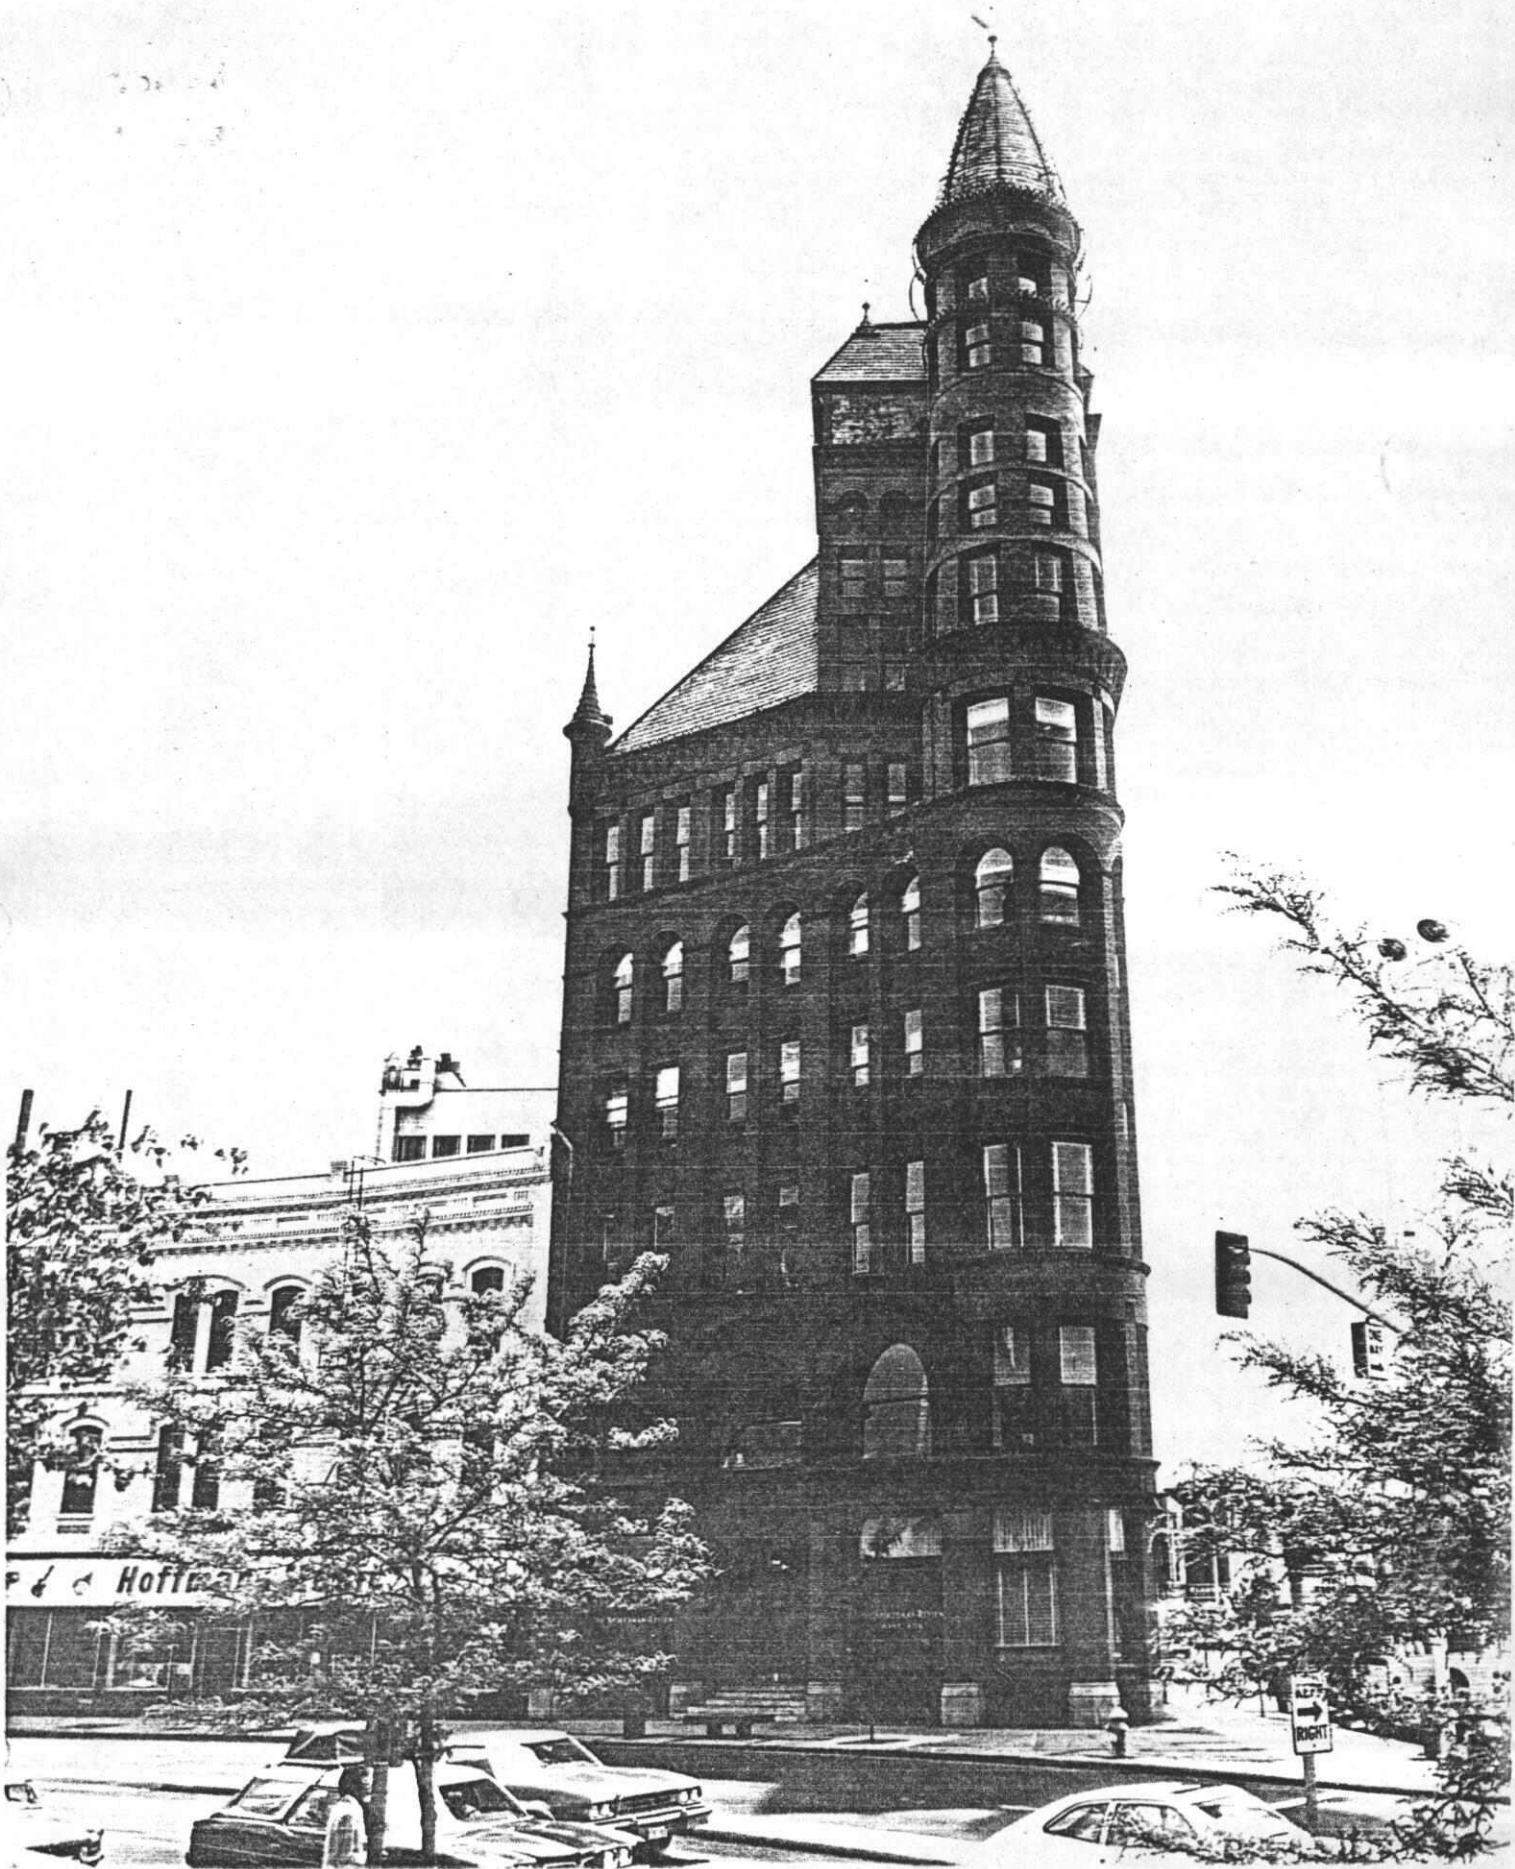
1. NAME			
COMMON:	The Review Building		
AND/OR HISTORIC:			
2. LOCATION			
STREET AND NUMBER:			
S.E. Corner of Riverside Avenue and Monroe Street			
CITY OR TOWN:			
Spokane			
STATE:	CODE	COUNTY:	CODE
Washington	53	Spokane	063
3. PHOTO REFERENCE			
PHOTO CREDIT:	William H. Trogdon		
DATE OF PHOTO:	April 12, 1970		
NEGATIVE FILED AT:	Eastern Washington State Historical Society		
4. IDENTIFICATION			
DESCRIBE VIEW, DIRECTION, ETC.			
View to the southeast, Riverside Avenue and Monroe Street facades (left to right).

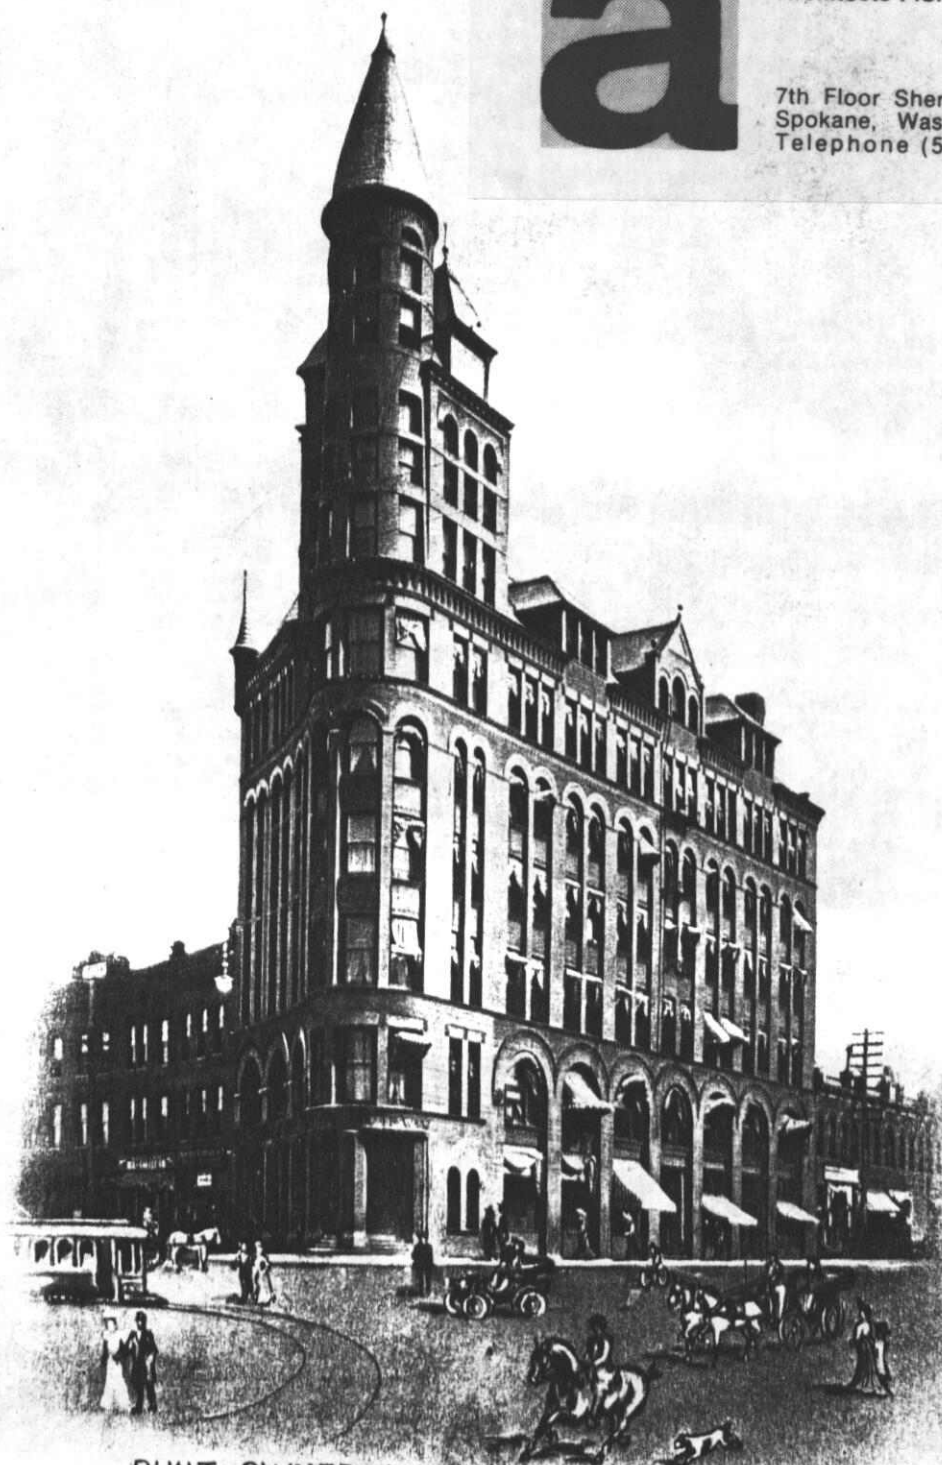
#1585. Review Bldg., early 1900's. S.E.
corner of Riverside and Monroe. 1889 Directory.

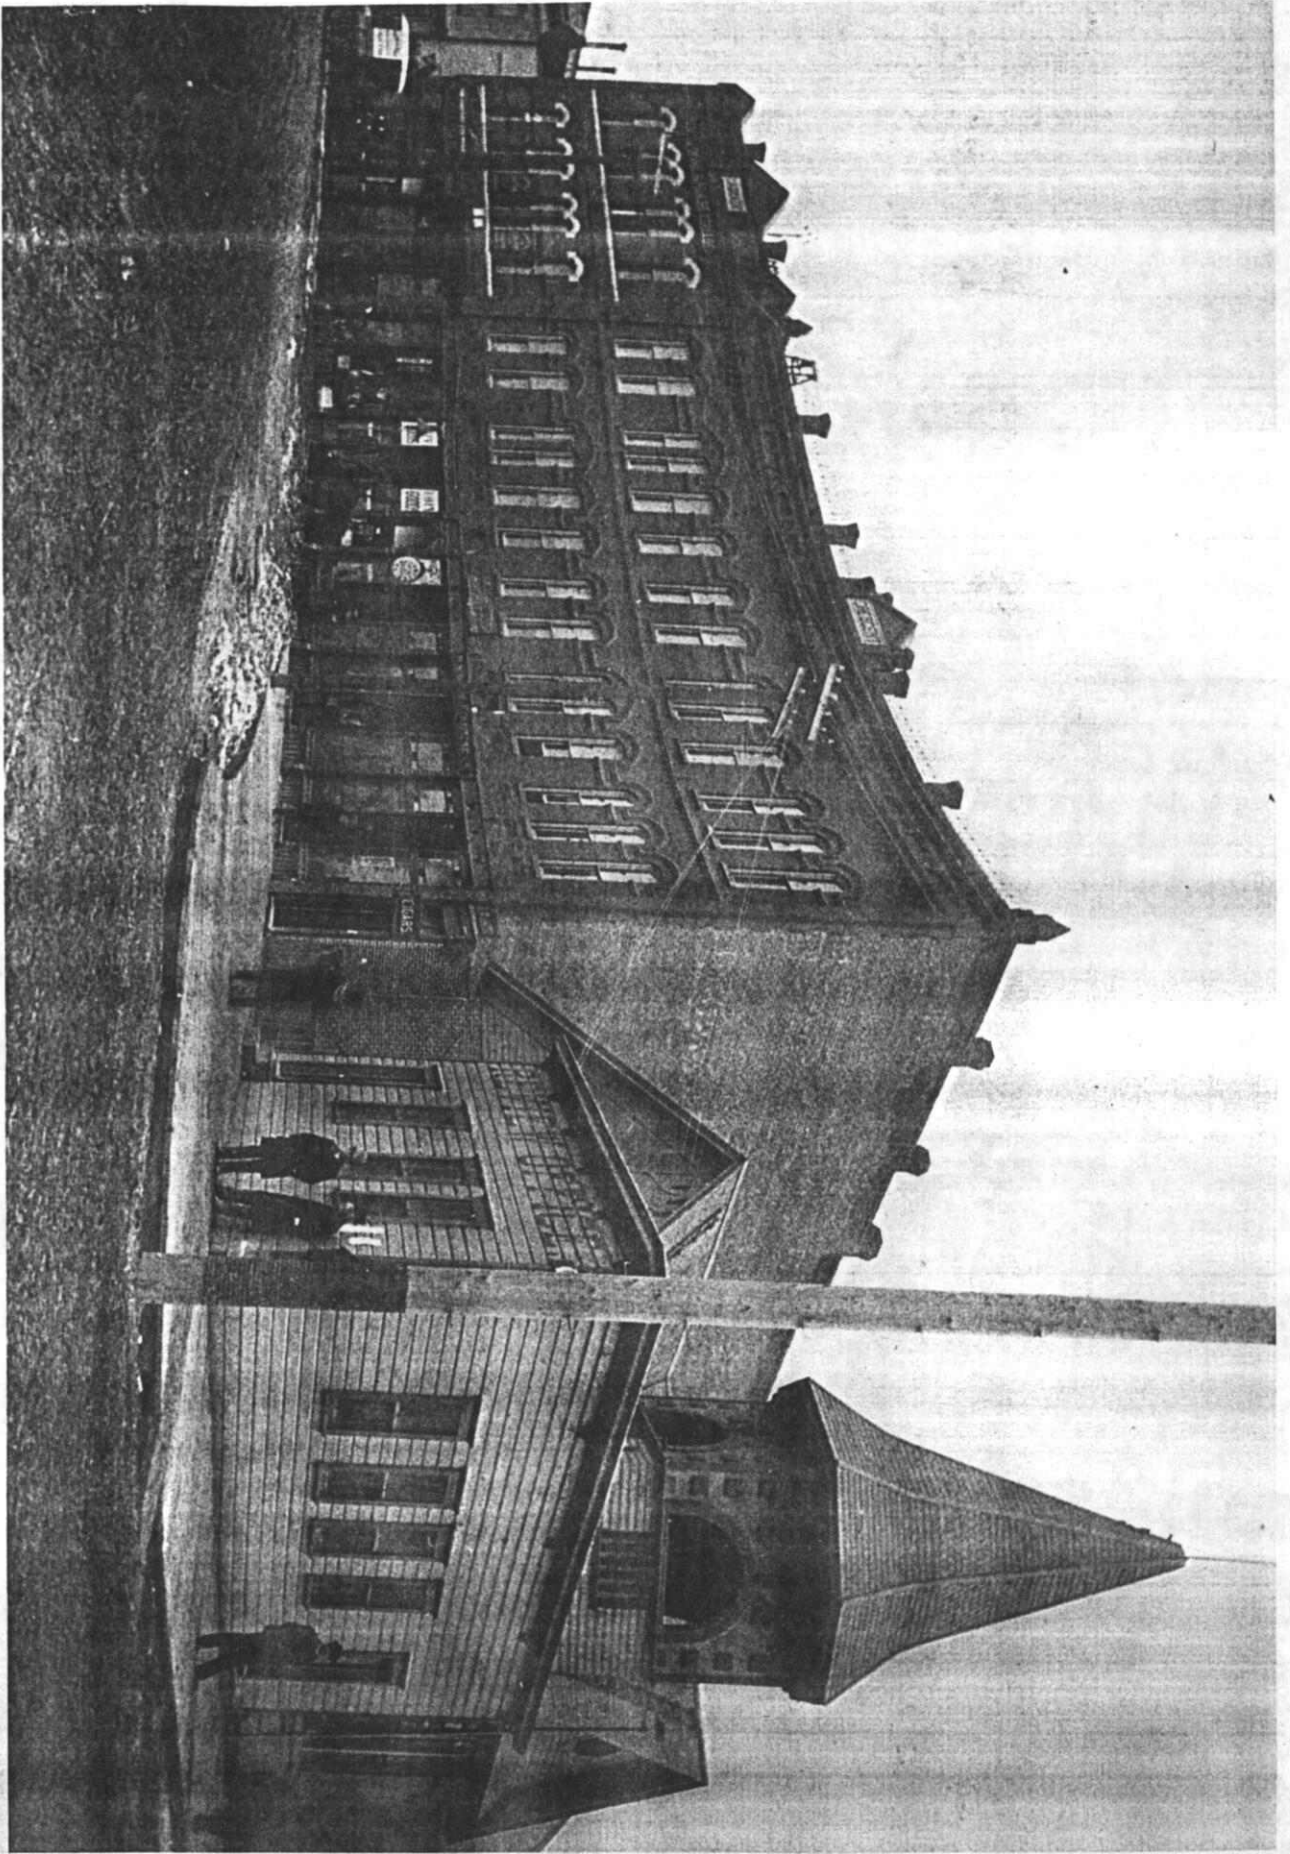
1. NAME			
COMMON:	The Review Building		
AND/OR HISTORIC:			
2. LOCATION			
STREET AND NUMBER:			
S.E. Corner of Riverside Avenue and Monroe Street			
CITY OR TOWN:			
Spokane			
STATE:	CODE	COUNTY:	CODE
Washington	53	Spokane	063
3. PHOTO REFERENCE			
PHOTO CREDIT:	William H. Trogdon		
DATE OF PHOTO:	April 12, 1970		
NEGATIVE FILED AT:	Eastern Washington State Historical Society		
4. IDENTIFICATION			
DESCRIBE VIEW, DIRECTION, ETC.			
Looking Southeast from Riverside Avenue
